Final Reclamation Inspection

Operator: PDC ENERGY INC

Location ID: 330514

Inspection Photos
Location Name: SKURICH ROTHE-65N63W 6NENW
Location ID: 330514

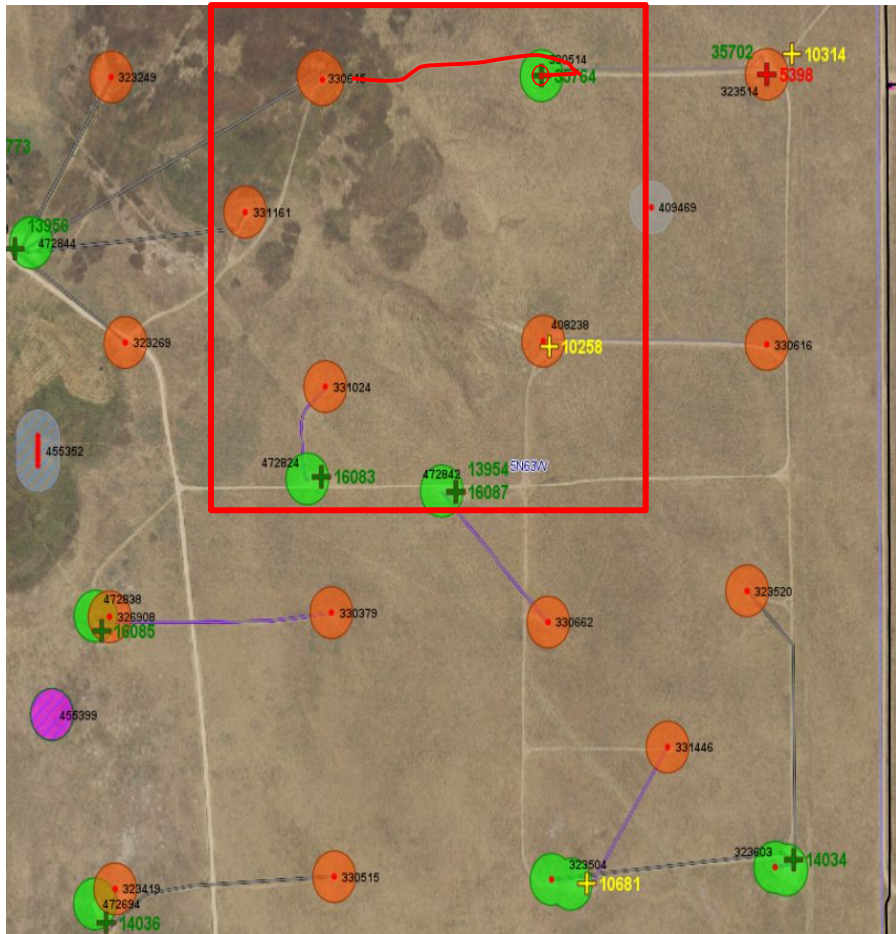
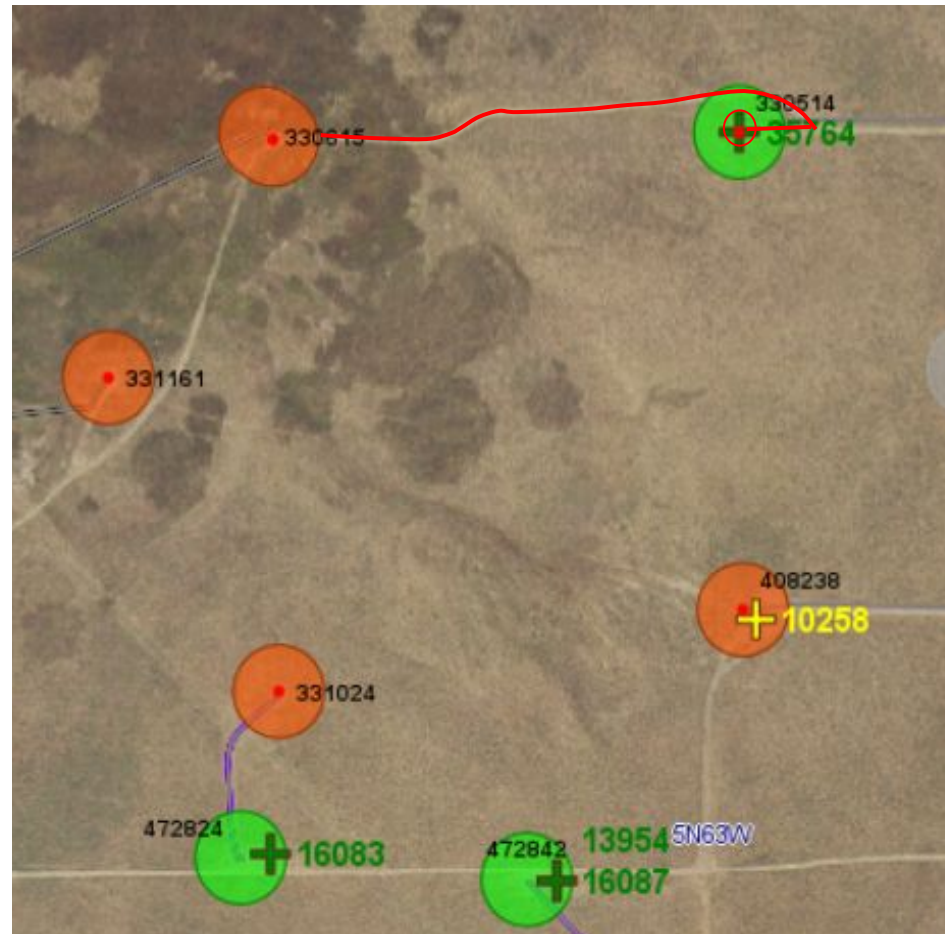
Photo 1 & 2: Satellite image of location showing an overview of area with the main lease road, access road and location highlighted in red.
