QB ENERGY OPERATING LLC ROLES-67S93W 13NESE (J13W) Facility # 334558

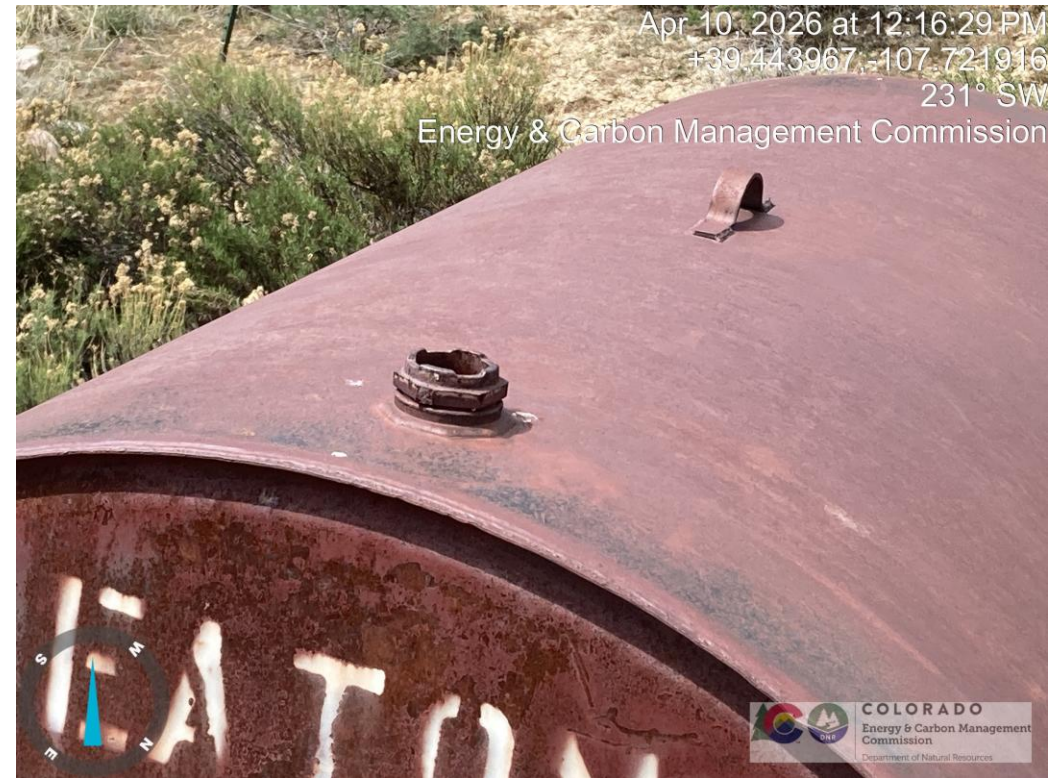
No lid on top of methanol tank.
