### Fort Lupton, CO, United States

Lat 40.094441, Long -104.780451  
03/25/2026 12:56 GMT-06:00  
ECMC : Environmental Inspection

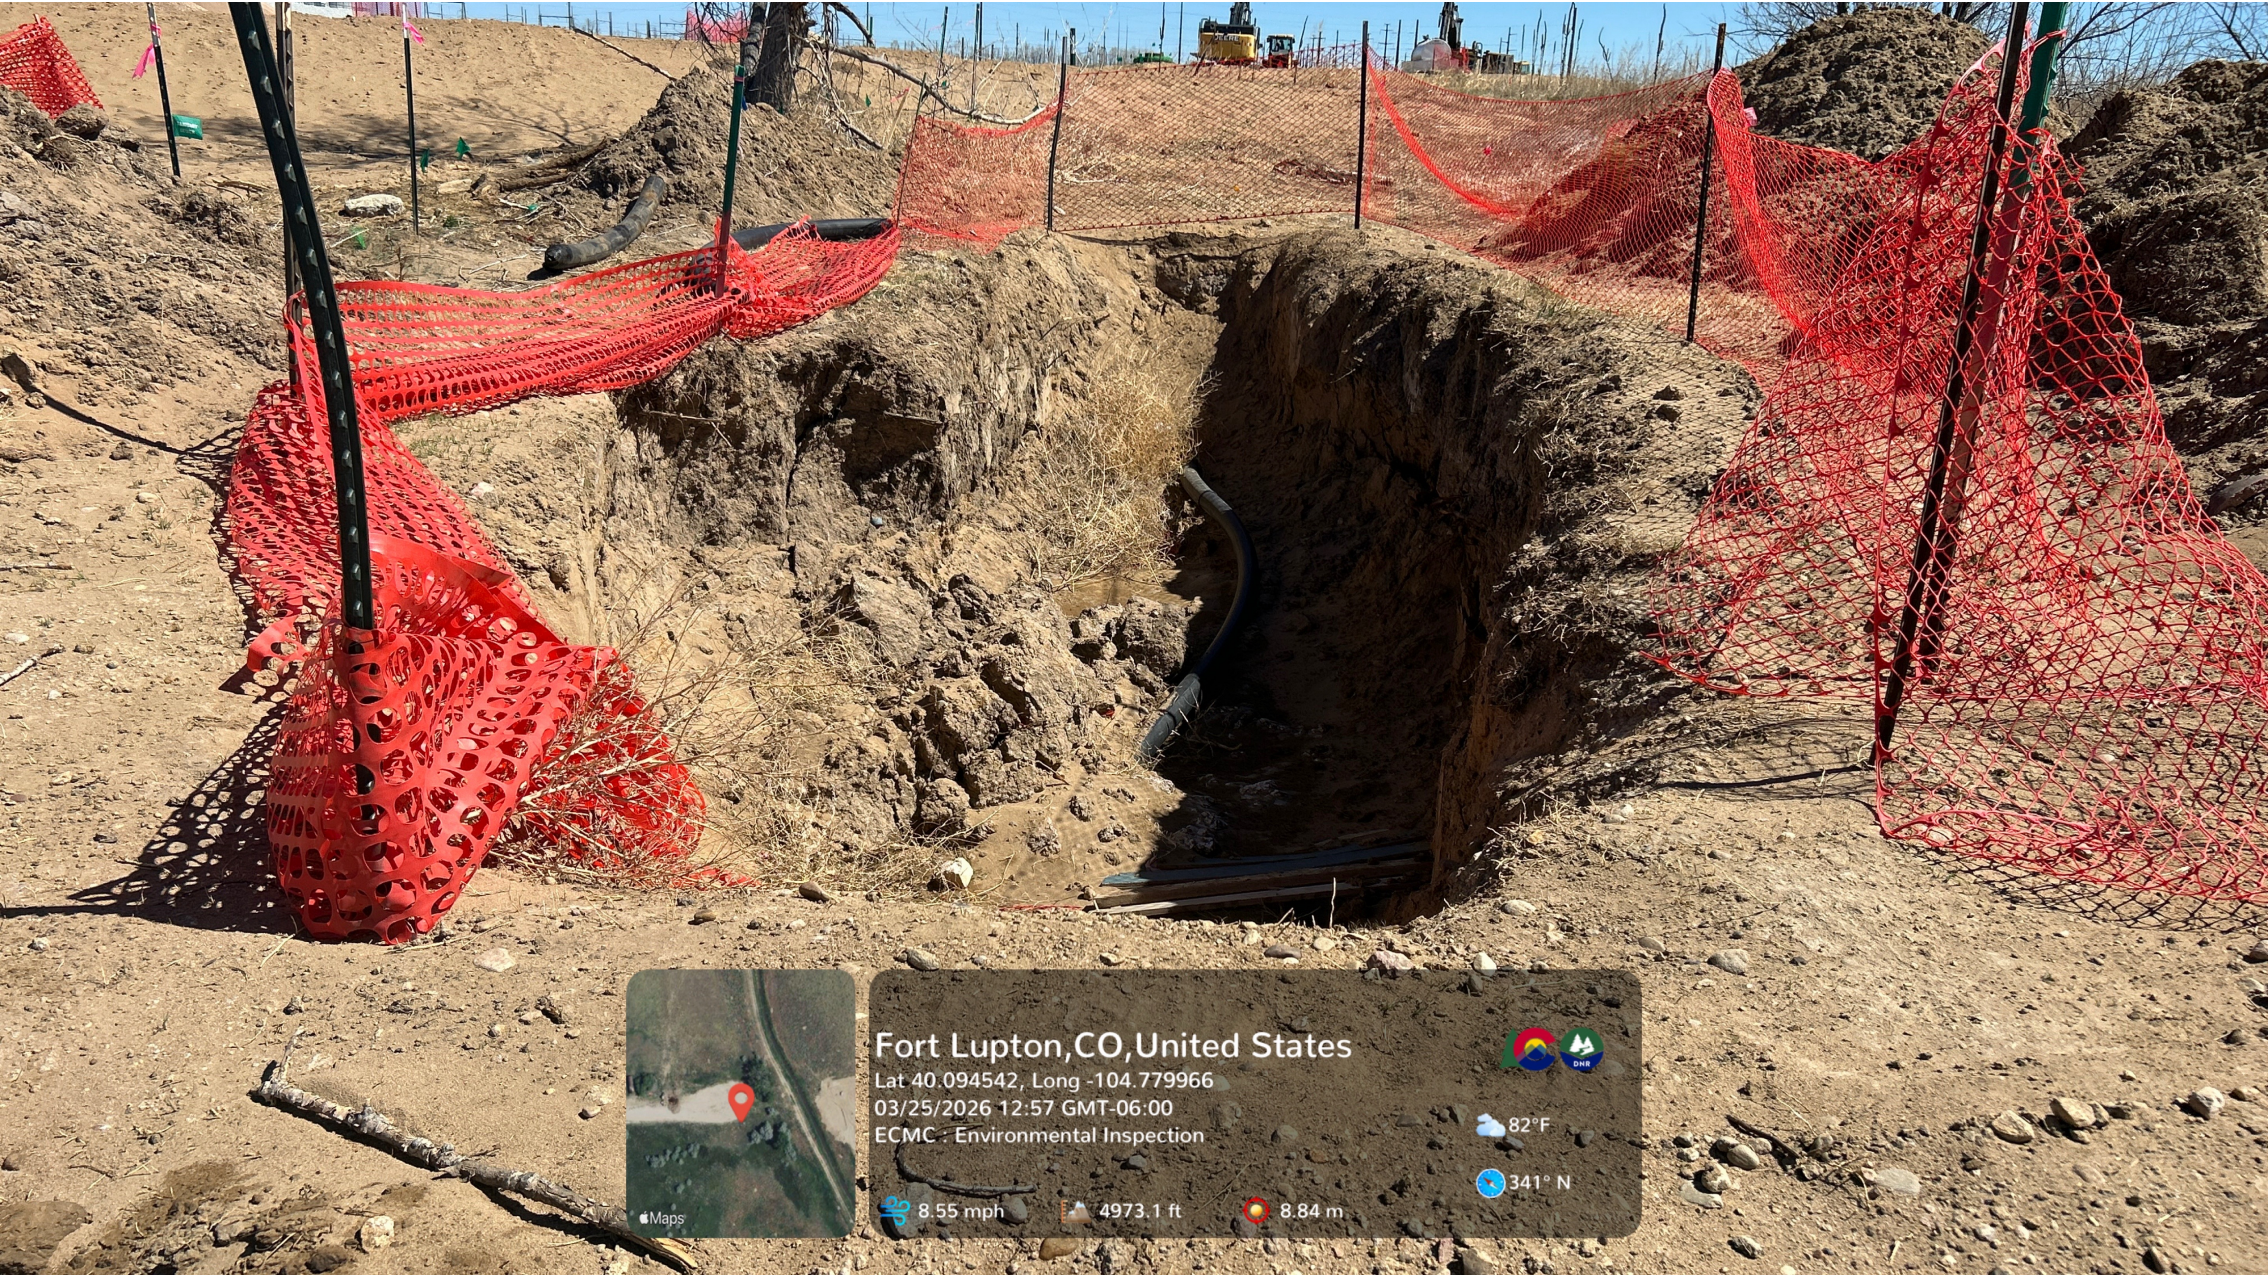
Flowlines are visible within the open excavation. Debris and soil mass failures obscure full visibility of the excavation base and sidewalls.

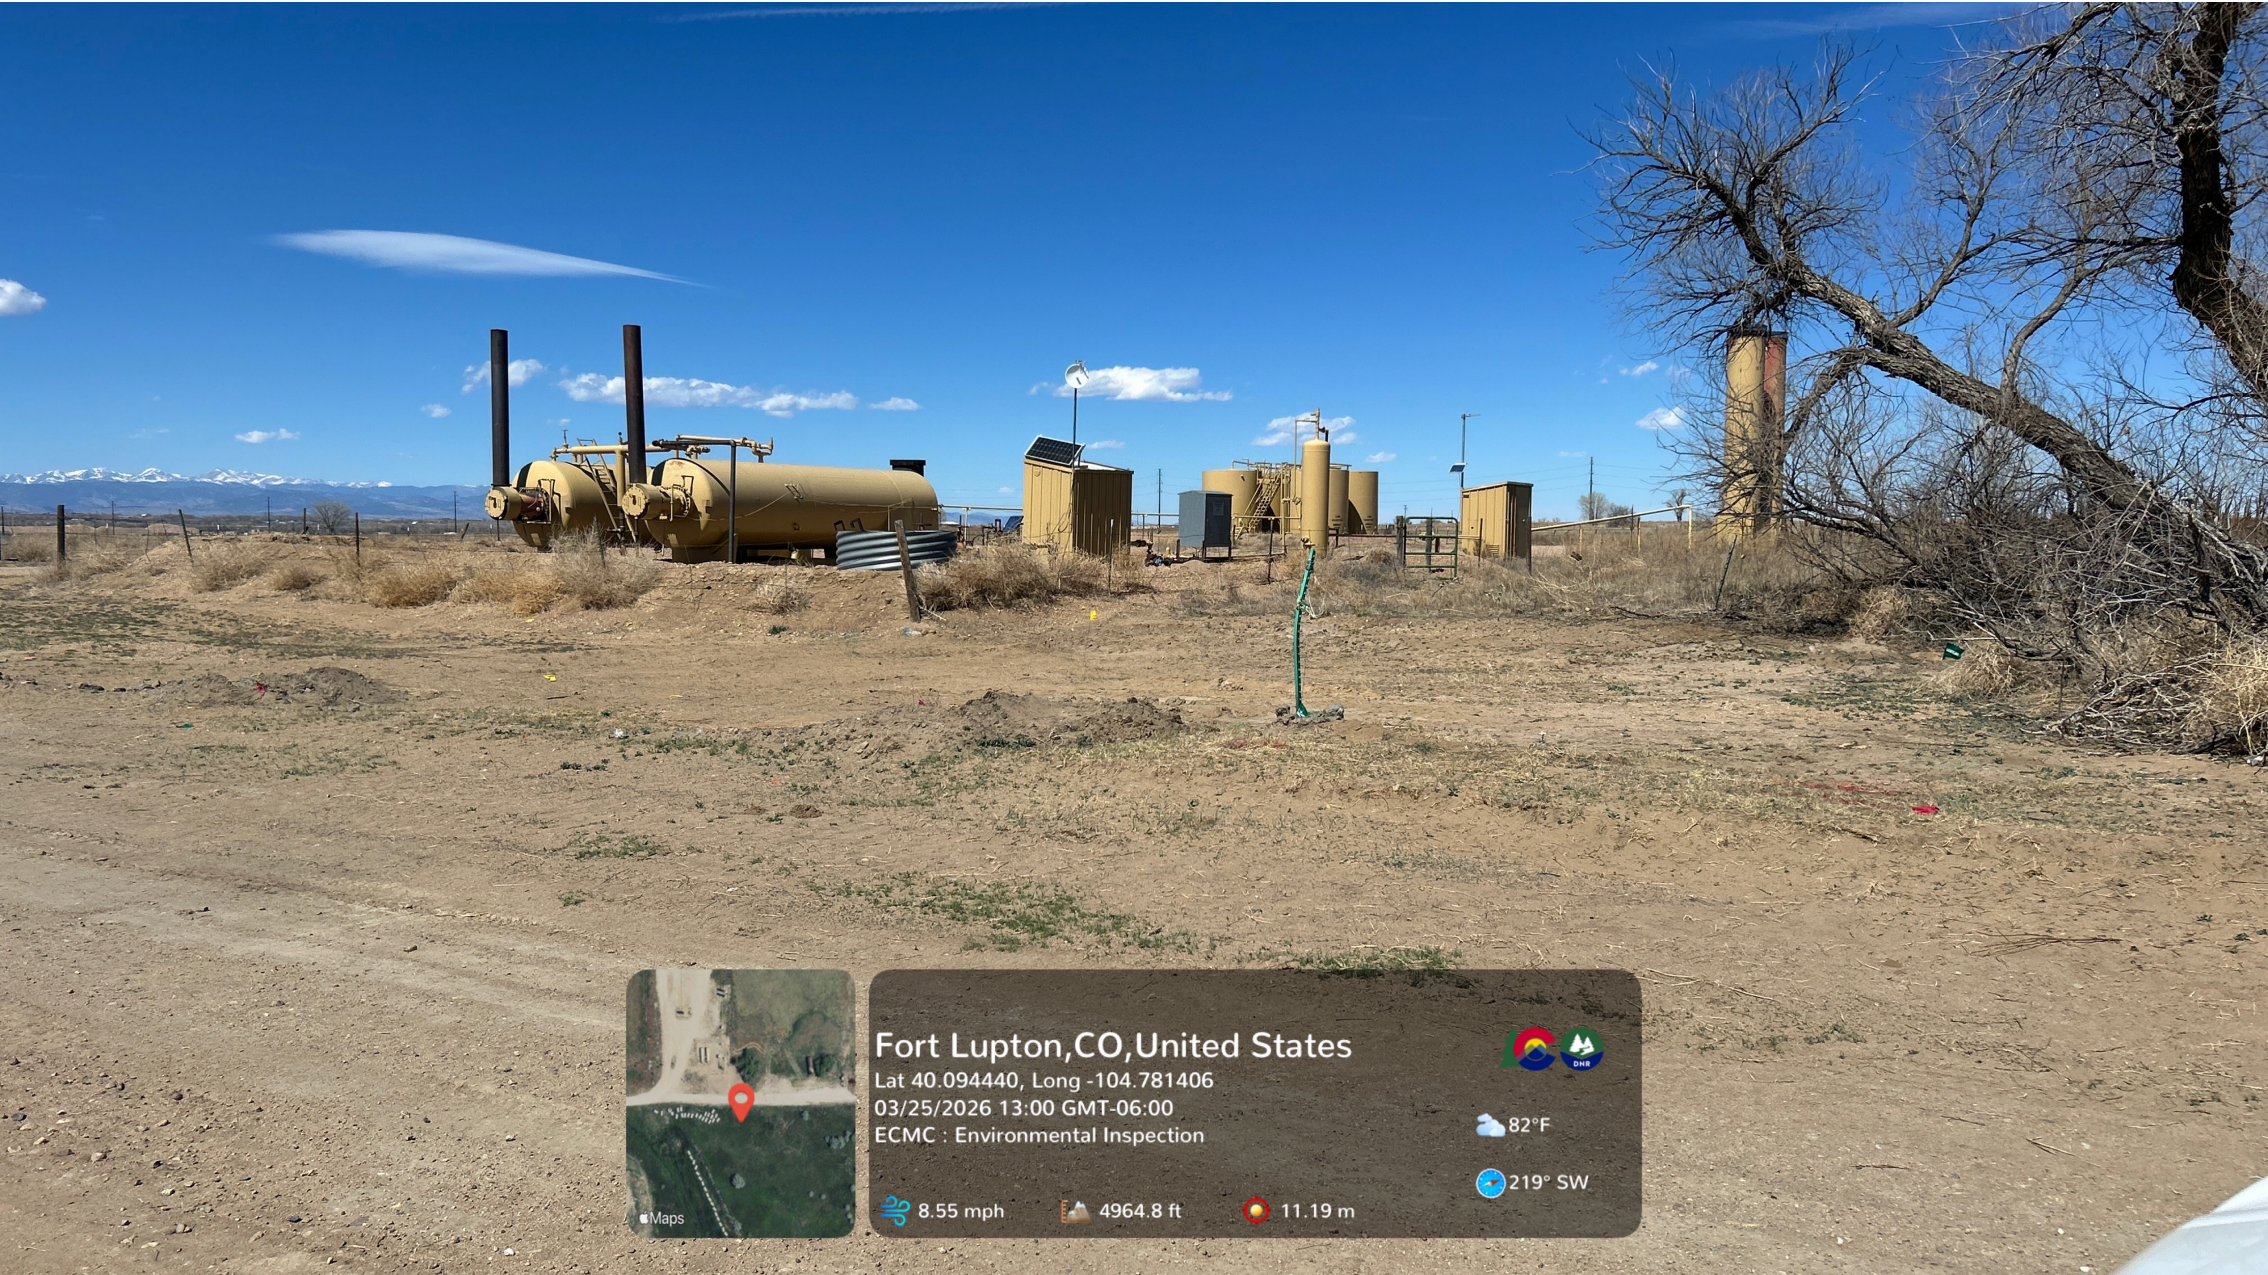
Looking at the Facility 2 Consolidation spill (Spill ID 490663). The excavation at the spill location has been backfilled. The Facility 2 tank battery is visible in the background.
