# CAST-M CASING INSPECTION

**KINDER MORGAN**

DOE CANYON # 10

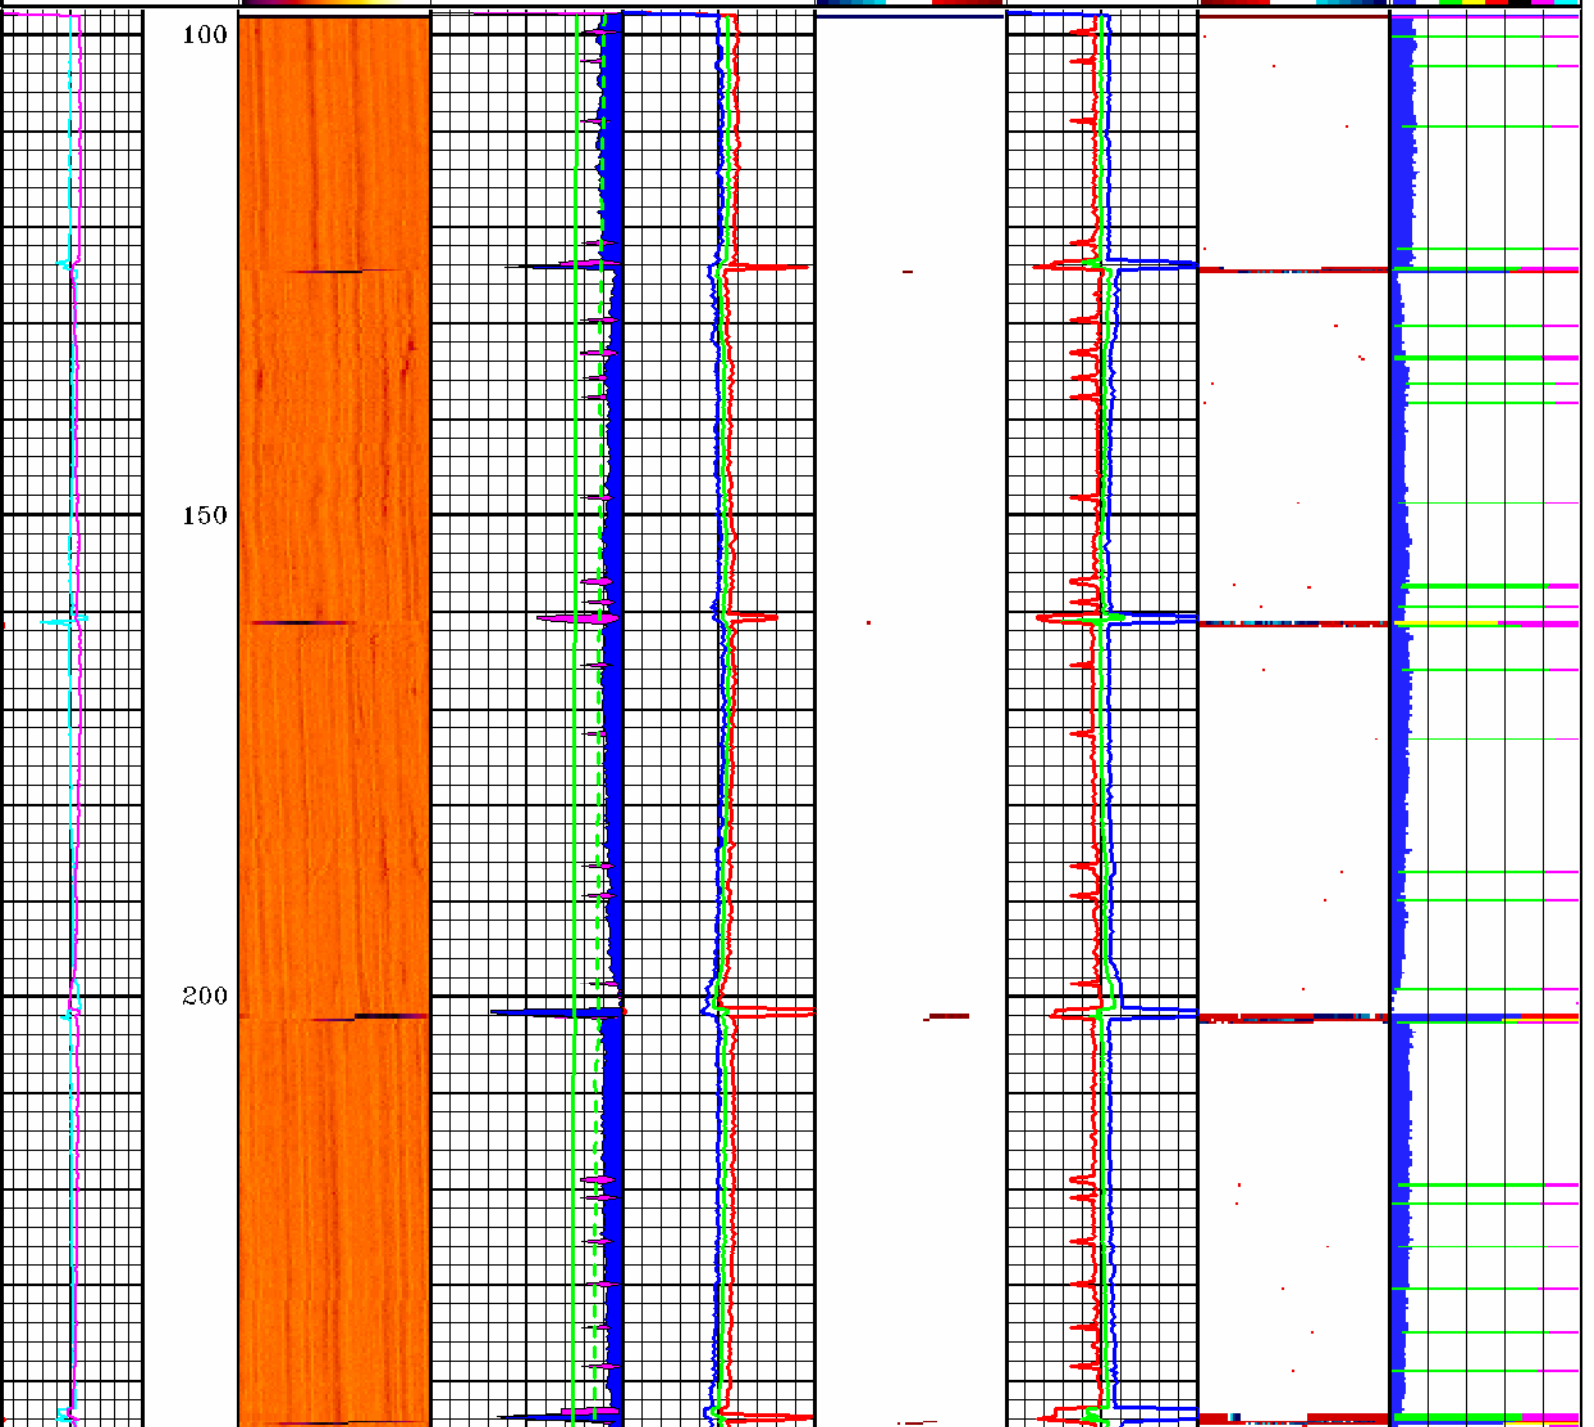
## VALUATION

INTERNAL%					
			EXTERNAL%

ECTY	1:240 FT.	PAMP	TOTDAMG	AVRADN	PRADN	AVTHIKN	THKPN	DAMAGEP
AVTHIK			INTDAMG	MXRADN		MXTHIKN		
AVRAD			FTT	MNRADN		MNTHIKN		
			FTT
