SPILL/RELEASE REPORT

Date of Incident: <u>5/7/2013</u> Facility Name & No: <u>Hotchkiss Federal 12-89-612S89W18NWNE (Fac. # 324481)</u>	County: <u>Gunnison</u>
Type of Facility (well, tank battery, flow line, pit): <u>Flow Line Hotchkiss Federal 18-31 Well Pad</u>	QtrQtr: <u>NWNE</u> Section: <u>18</u>
Well Name and Number: <u>Hotchkiss Federal 18-31</u>	Township: <u>12S</u> Range: <u>89W</u>
API Number: <u>05-051-06071</u>	Meridian: <u>6th</u>

Attachment A - Spill Location Map
Location: 18-31
Gunnison Energy Corporation

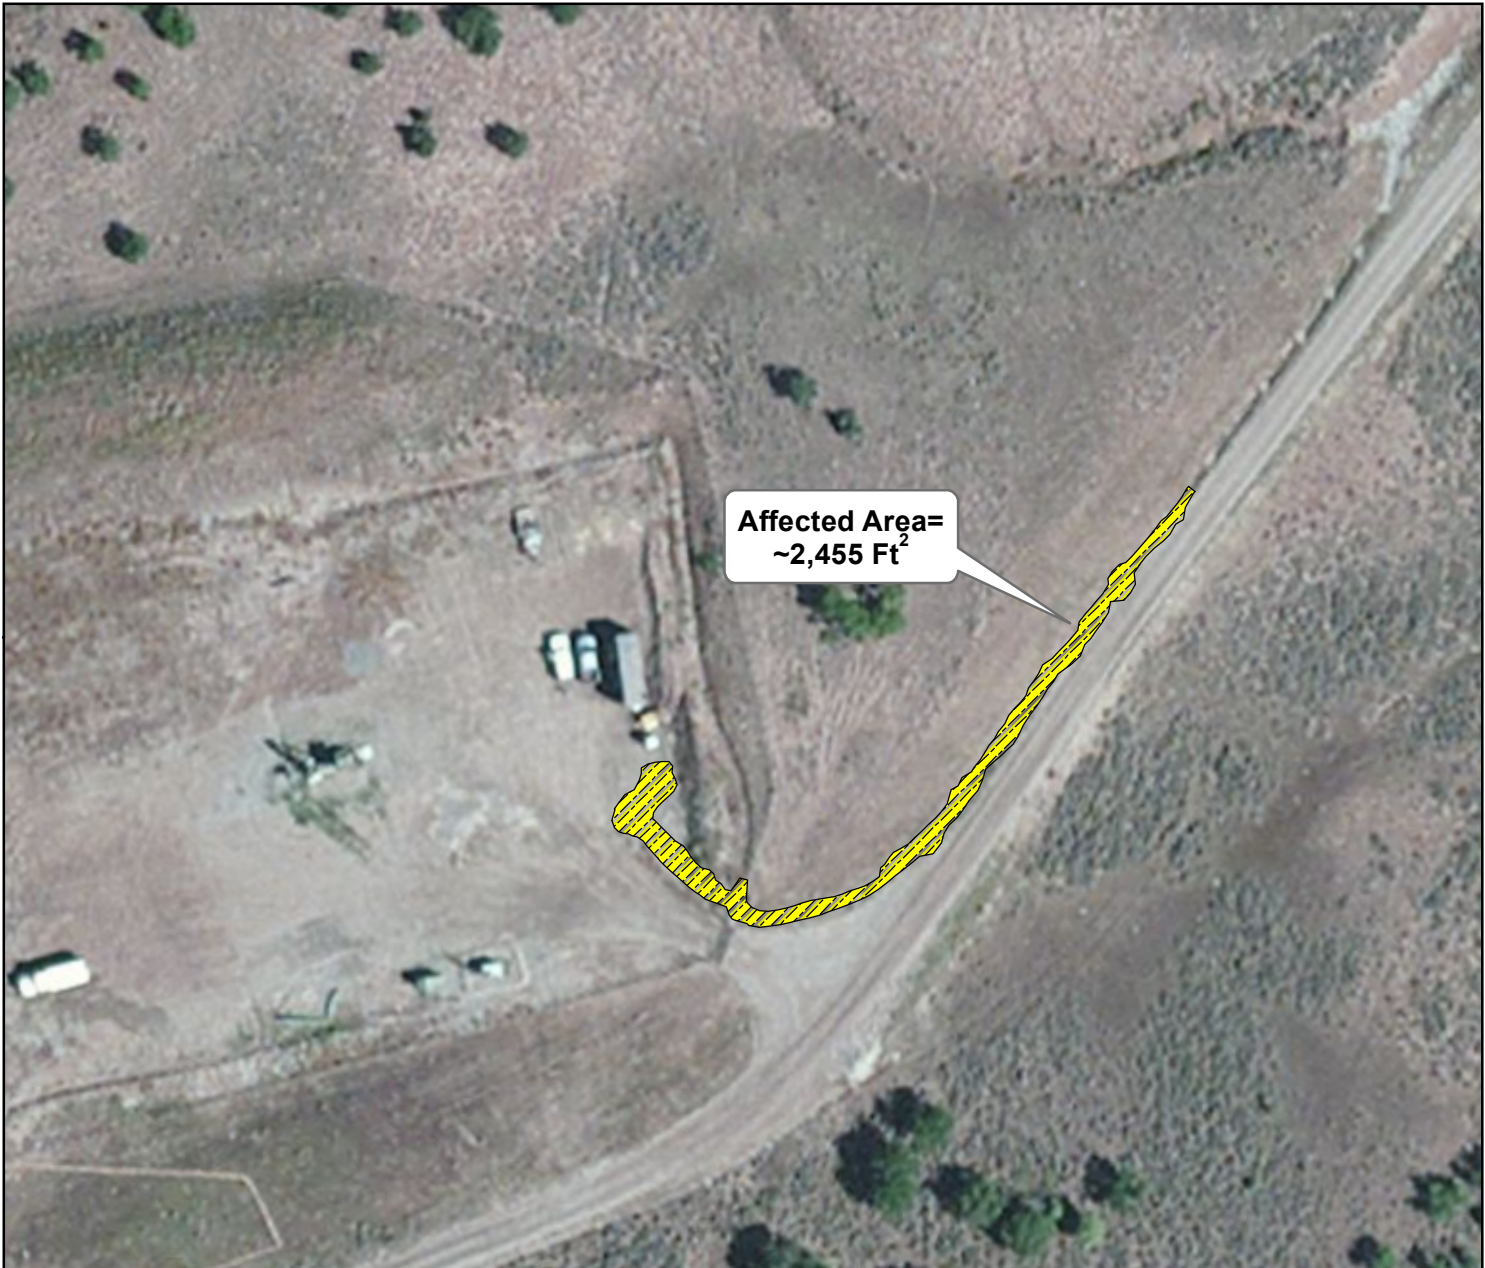
Affected Area=
~2,455 Ft²

Cause of spill (e.g. equipment failure, human error, etc.): Equipment Failure Detailed description of the spill/release incident:
 The ball valve on the flow line running from the separator units to an area where production equipment was previously placed failed due to freezing. this allowed produced water to migrate to the surface. The produced water migrated out onto the well pad and then flowed off the southeast corner and down the access road bar ditch approximately 475 feet.
