**Culver 44-12**  
**774' FSL & 664' FEL, (SE/SE), Sec. 12, T8N, R79W, 6th p.m.**  
**Lat/Long: 470.67314/-106.19994 (11/3/10, R. Miller, PDOP 1.8)**  
**Jackson County, Colorado**  
**API #05-057-06484**

**P&A Procedure**

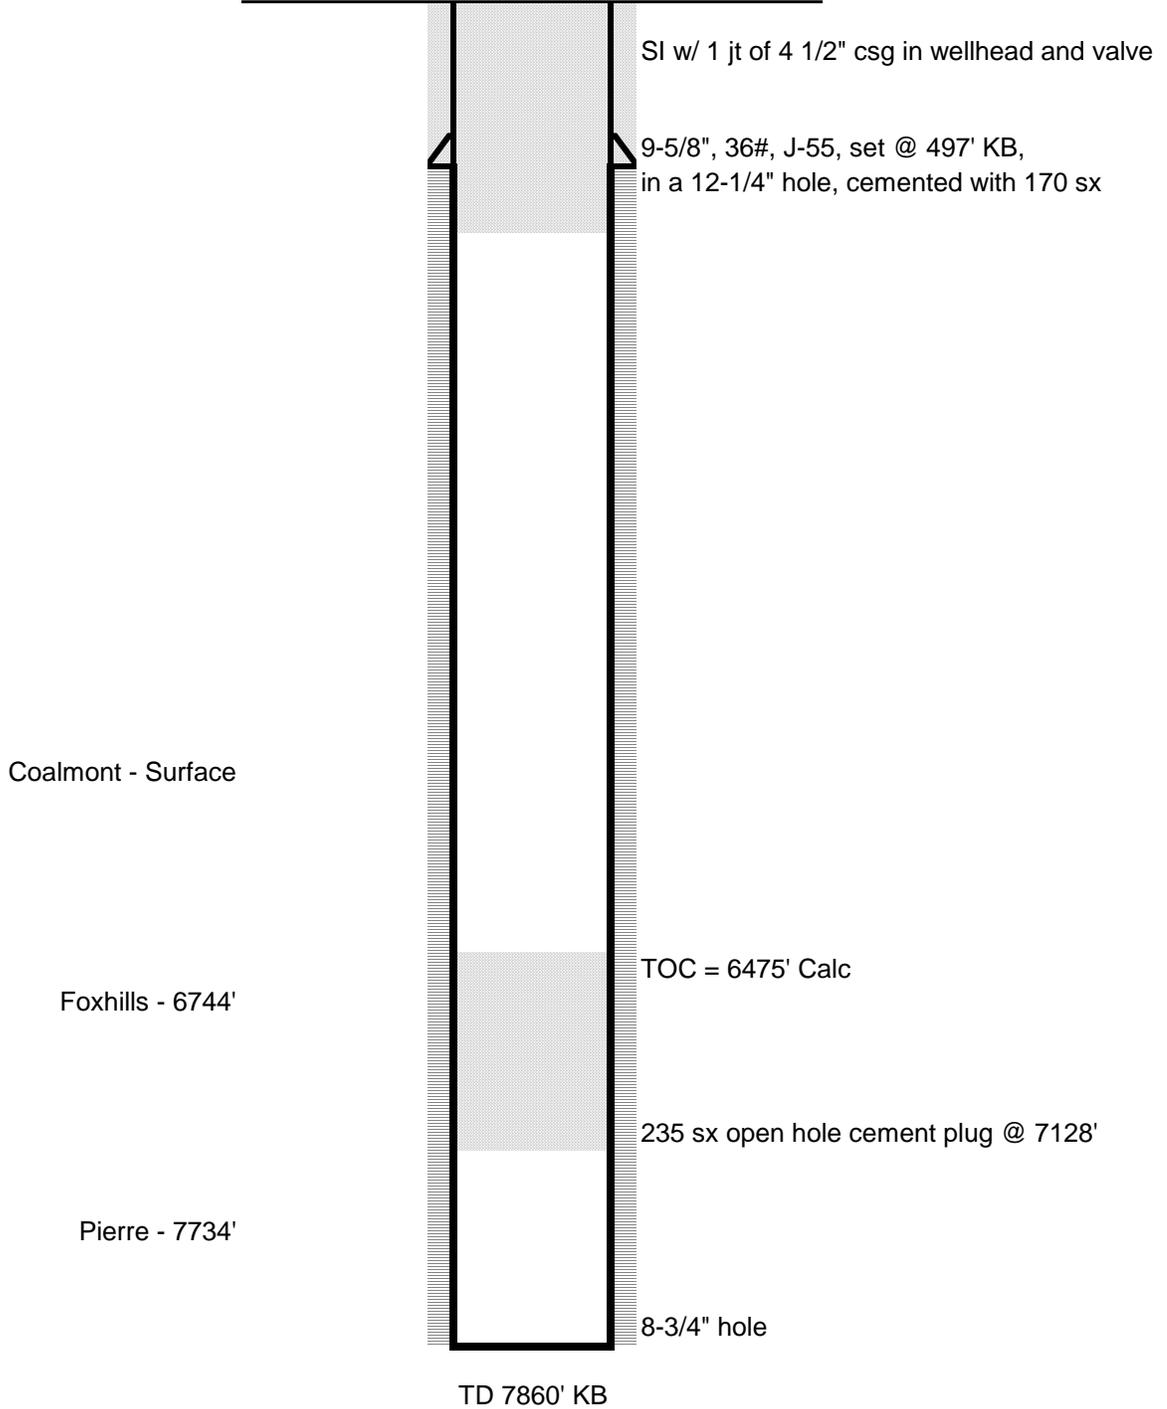
**Culver 44-12**  
**774' FSL & 664' FEL, (SE/SE), Sec. 12, T8N, R79W, 6th p.m.**  
**Lat/Long: 470.67314/-106.19994 (11/3/10, R. Miller, PDOP 1.8)**  
**Jackson County, Colorado**  
**API #05-057-06484**

8284' KB  
8270' GL

1. Currently well well is TA with an open hole cement plug set @ 7128' and a calculated TOC of 6475'.
2. RIH with work string to 600' and cement back to surface with 250 sx.
3. SD and mointor cement level, top off if necessary
4. Cut casing 4' below surface and weld on plate with weep hole.
5. Plate to contain following info.
