Bison Oil Well Cementing Single Cement Surface Pipe

Customer: encana
 Well Name: McConahay 1c-34h

County: weld
 State: Colorado
 Sec: 34
 Twp: 2n
 Range: 66w

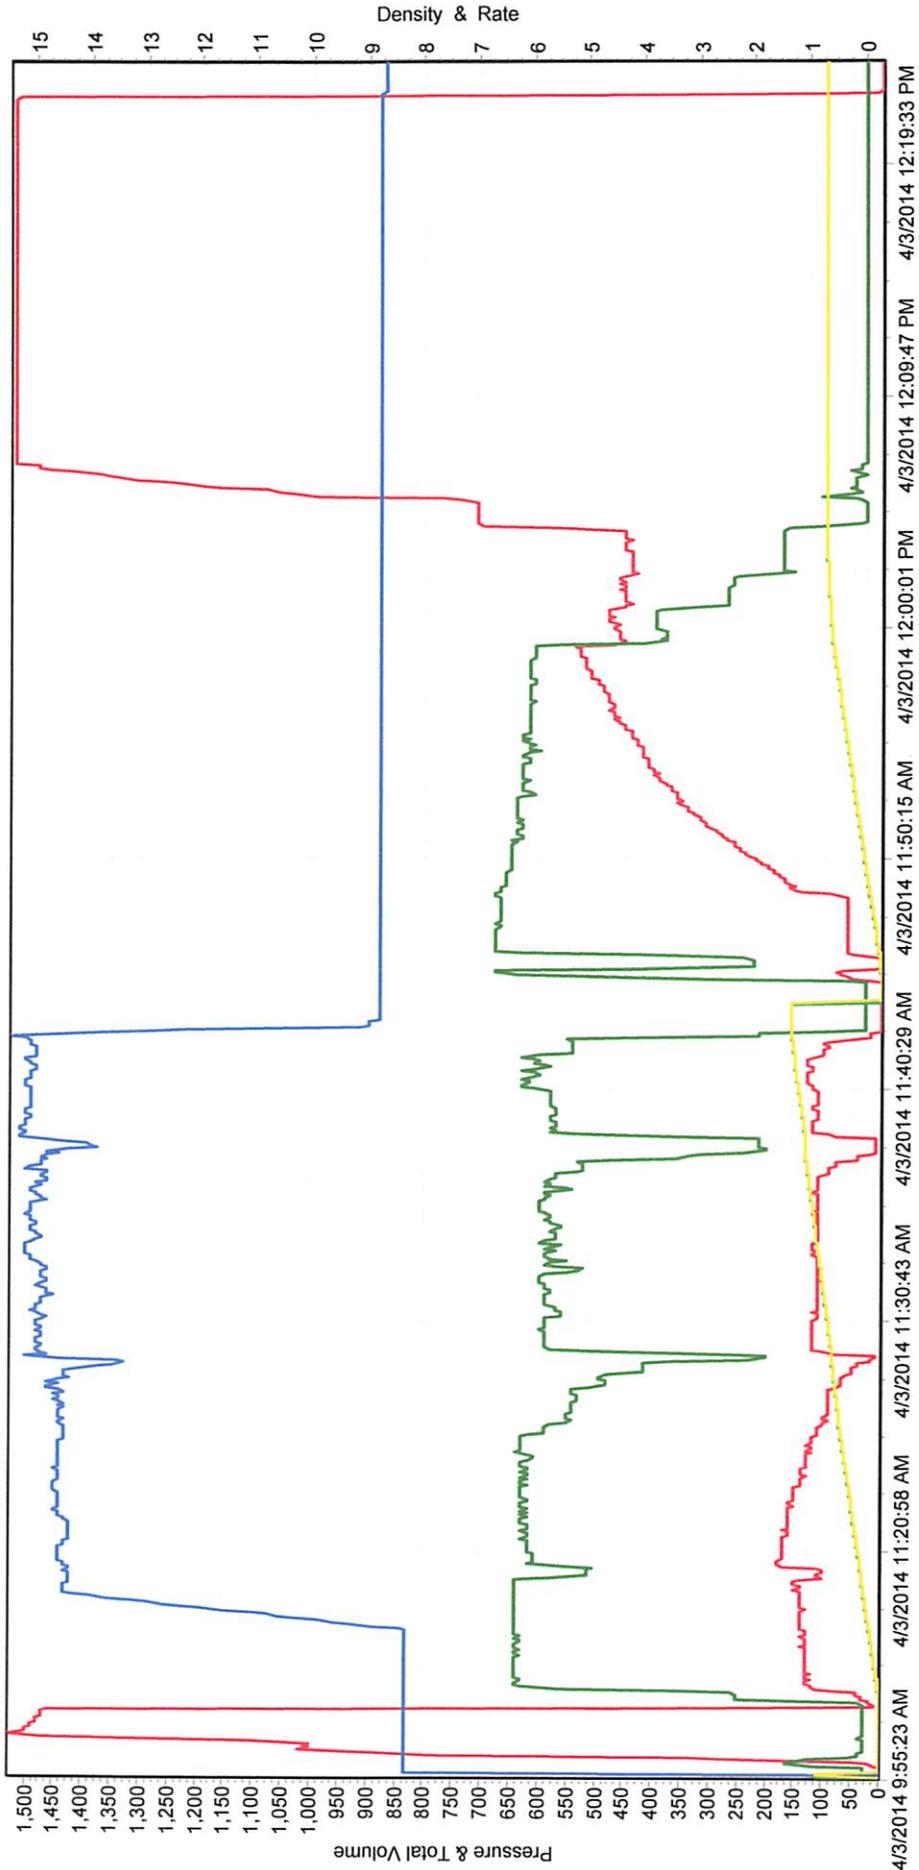
M/D TOTCO 2000 SERIES

— PSI — Barrels / Minute — Barrels — Lbs / Gallon — Stage Volume
