Love Ranch Centralized E&P Waste Annual Report  
Piceance Creek Facility  
Facility ID: 149012

Centralized E&P Waste Management Facility

Love Ranch Evaporation Pond

COGCC Facility No. 149012

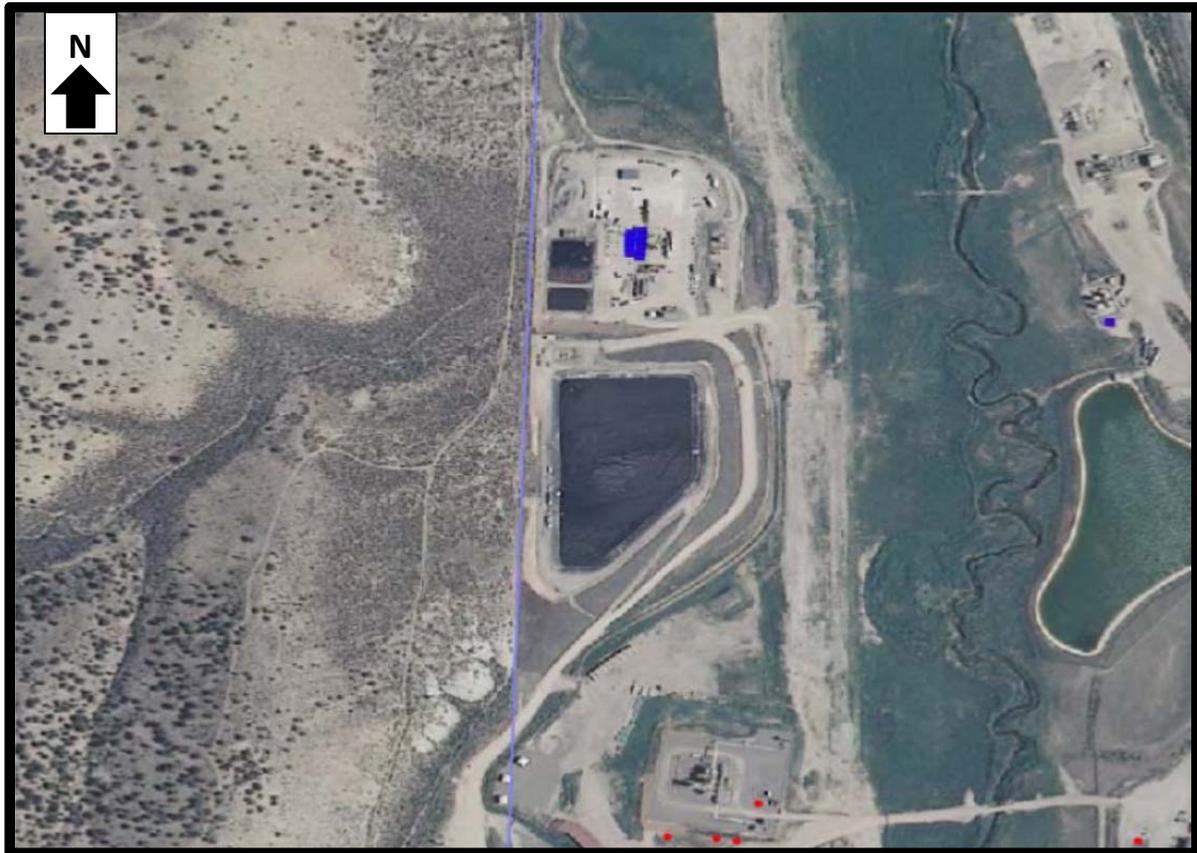
Love Ranch Centralized E&P Waste site is located in Rio Blanco County, approximately 45 miles north/northwest of Rifle, Colorado. This site includes a salt water disposal (SWD) pond and its associated pumping and storage facilities. The purpose of the pond is to retain produced water from natural gas operations and production.

Location: SWNW Section 9, Township 2 South, Range 97 West

Latitude/Longitude: 39.892642 / -108.296246
