# PIONEER

RE: 2014 1101(e)(1) Variance report

Pioneer Natural Resources USA, Inc. ("Pioneer") is submitting this letter in compliance with the conditions of approval of a variance to COGCC rule 1101(e)(1). This variance, document 200338696, was approved on 3/1/12. Pioneer has completed the installation of pressure transducers on water flow line at 161 wells in strategic locations throughout the field. These transducers are linked to our SCADA system and they monitor pressure on the water gathering system and initiate shut-down of the water pump on the wellhead if pressure spikes or other conditions are detected. These sensors also aid in the operation of the wells and ensure that we operate our 800 mile water gathering system within manufacturer's specifications and best engineering limits.

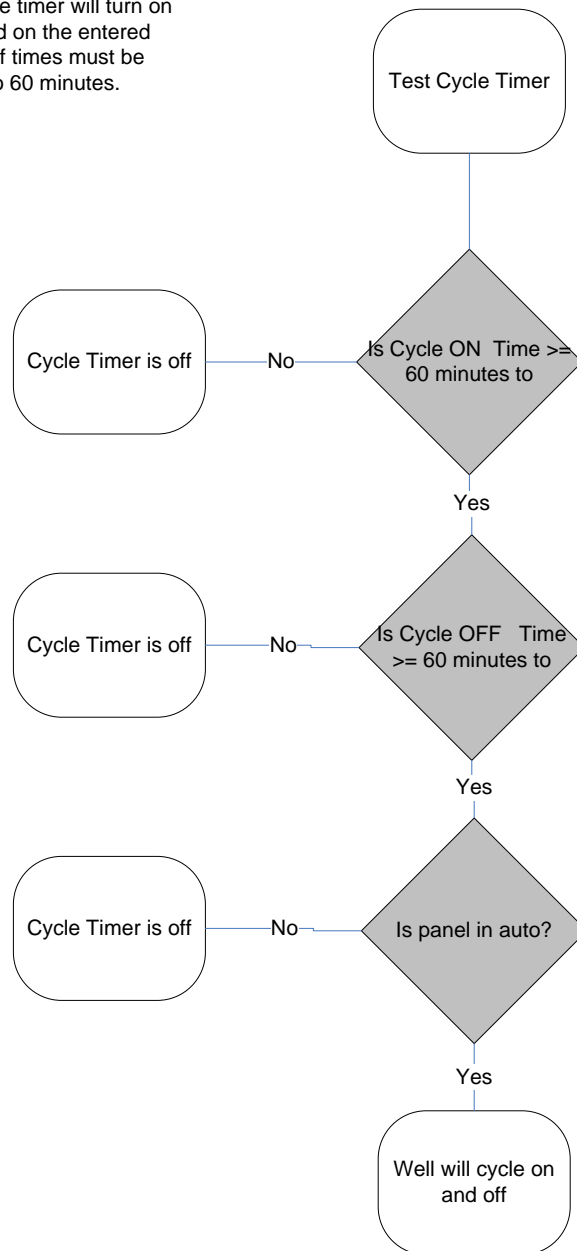
## Cycle Operation

When enabled, the cycle timer will turn on and off the well based on the entered times. The on and off times must be greater or equal to 60 minutes.
