SITE INVESTIGATION AND REMEDIATION WORKPLAN

Name of Operator: OXY USA Inc.

Facility Name: Brush Creek Gathering System

Facility Number: 412237 (Spill point #441603)

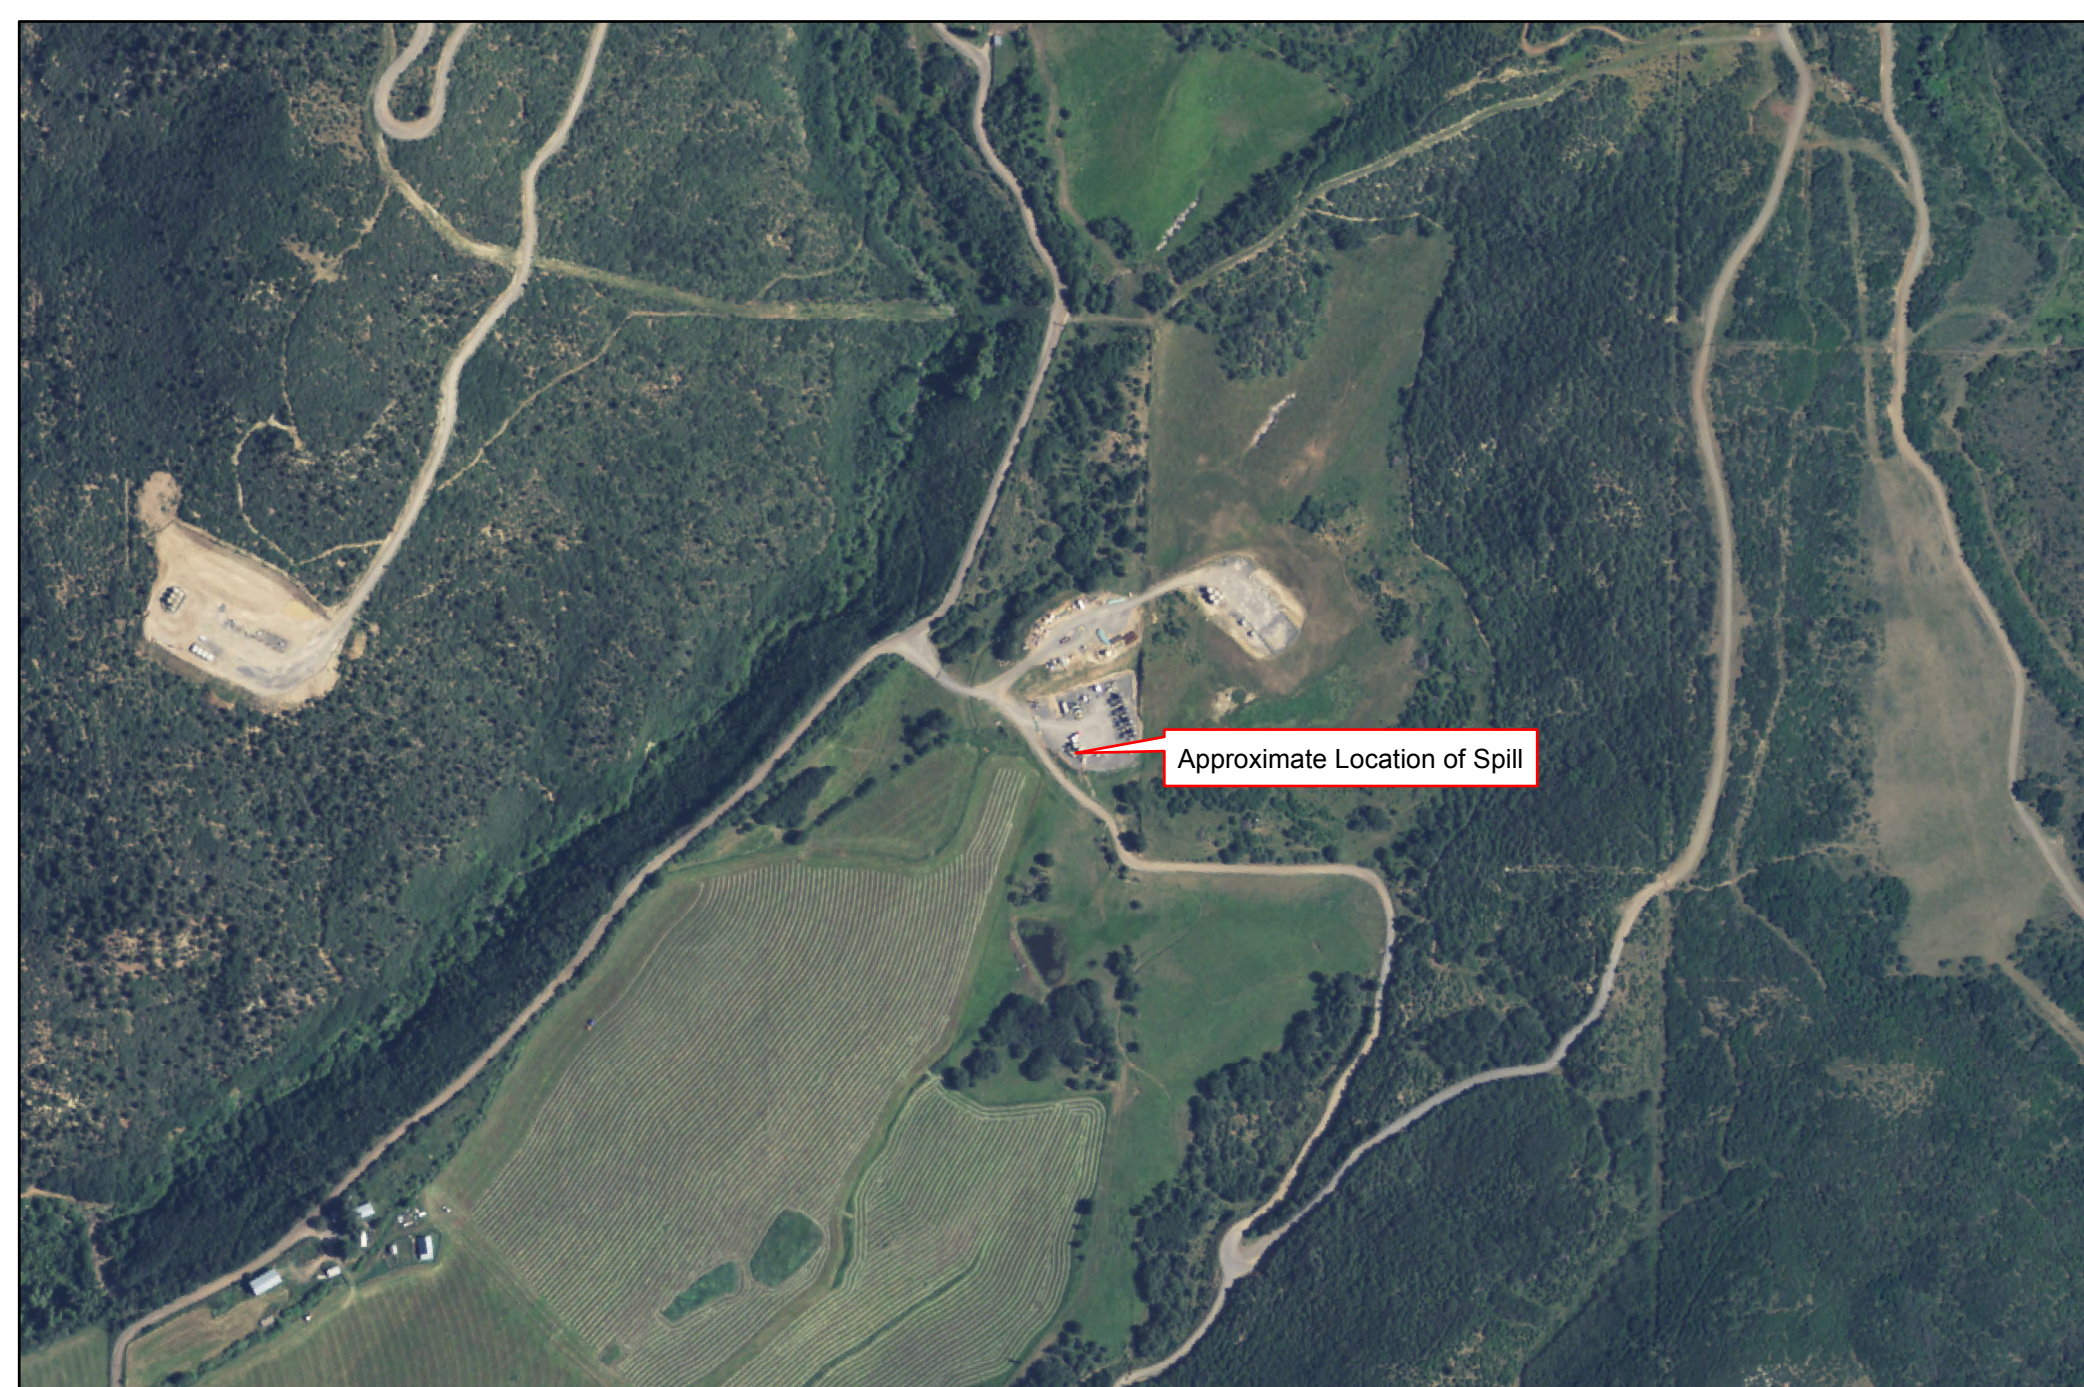
North Wall
North Hole Bottom
East Wall
West Wall 8'
South Bottom Low
South Wall 8'

- ⊗ Proposed Down-Gradient MW Location
- Excavation Characterization Sample Location
- Approximate Spill Excavation

Brush Creek Compressor Station (Fac ID 412237) spill occurred on 4/23/2015

QtrQtr: NWNE Section: 14 Township: 9S Range: 94W 6th PM
