Love Ranch Centralized E&P Waste Annual Report

Piceance Creek Facility

Love Ranch Evaporation Pond

LOVE RANCH 8 EVAPORATION POND (SWD POND) RIO BLANCO COUNTY, COLORADO

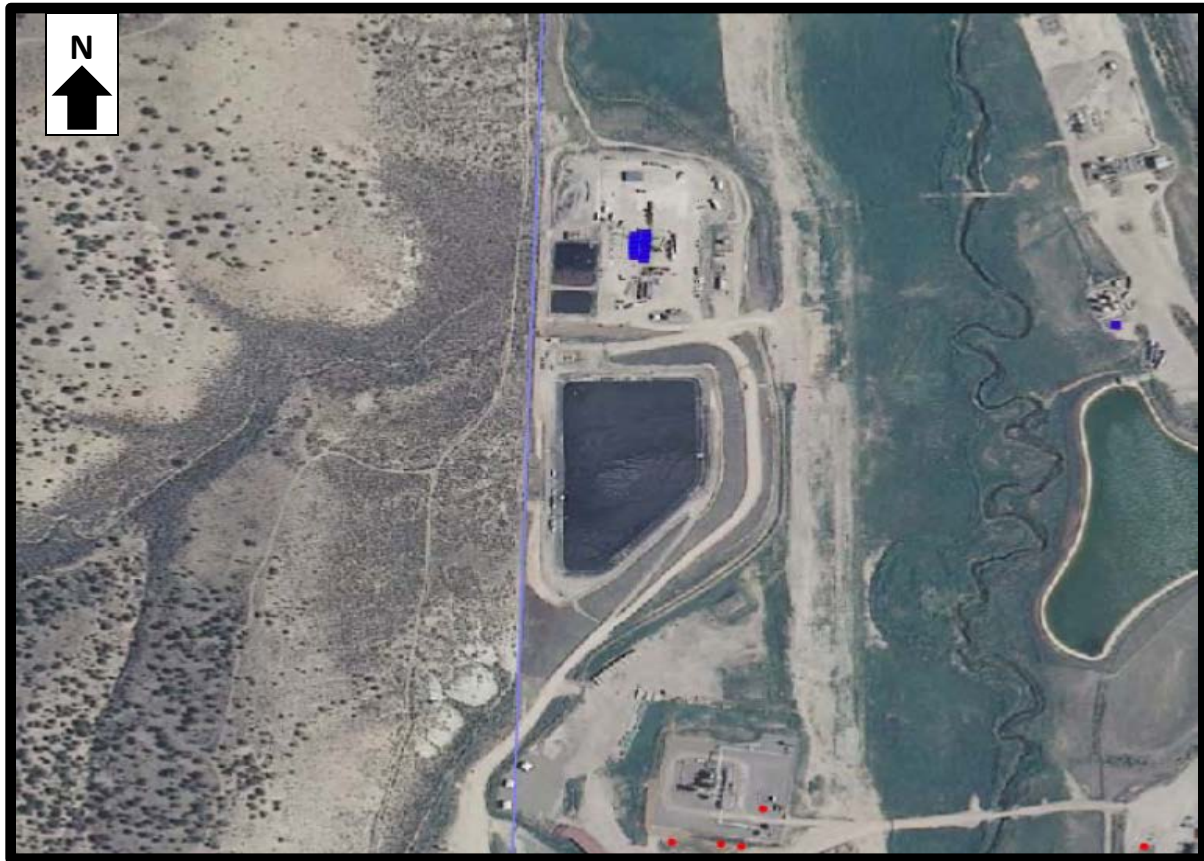
Love Ranch Centralized E&P Waste site is located in Rio Blanco County, approximately 45 miles north/northwest of Rifle, Colorado. This site includes a salt water disposal (SWD) pond and its associated pumping and storage facilities. The purpose of the pond is to retain produced water from natural gas operations and production.

Location: SWNW Section 9, Township 2 South, Range 97 West

Latitude/Longitude: 39.892642 / -108.296246
