LINN Energy

Piceance Asset

Parachute, Colorado

K15 696 Landfarming Plan – Land Application #443348

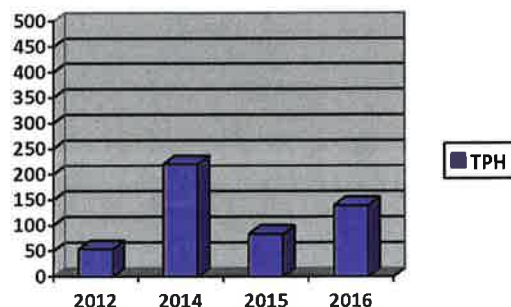
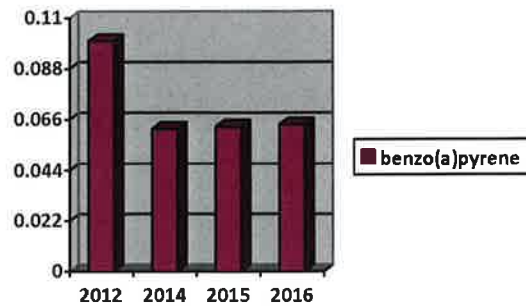
- At the current time, this location has been tilled three times. Analysis of the pre-treatment samples recommended increasing the ammonia-phosphorus fertilizer at a slightly higher rate than previous rate and adding fulvic acid. A copy of the pre-treatment lab report is attached to the Form 27. The landfill spoils piles have been spread out even more on the site, but to achieve optimum exposure to sunlight and air, approximately 6,500 cubic yards will be moved to the L15 696 and spread out to approximately 12" – 16" high. The remaining 6,294 cubic yards will be spread out on the K15 696 pad to approximately 12" – 14" depth. A diagram of the L15 696 pad is attached to the Form 27.
