Subject: **Proposed Remediation Report**
 Stephens #1
 API # 05-123-11552
 SENW Sec 15, T4N, R66W
 Weld County, Colorado
 Fremont Project No. C014-027
 Facility #243760, Remediation # 8307, Spill #2148350

PROPOSED REMEDIATION REPORT
HOMESTEAD OIL INC.
STEPHENS #1 WATER VAULT RELEASE
WELD COUNTY, COLORADO
FREMONT PROJECT NO. C014-027
FACILITY #243760, REMEDIATION #8307, SPILL #2148350

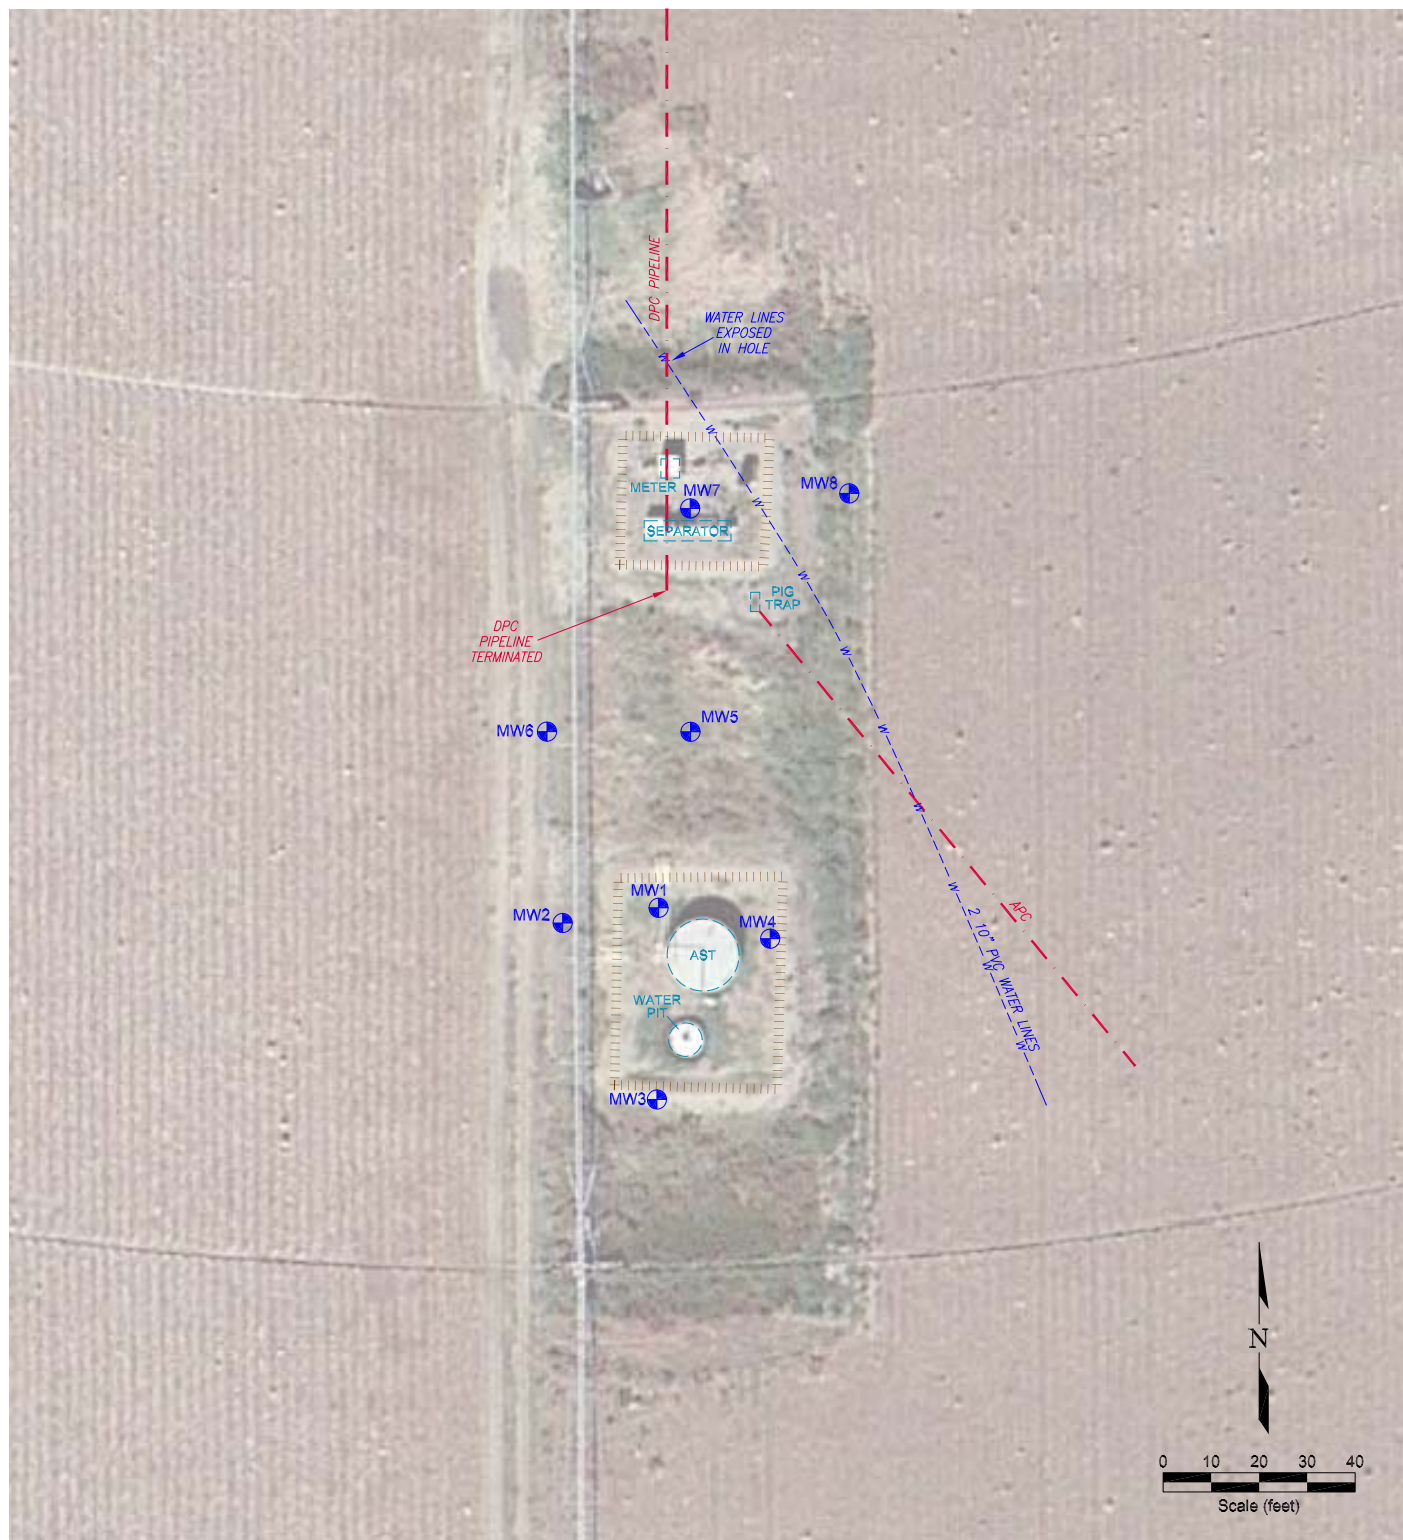
Figure 2
SITE MAP

MONITORING WELL
	CONTAINMENT
	FORMER FACILITY
	PIPELINE
	WATER LINE (buried)

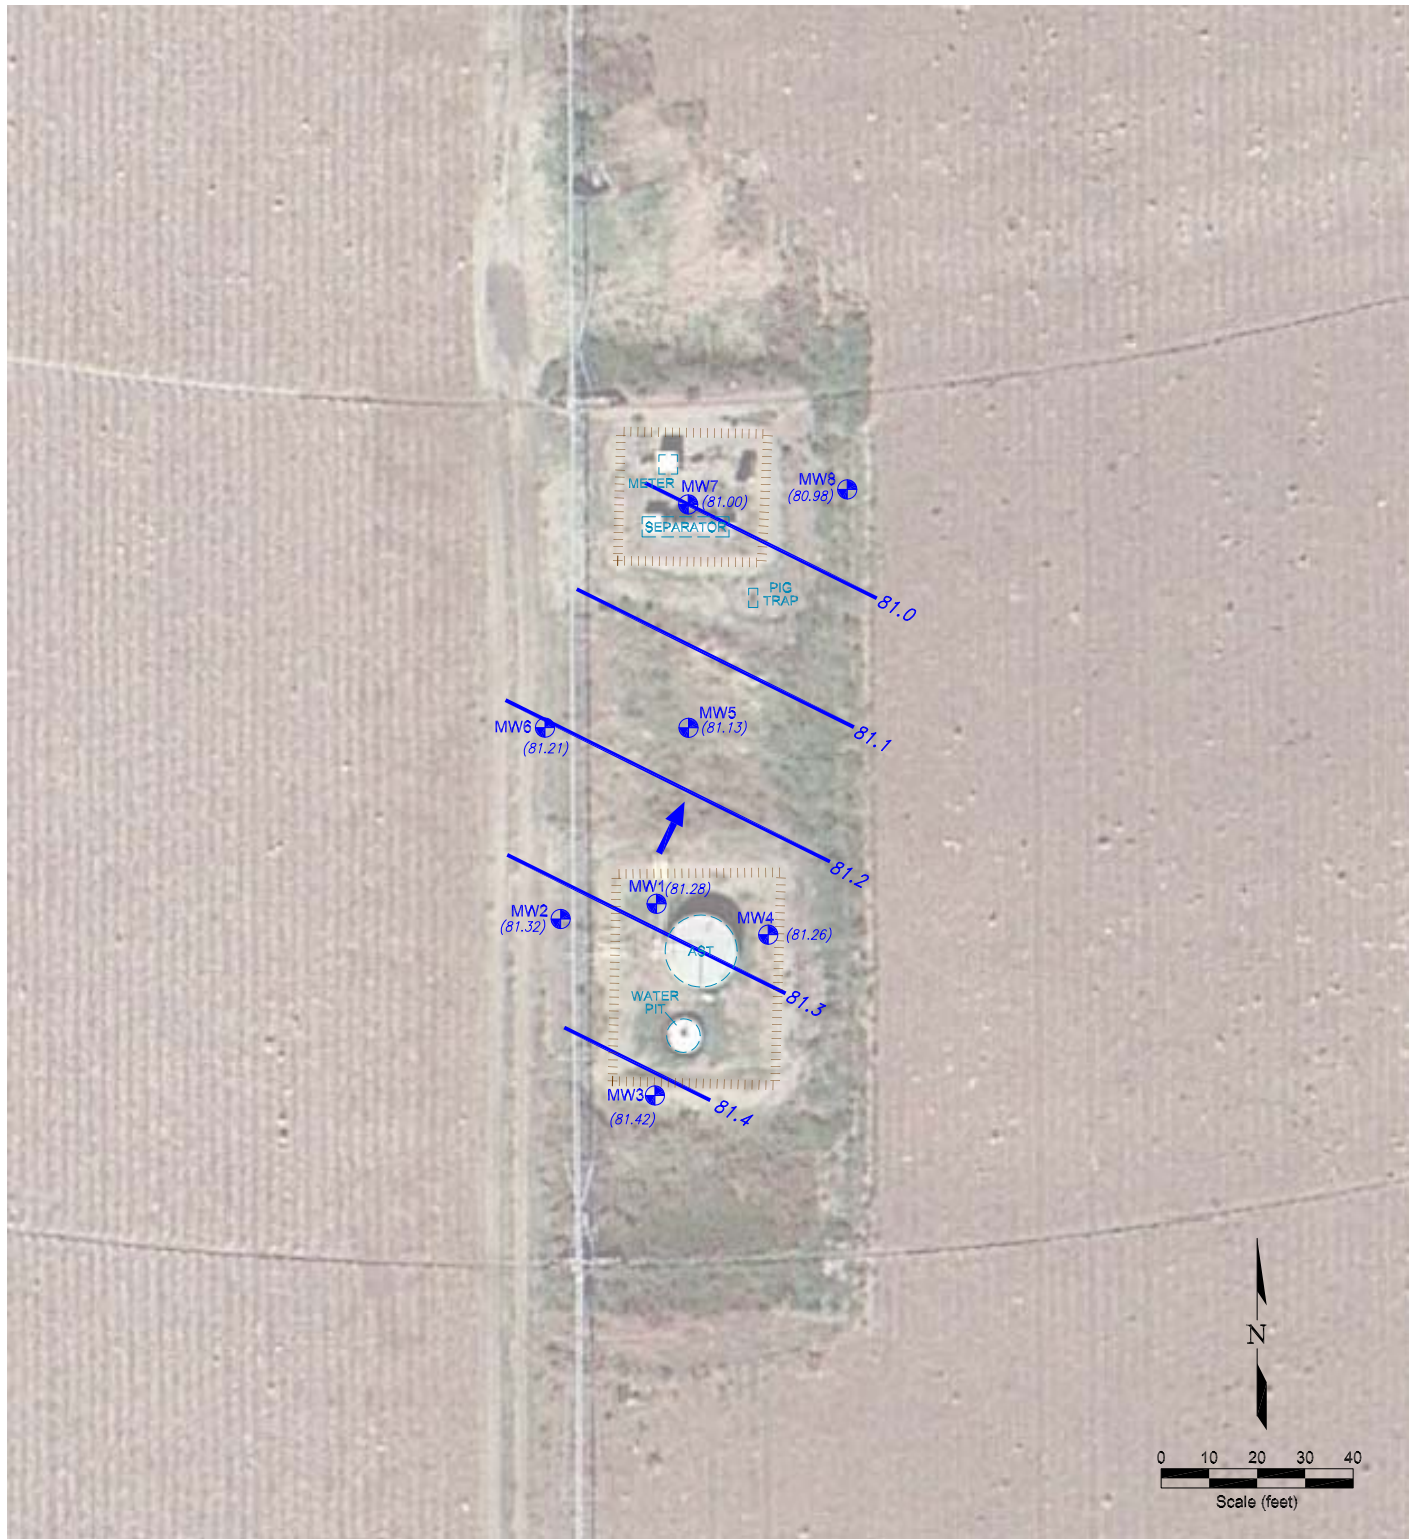
Figure 3
INFERRED GROUNDWATER CONTOUR
AUGUST 20, 2014

GROUND WATER ELEVATION (ft above arbitrary datum)
-

WATER TABLE CONTOUR
-

GROUND WATER FLOW DIRECTION

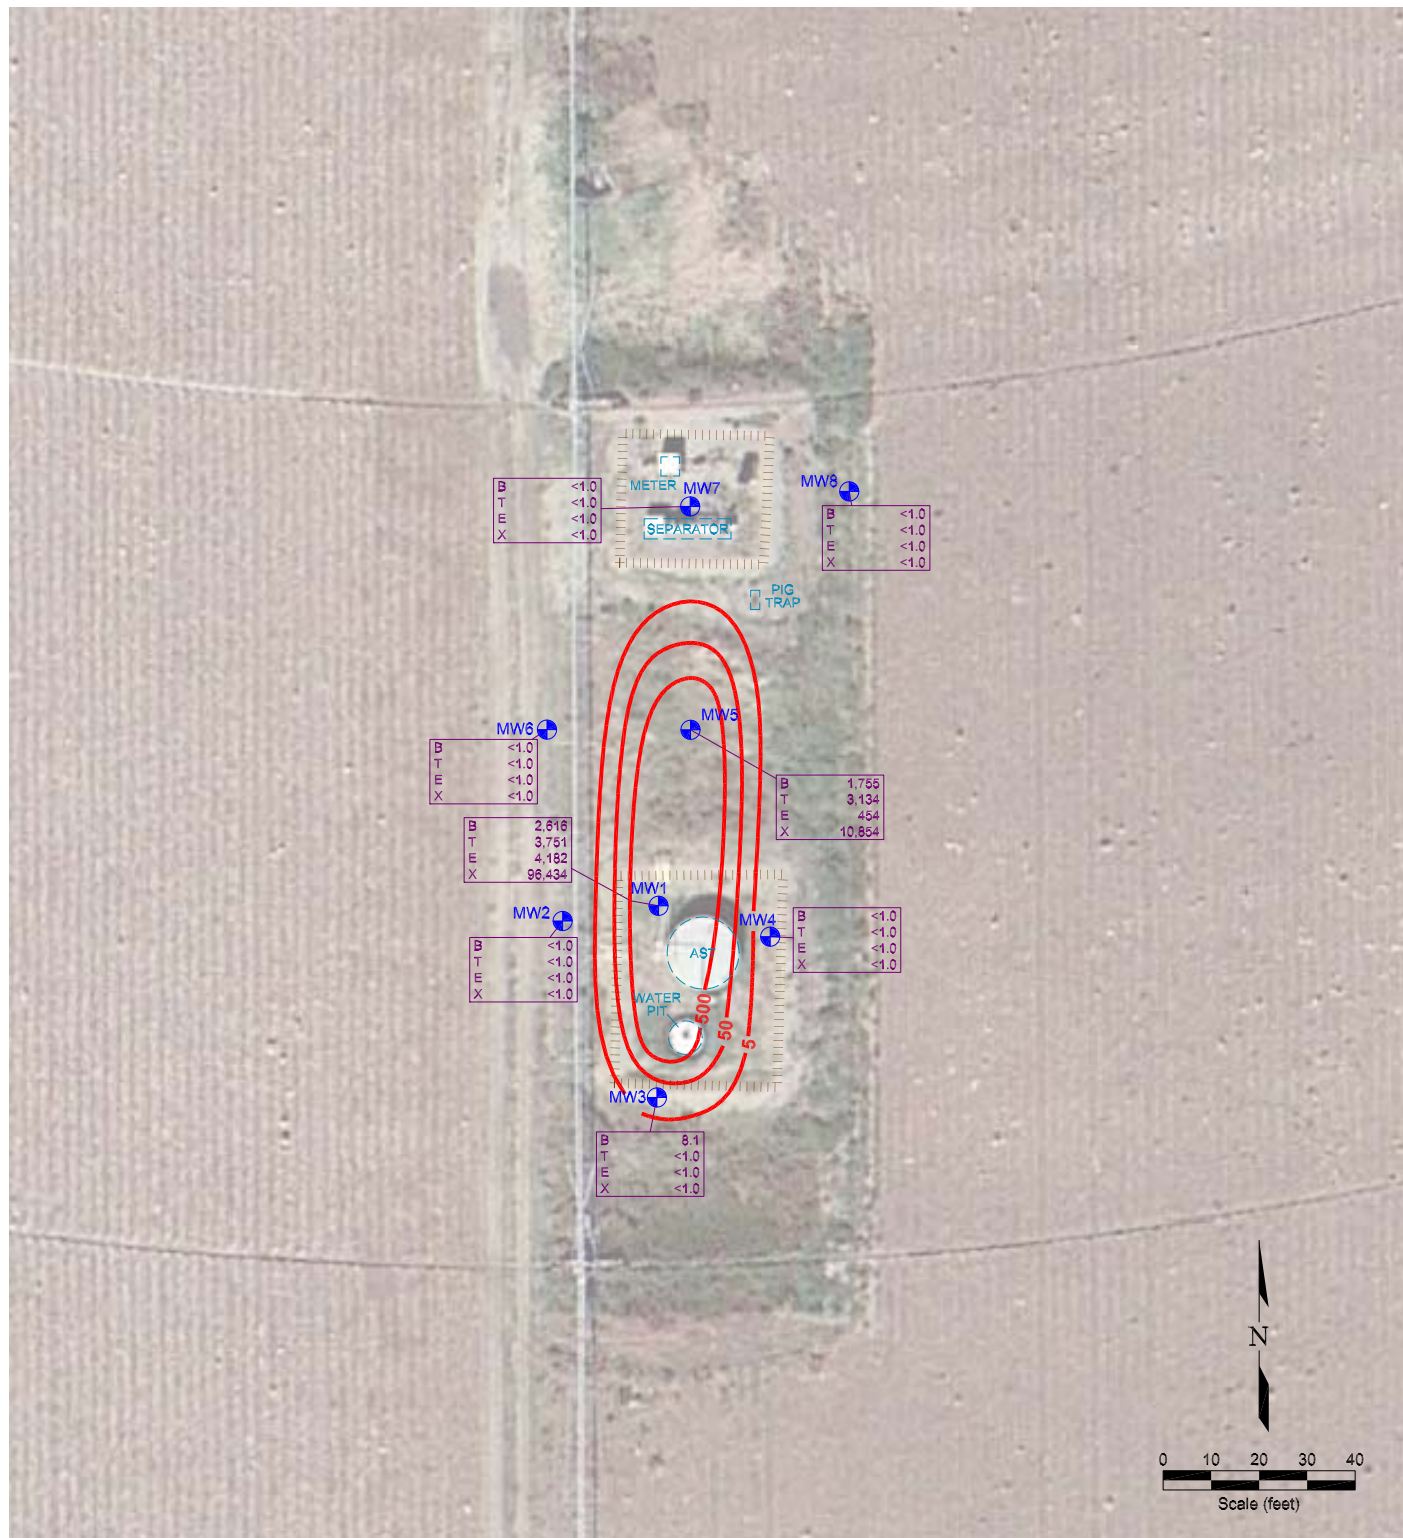
Figure 4
GROUND WATER CHEMISTRY MAP
AUGUST 20, 2014

BENZENE (ug/L)
TOLUENE (ug/L)
ETHYLBENZENE (ug/L)
TOTAL XYLENES (ug/L)

BENZENE ISOCONCENTRATION (ug/L)
Dashed where inferred
