VISUAL ASSESSMENT REPORT

RWF 43-9 Well Pad & Access Road

Garfield County, CO

May 2020

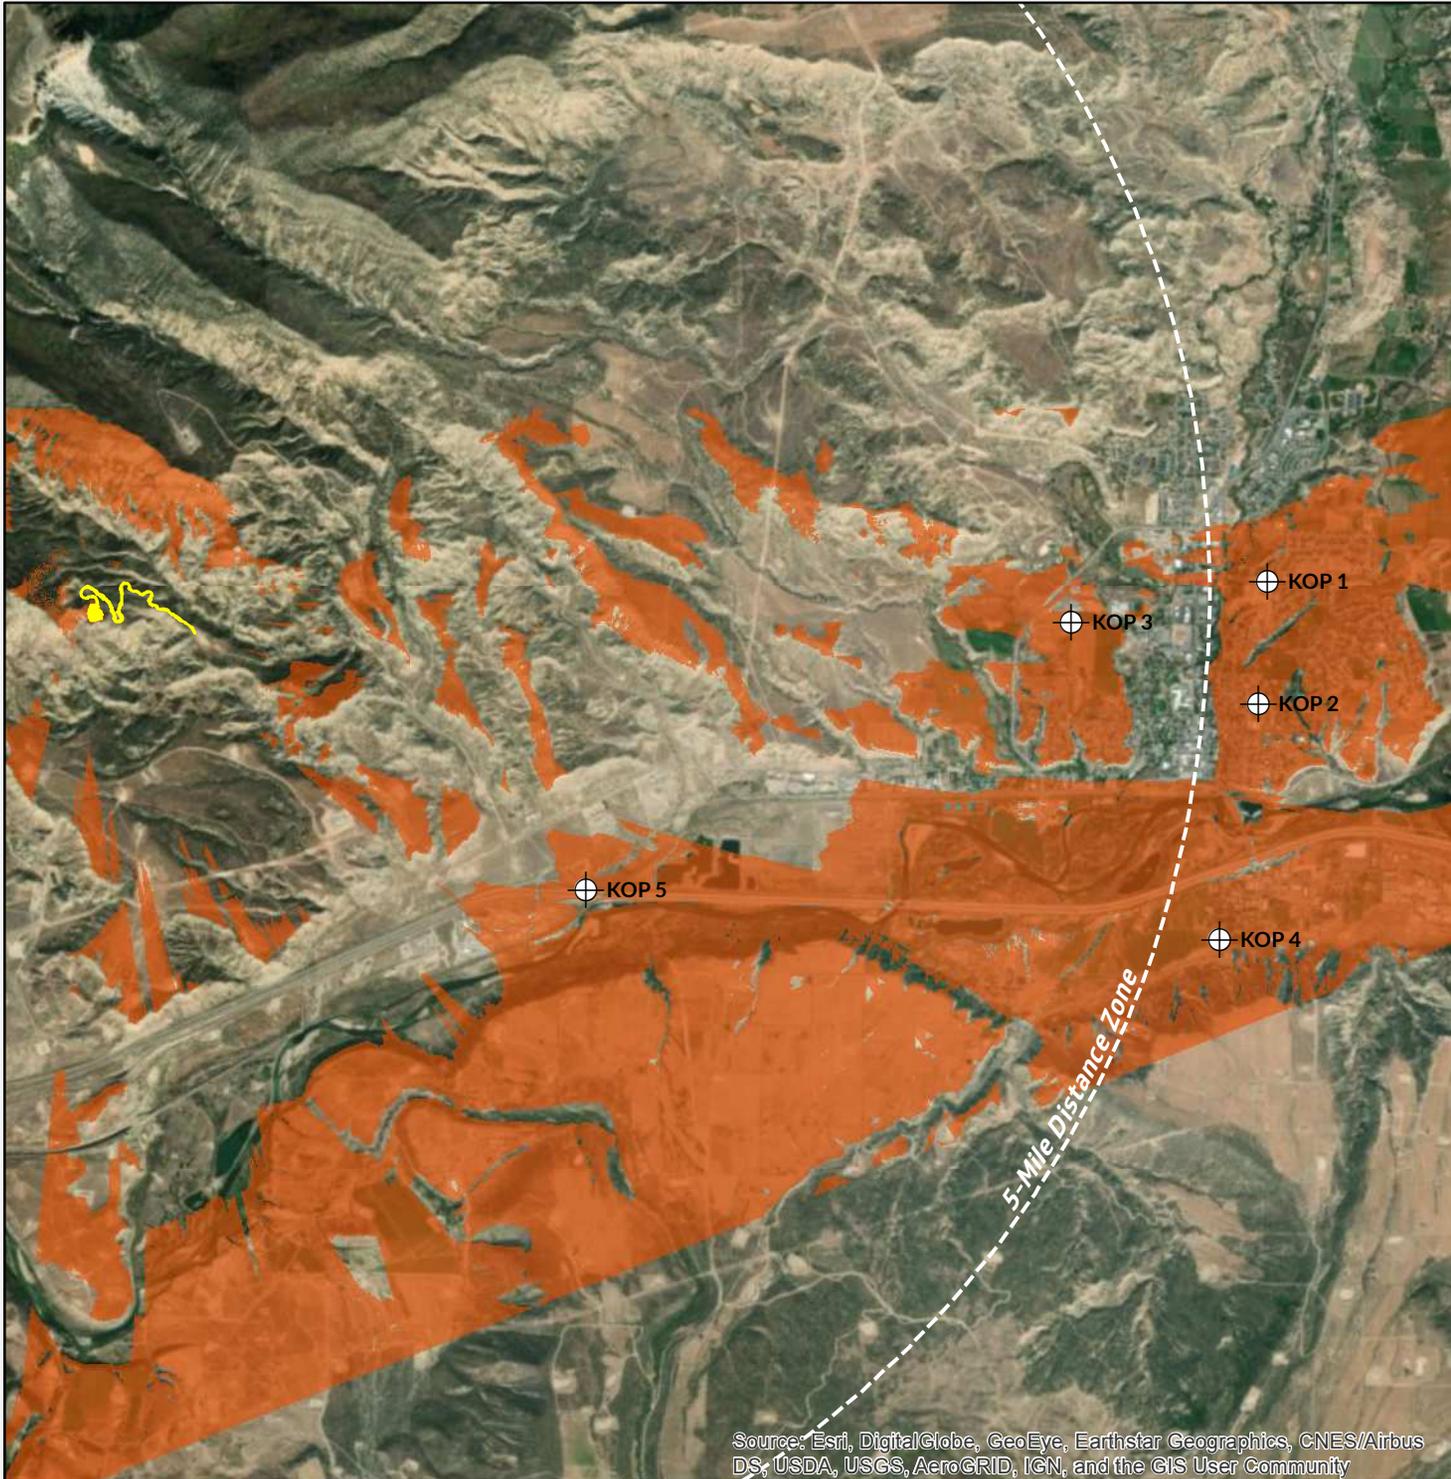
Areas where proposed pad is potentially visible

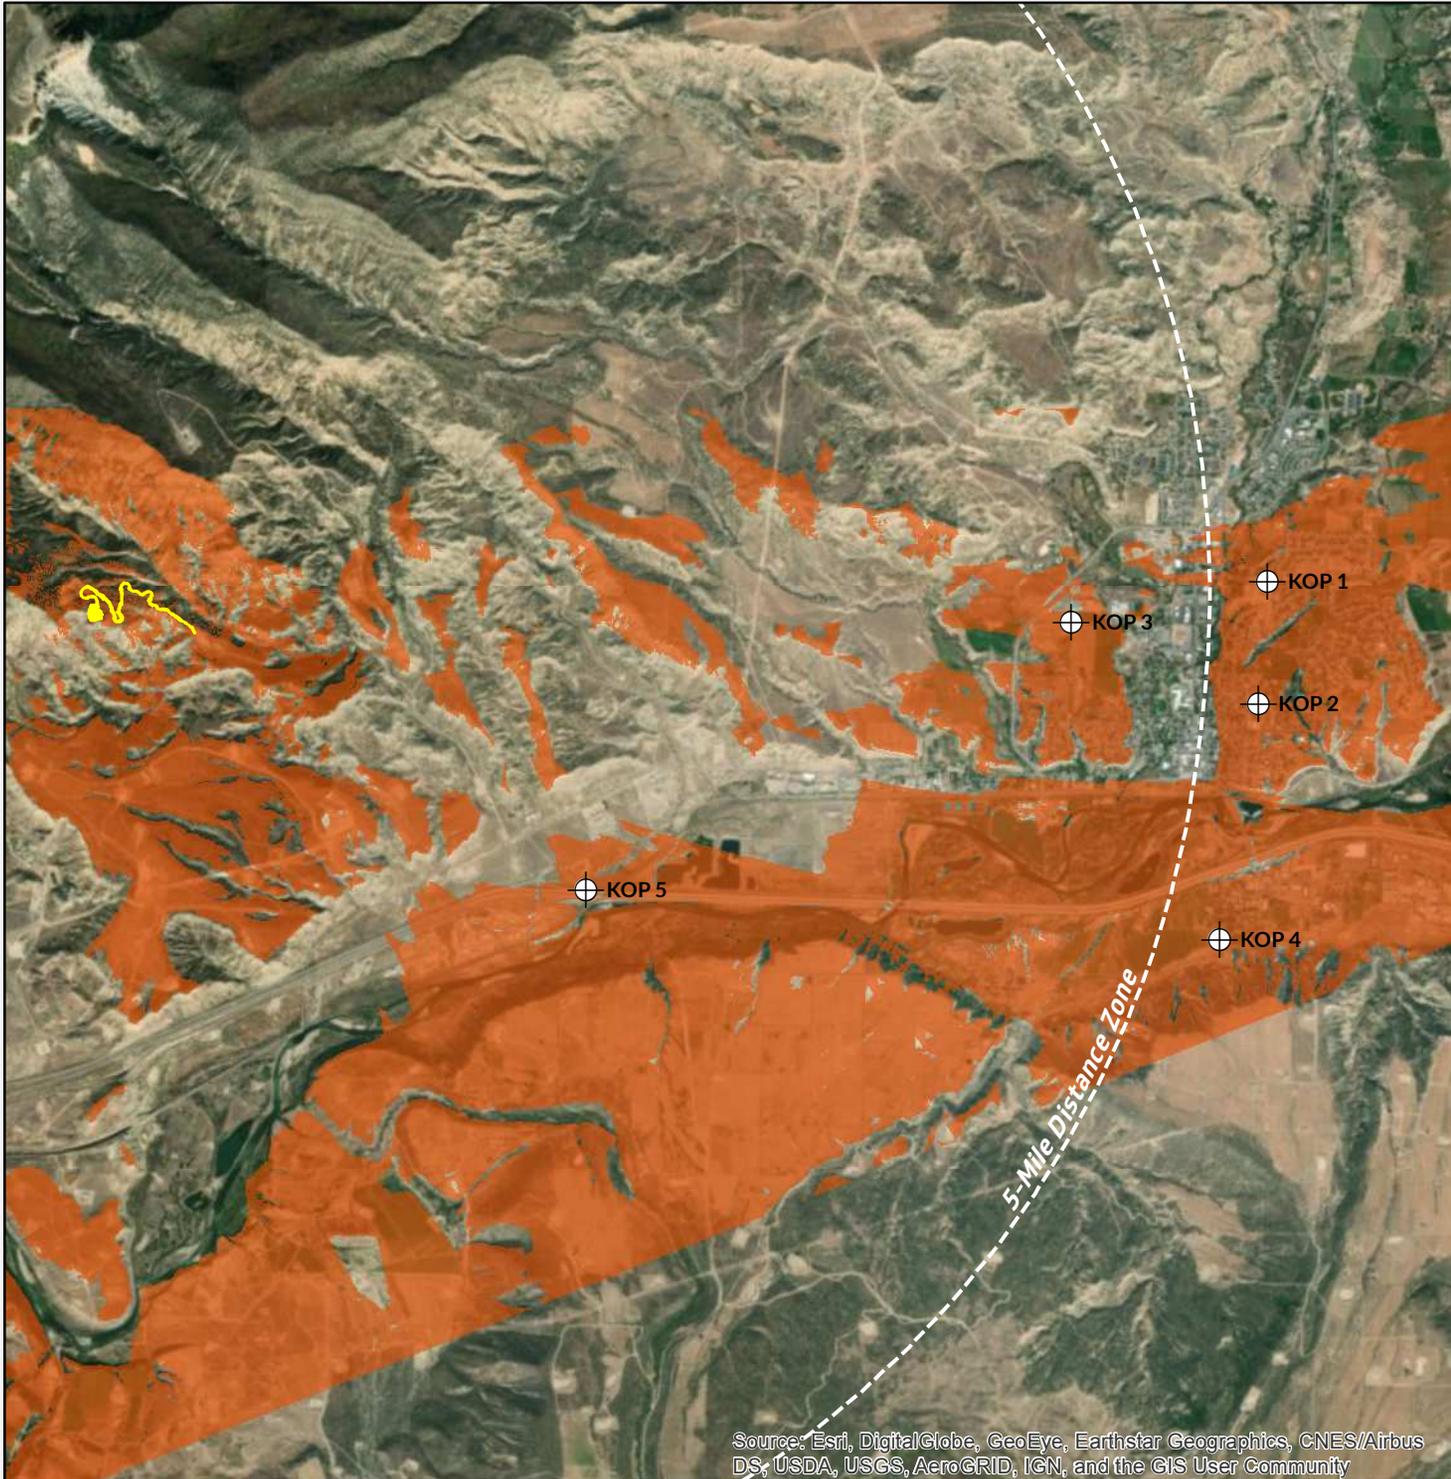
Areas where proposed road is potentially visible

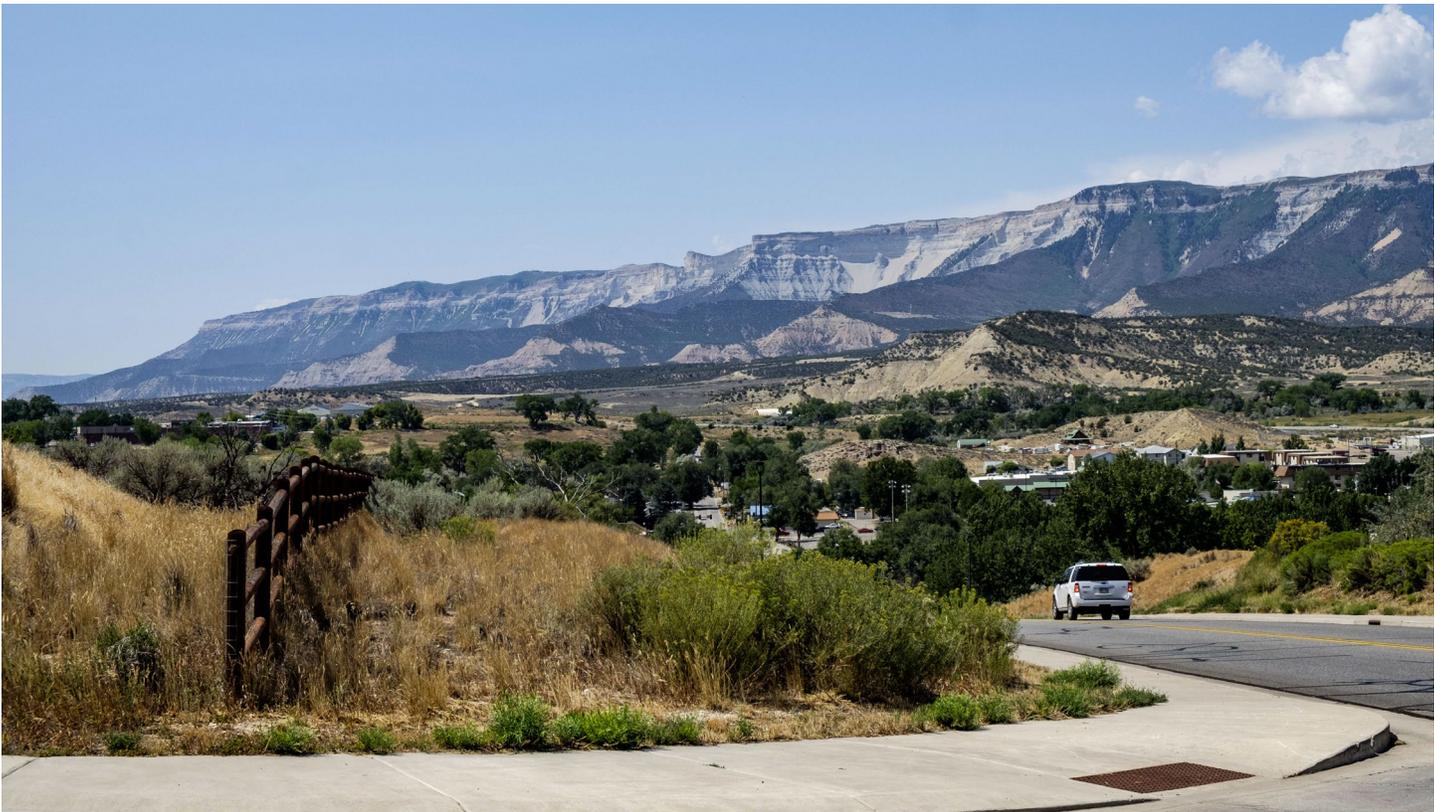
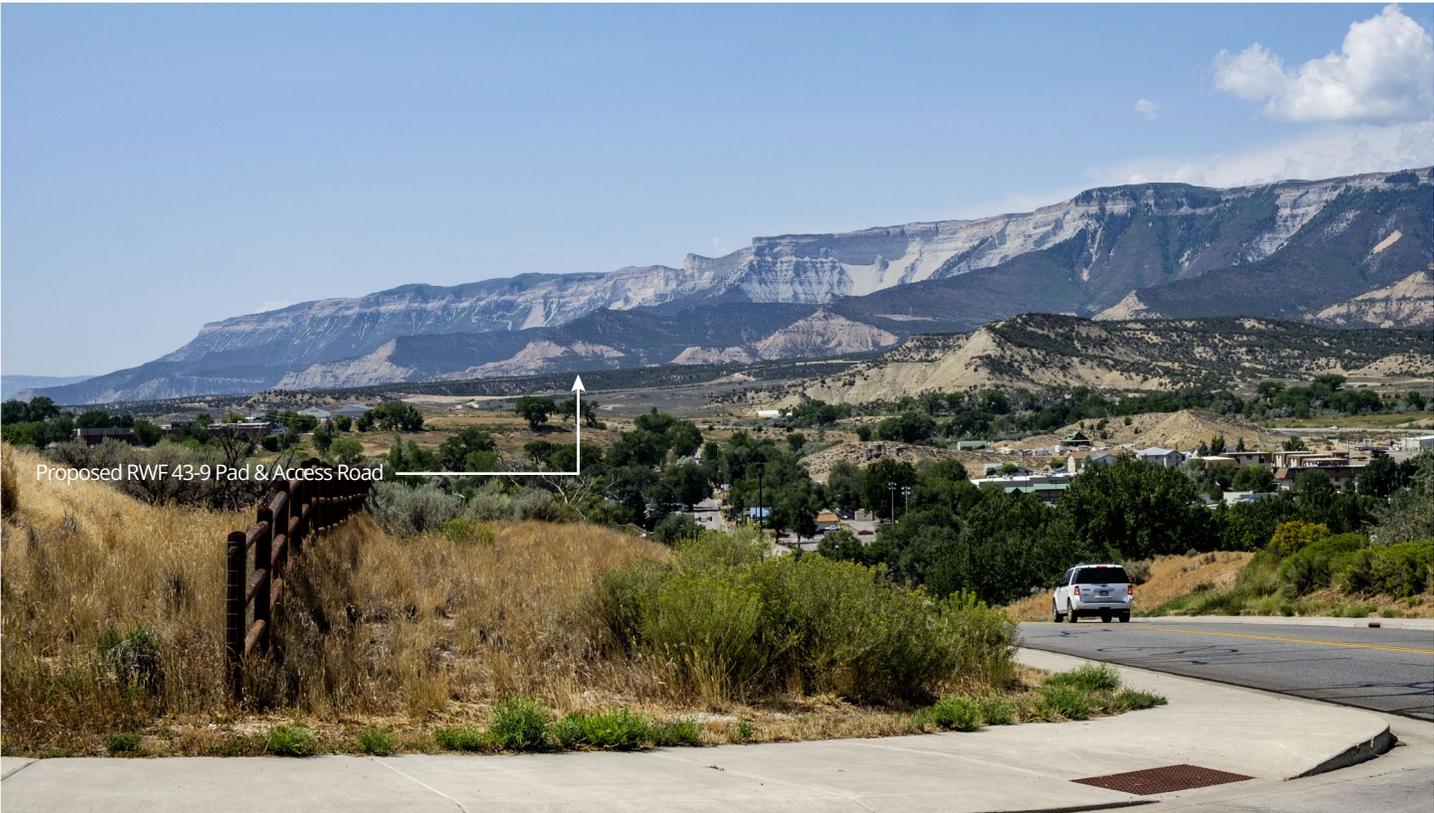
Existing Conditions

Proposed Conditions

Visual Simulation: KOP 1
Looking West onto RWF 43-9 Pad and Access Road
Background Distance Zone
RWF 43-9
Figure 1-4

KOPs 1, 2 and 3 are discussed together as the observers share a similar viewing orientation and experience from their respective locations looking west onto the proposed project site. Figures 1-4, 1-5, and 1-6 simulate implementation of the proposed road and pad site for KOPs #1, #2 and #3, respectively. From each of the three locations, the proposed pad site is fully hidden and not visible to the observer due to existing mature pinyon-juniper stands that remain on the southern and eastern perimeters of the proposed pad site. While the upper portion of the cut face on the pads western perimeter is visible, the exposed slope blends seamlessly with the ridges southern face that is naturally devoid of vegetation, and therefore not drawing attention to the observer. Due to differences in observer elevations, the three KOPs observe different amounts of the proposed access road leading to the proposed pad site. The observer at KOP #2 can see nearly the entire proposed road alignment. By contrast, the lower two-thirds and lower half of the proposed access road are not visible to the KOP #1 and KOP #3 observers, respectively, due to an existing low-slung ridge lying directly west of the proposed project site. While the resulting cut and fill faces along the proposed road alignment are technically visible to all three observer locations, implementing the recommended mitigation strategy of applying a surface colorant in an irregular stippled pattern to exposed soils is highly effective in minimizing potential visual impacts. The mitigation strategy results in conditions where the exposed cut and fill faces, exceeding 40 feet in some areas, are nearly imperceptible to the observers and appear as a continuation of similar color and texture of the surrounding existing vegetation.

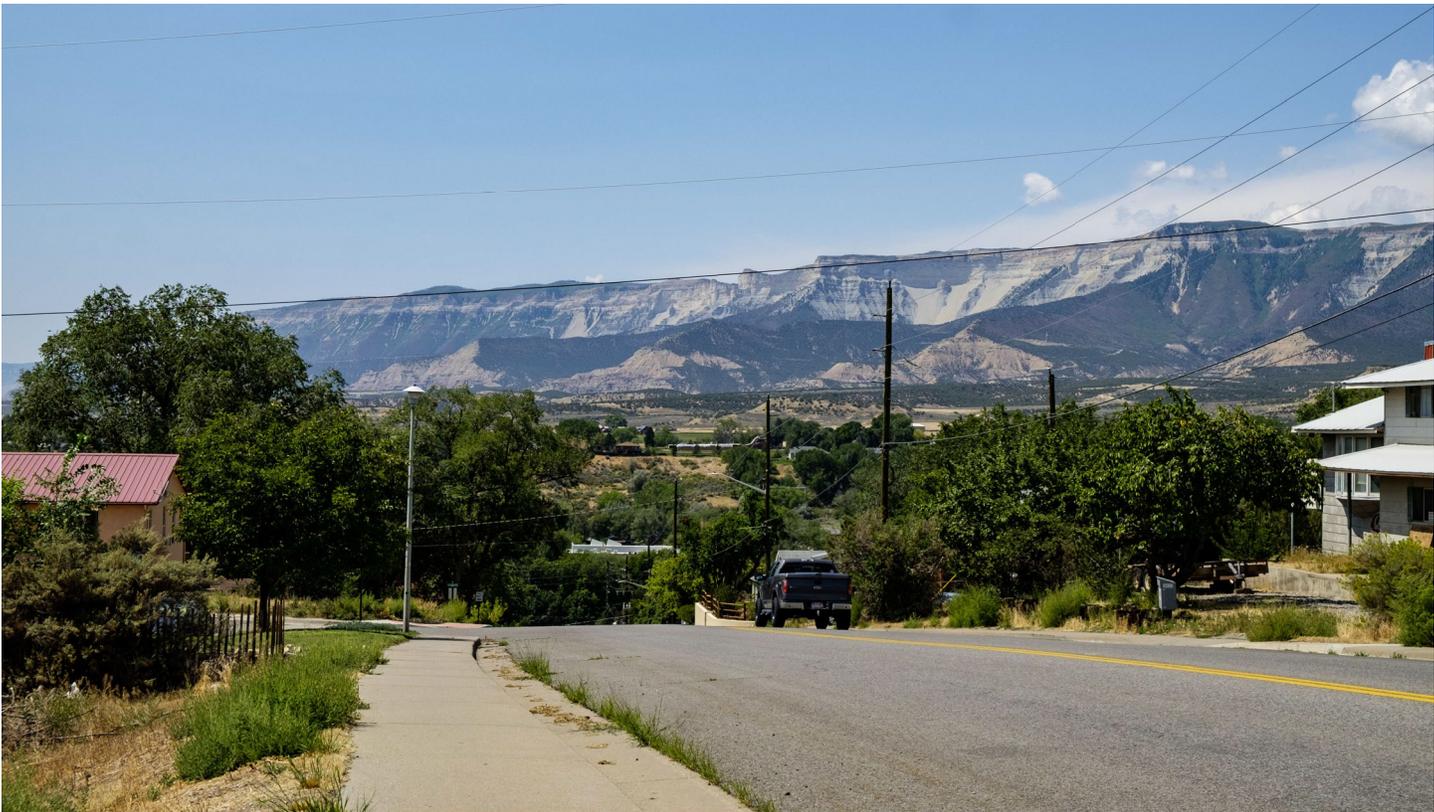
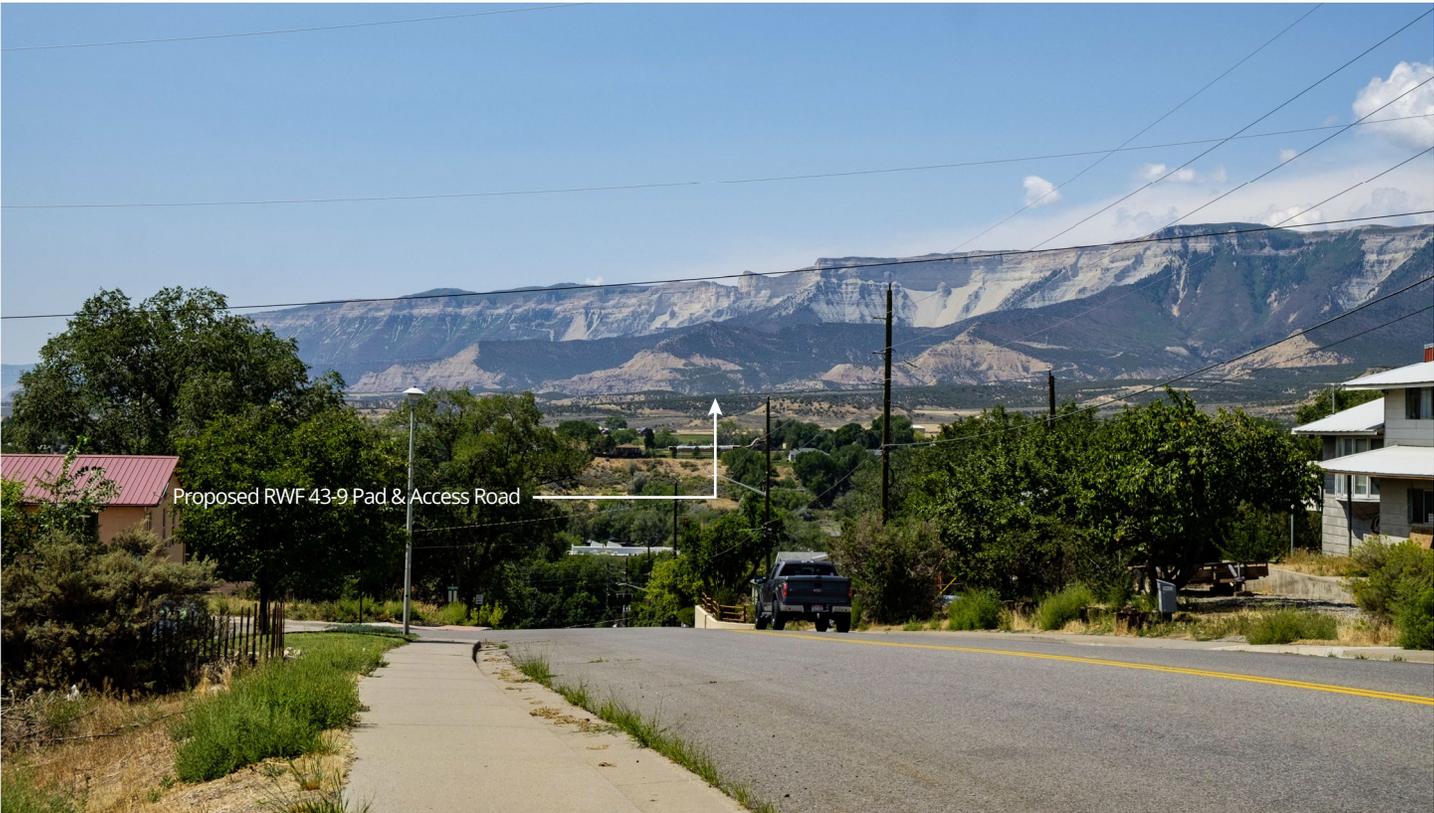
Existing Conditions

Proposed Conditions

Visual Simulation: KOP 2
Looking West onto RWF 43-9 Pad and Access Road
Background Distance Zone
RWF 43-9
Figure 1-5

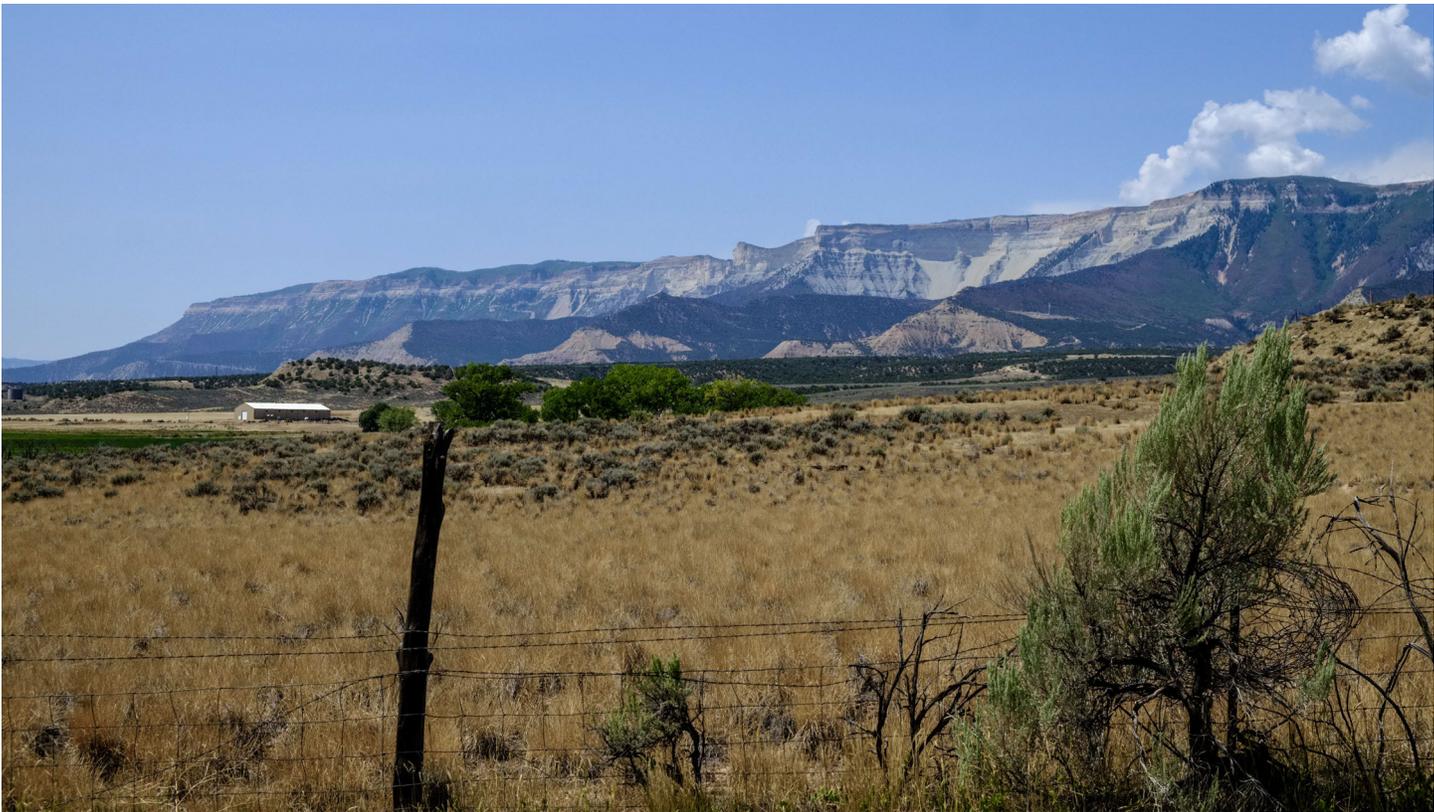
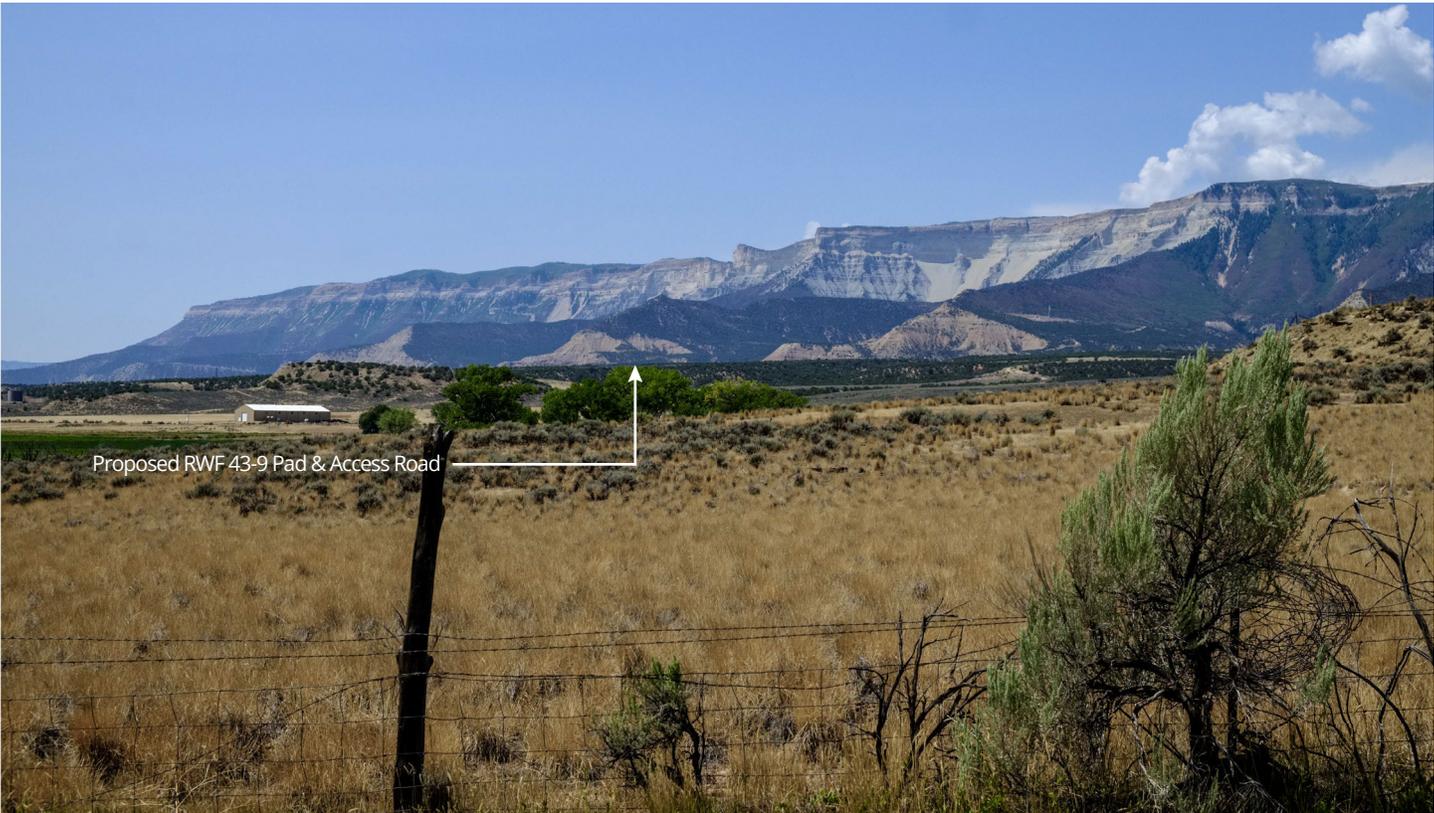
Existing Conditions

Proposed Conditions

Visual Simulation: KOP 3
Looking West onto RWF 43-9 Pad and Access Road
Background Distance Zone
RWF 43-9
Figure 1-6

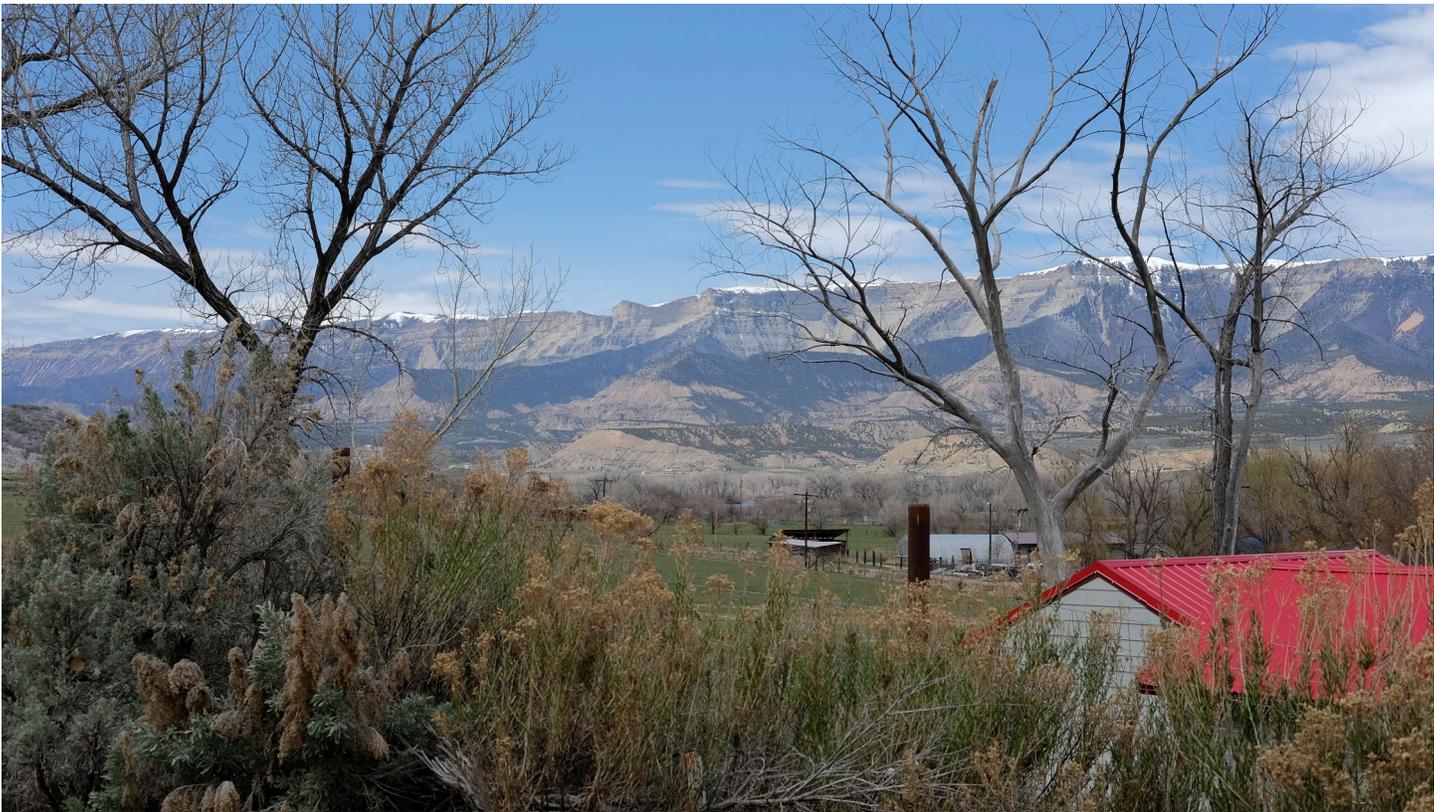
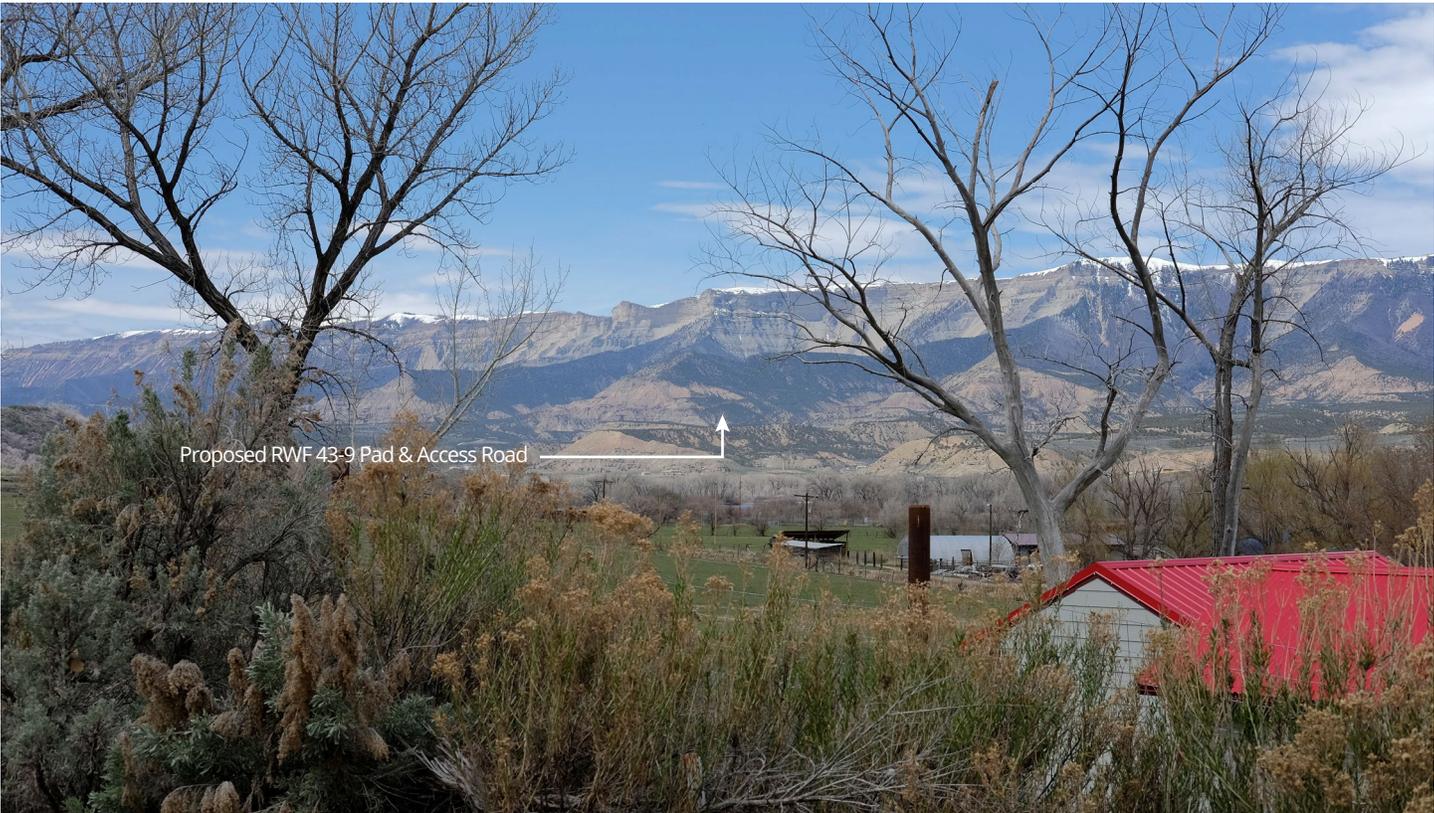
Existing Conditions

Proposed Conditions

Visual Simulation: KOP #4
Looking Northwest onto RWF 43-9 Pad and Access Road
Background Distance Zone
RWF 43-9
Figure 1-7

Figure 1-7 demonstrates that the proposed RWF 43-9 pad site and associated operating equipment are fully hidden to the KOP #4 observer due to existing mature pinyon-juniper stands that remain on the southern and eastern perimeters of the proposed pad site. From this location, only the bottom portion of the road is screened by an existing ridge, while the remainder of the proposed road alignment is visible. Because the observer is looking onto the proposed road alignment at an approximate 45-degree angle, the cut and fill faces are more visible as compared to observers at KOP locations #1, #2 and #3.

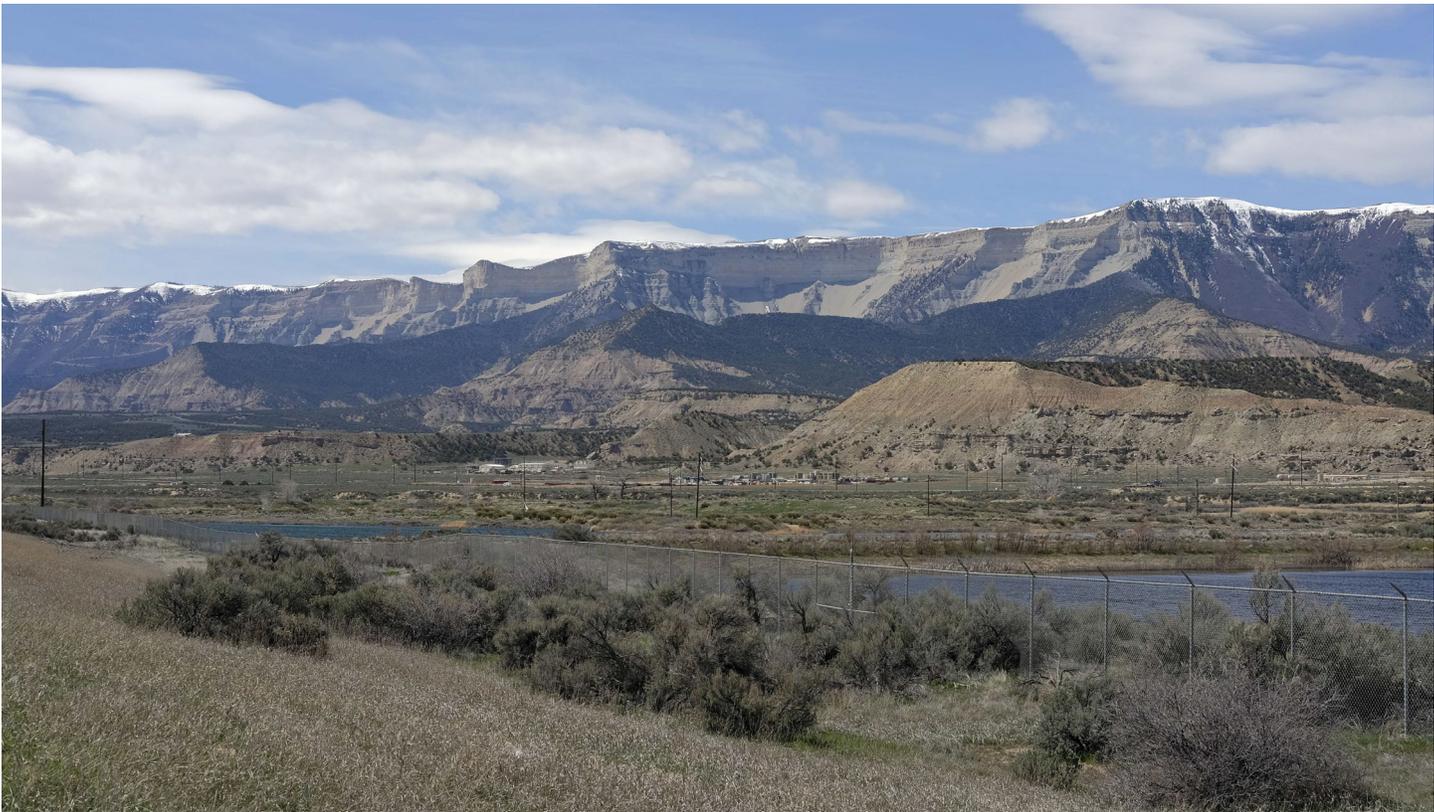
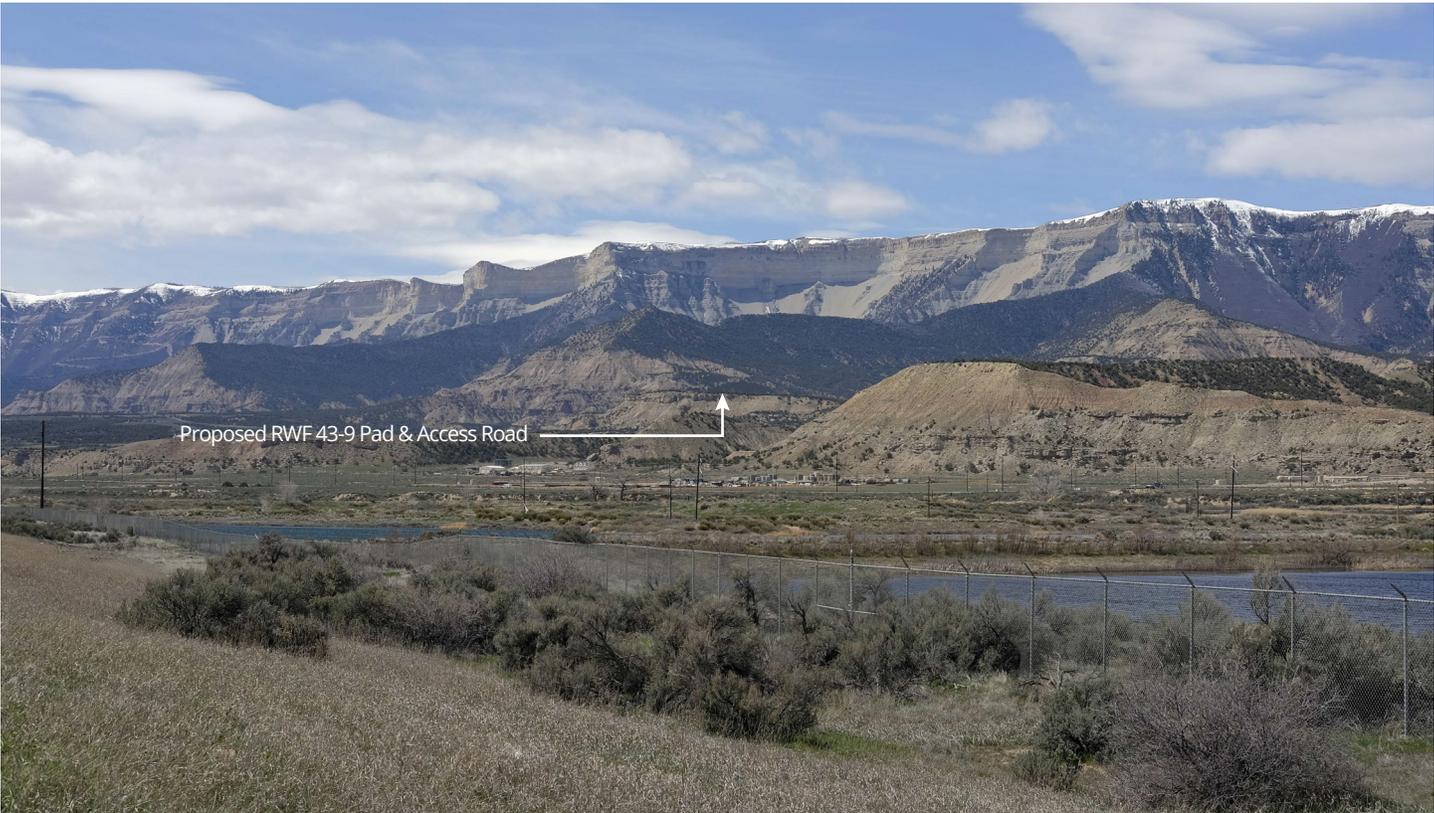
Existing Conditions

Proposed Conditions

Visual Simulation: KOP #5
Looking Northwest onto RWF 43-9 Pad and Access Road
Middleground Distance Zone
RWF 43-9
Figure 1-8

Figure 1-8 depicts proposed conditions that result from installation of the proposed RWF 43-9 pad site and access road from the KOP #5 location. The viewer at this location is approximately 2.5 miles southeast of the project area. Similar to all other KOP locations, the existing mature pinyon-juniper stands that remain on the southern and eastern perimeters of the proposed pad prevent any portion of the pad site from being visible to the observer. An intervening existing ridge feature fully obscures the lower two-thirds of the proposed access road from this location. The potential visual impacts from the remaining upper portion of the road that is visible to the observer are again successfully mitigated by application of the surface colorant to exposed soils. While a faint horizontal line is again evident in the dense pinyon-juniper woodland along the proposed access road and pad sites, the line does not draw attention as the color and texture blend almost seamlessly with the surrounding existing vegetation.
