RECLAMATION PLAN FOR RULE 915.b.

OPERATOR NAME/NUMBER: SIMCOE, LLC 10749

LOCATION NAME: Perino Water Transfer Station

DATE:11/3/2021

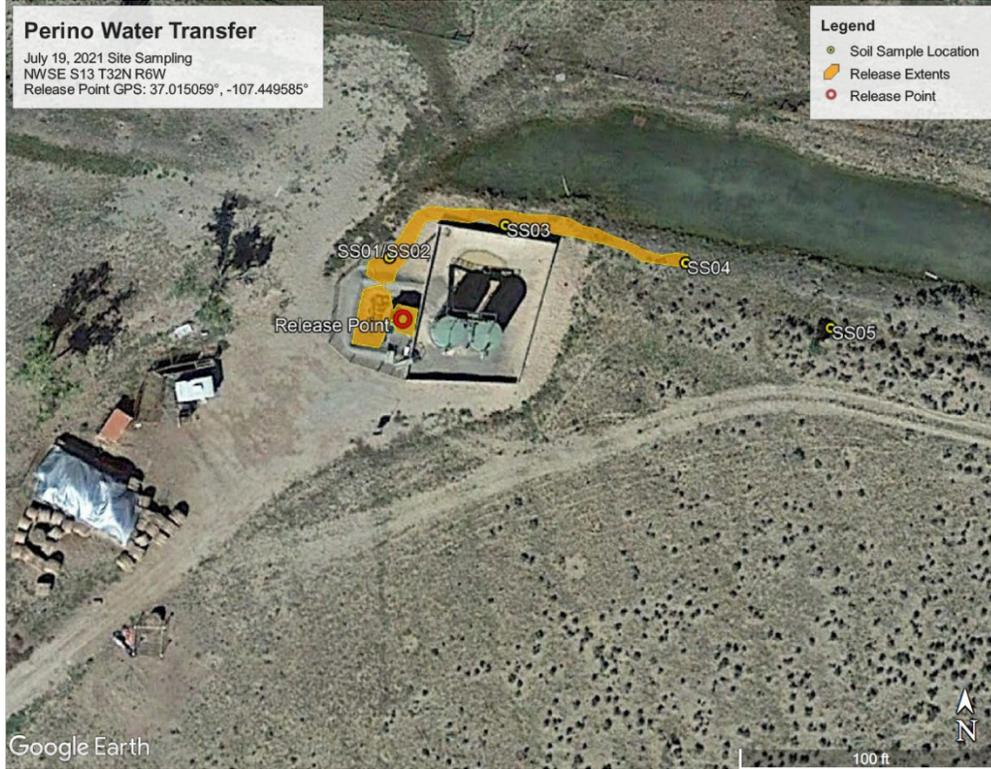
### Map of impacted area

<b>Spill Area</b>	<b>0.05 acres</b>
<b>Reclamation Area (includes access road, location, and spill area)</b>	<b>0.61 acres</b>
<b>Total Location Disturbance</b>	<b>0.61 acres</b>
<b>Staging Disturbance area to reclaim</b>	<b>N/A</b>
<b>Total Area to be reclaimed</b>	<b>0.61 acres</b>

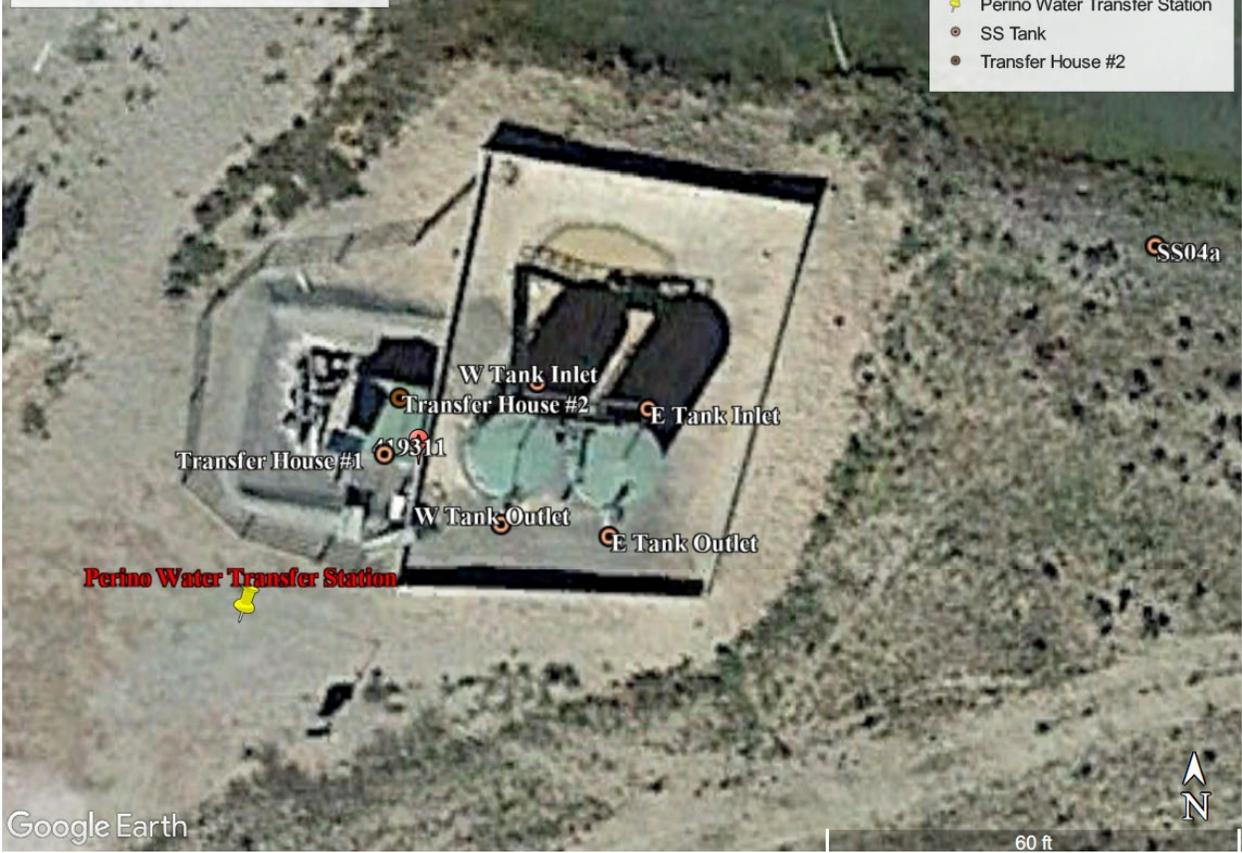
# Perino WTS Sample Map

Map of sampling planned – NOTE July Sampling mapped on above map

Areas of sampling during decom of location.

- Perino reclamation area
- Perino Water Transfer Station
- SS Tank
- Transfer House #2

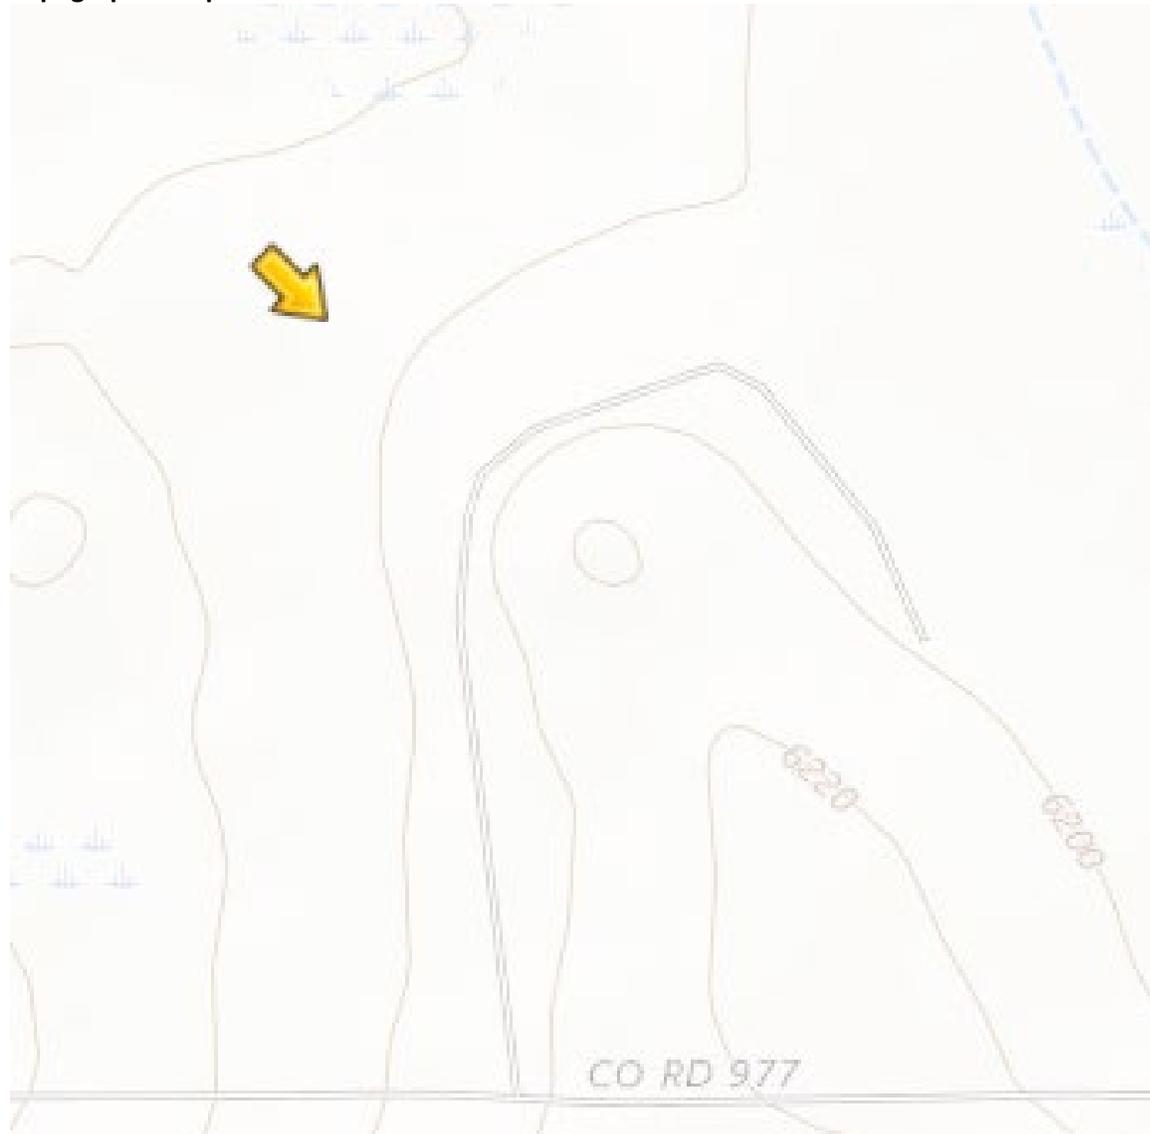
Topographic map of area

Current and historical use of the land has been non-irrigated grazing. The soils consist of Bodot Clay. The topography is approximately a 3% slope that is north to northwest facing.
