**CARBON STORAGE SOLUTIONS**

FRONT RANGE #1

**GEOLOGIC HAZARD MAP EXHIBIT 1**

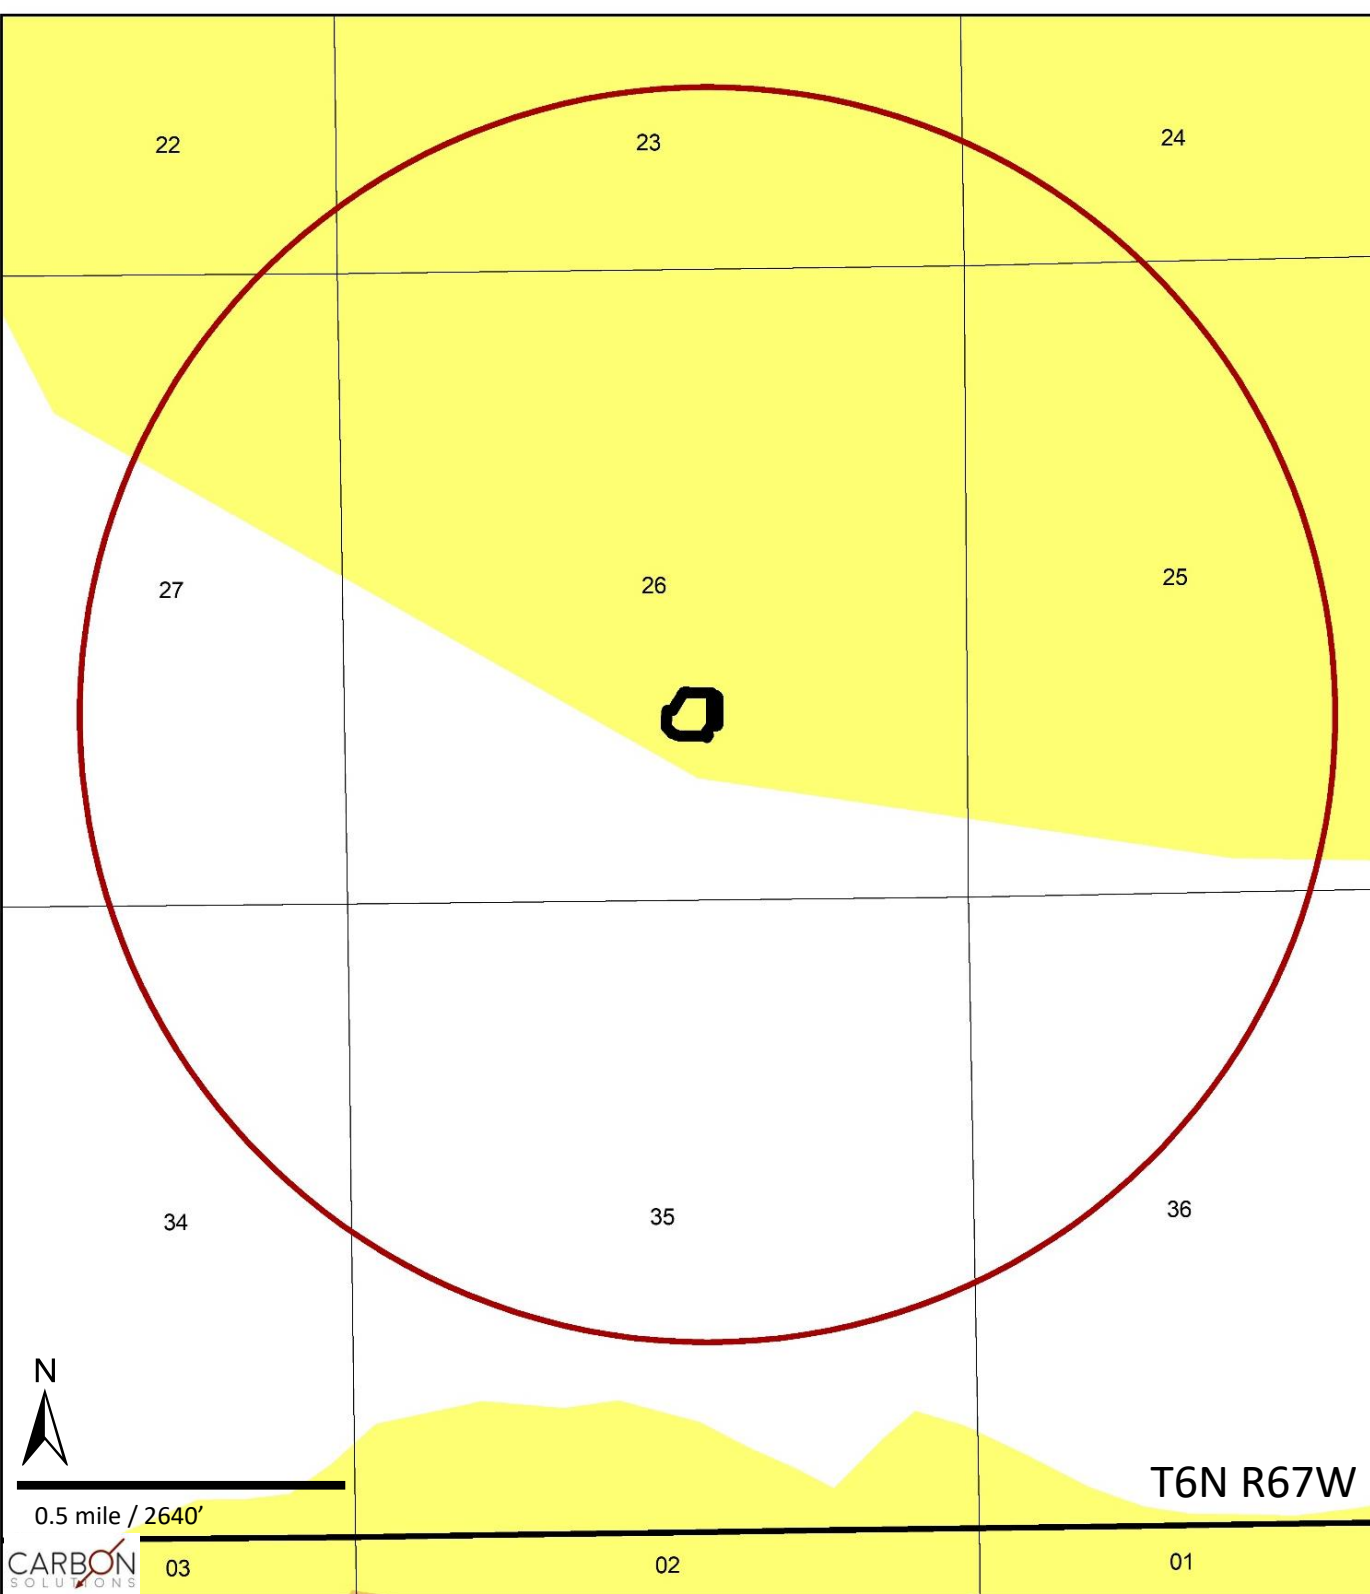
**GEOLOGIC HAZARD MAP EXHIBIT 2**

## Collapsible Soil

Loess – can be a collapsible soil

Per analysis by other operators in the general area, there have been no known cases of subsidence due to eolian soil collapse in the area as a result of drilling operations in the greater Wattenberg Field area.

Collapsible soils are identified as a potential hazard. Prior to construction at the proposed location, topsoil is removed. During the cut and fill process, the ground is wetted and compacted. A cap of about 4-6" of road base provides additional protection from differential compaction. The grade and ditches promote flow off of the proposed location to further mitigate the risk of water saturating soils. Considering the soil composition, and the facility design and management, I determine the collapsible soil hazard is low.
