**GEOLOGIC HAZARD MAP
LABRISA 11-35HZ**

SECTION 35, TOWNSHIP 2 NORTH, RANGE 65 WEST, 6TH P.M., WELD COUNTY, COLORADO

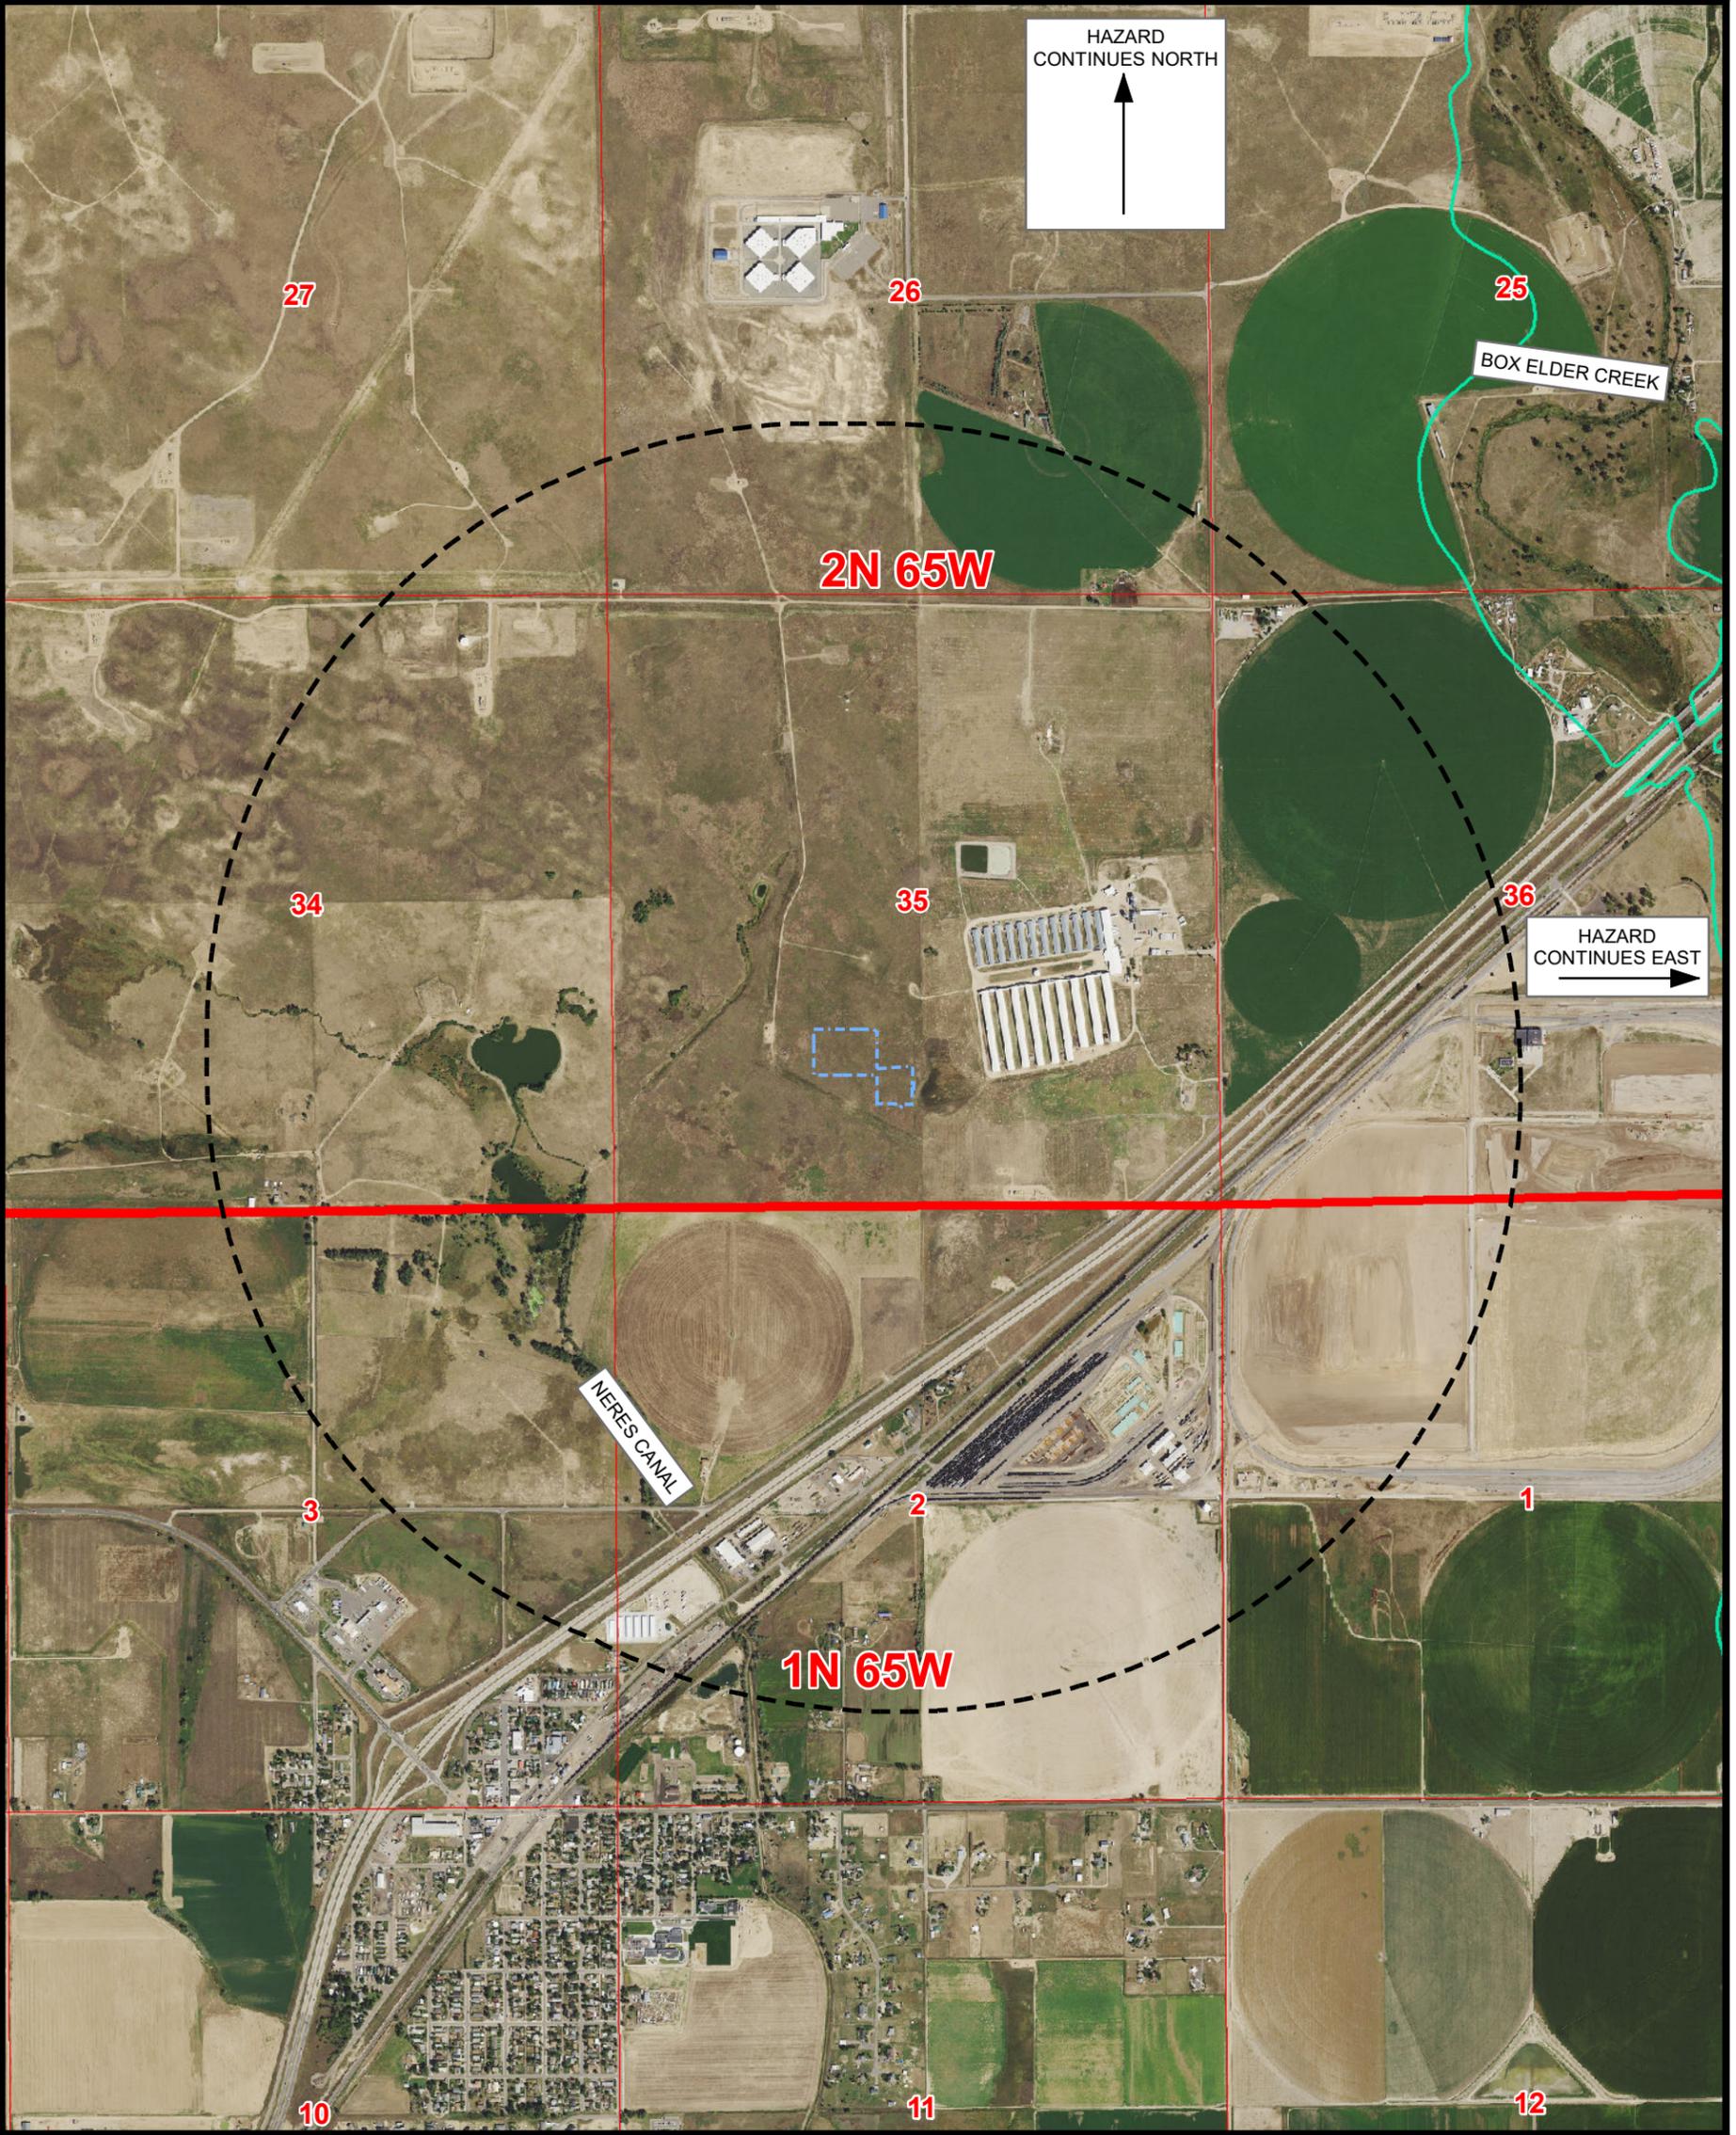
HAZARD
CONTINUES NORTH
↑

HAZARD
CONTINUES EAST
→

The data source for floodplain information shown on the figure is the Federal Emergency Management Agency GIS Datasets (both effective and preliminary). USDA Natural Resources Conservation Service soil data, the Weld County Soil Survey and the Colorado Geological Survey's Collapsible Soils webmap was used for the soil hazards evaluation. Additional datasets, maps, and published papers used to evaluate other possible geologic hazards included in CO Rev Stat § 24-65.1-103 are listed below.

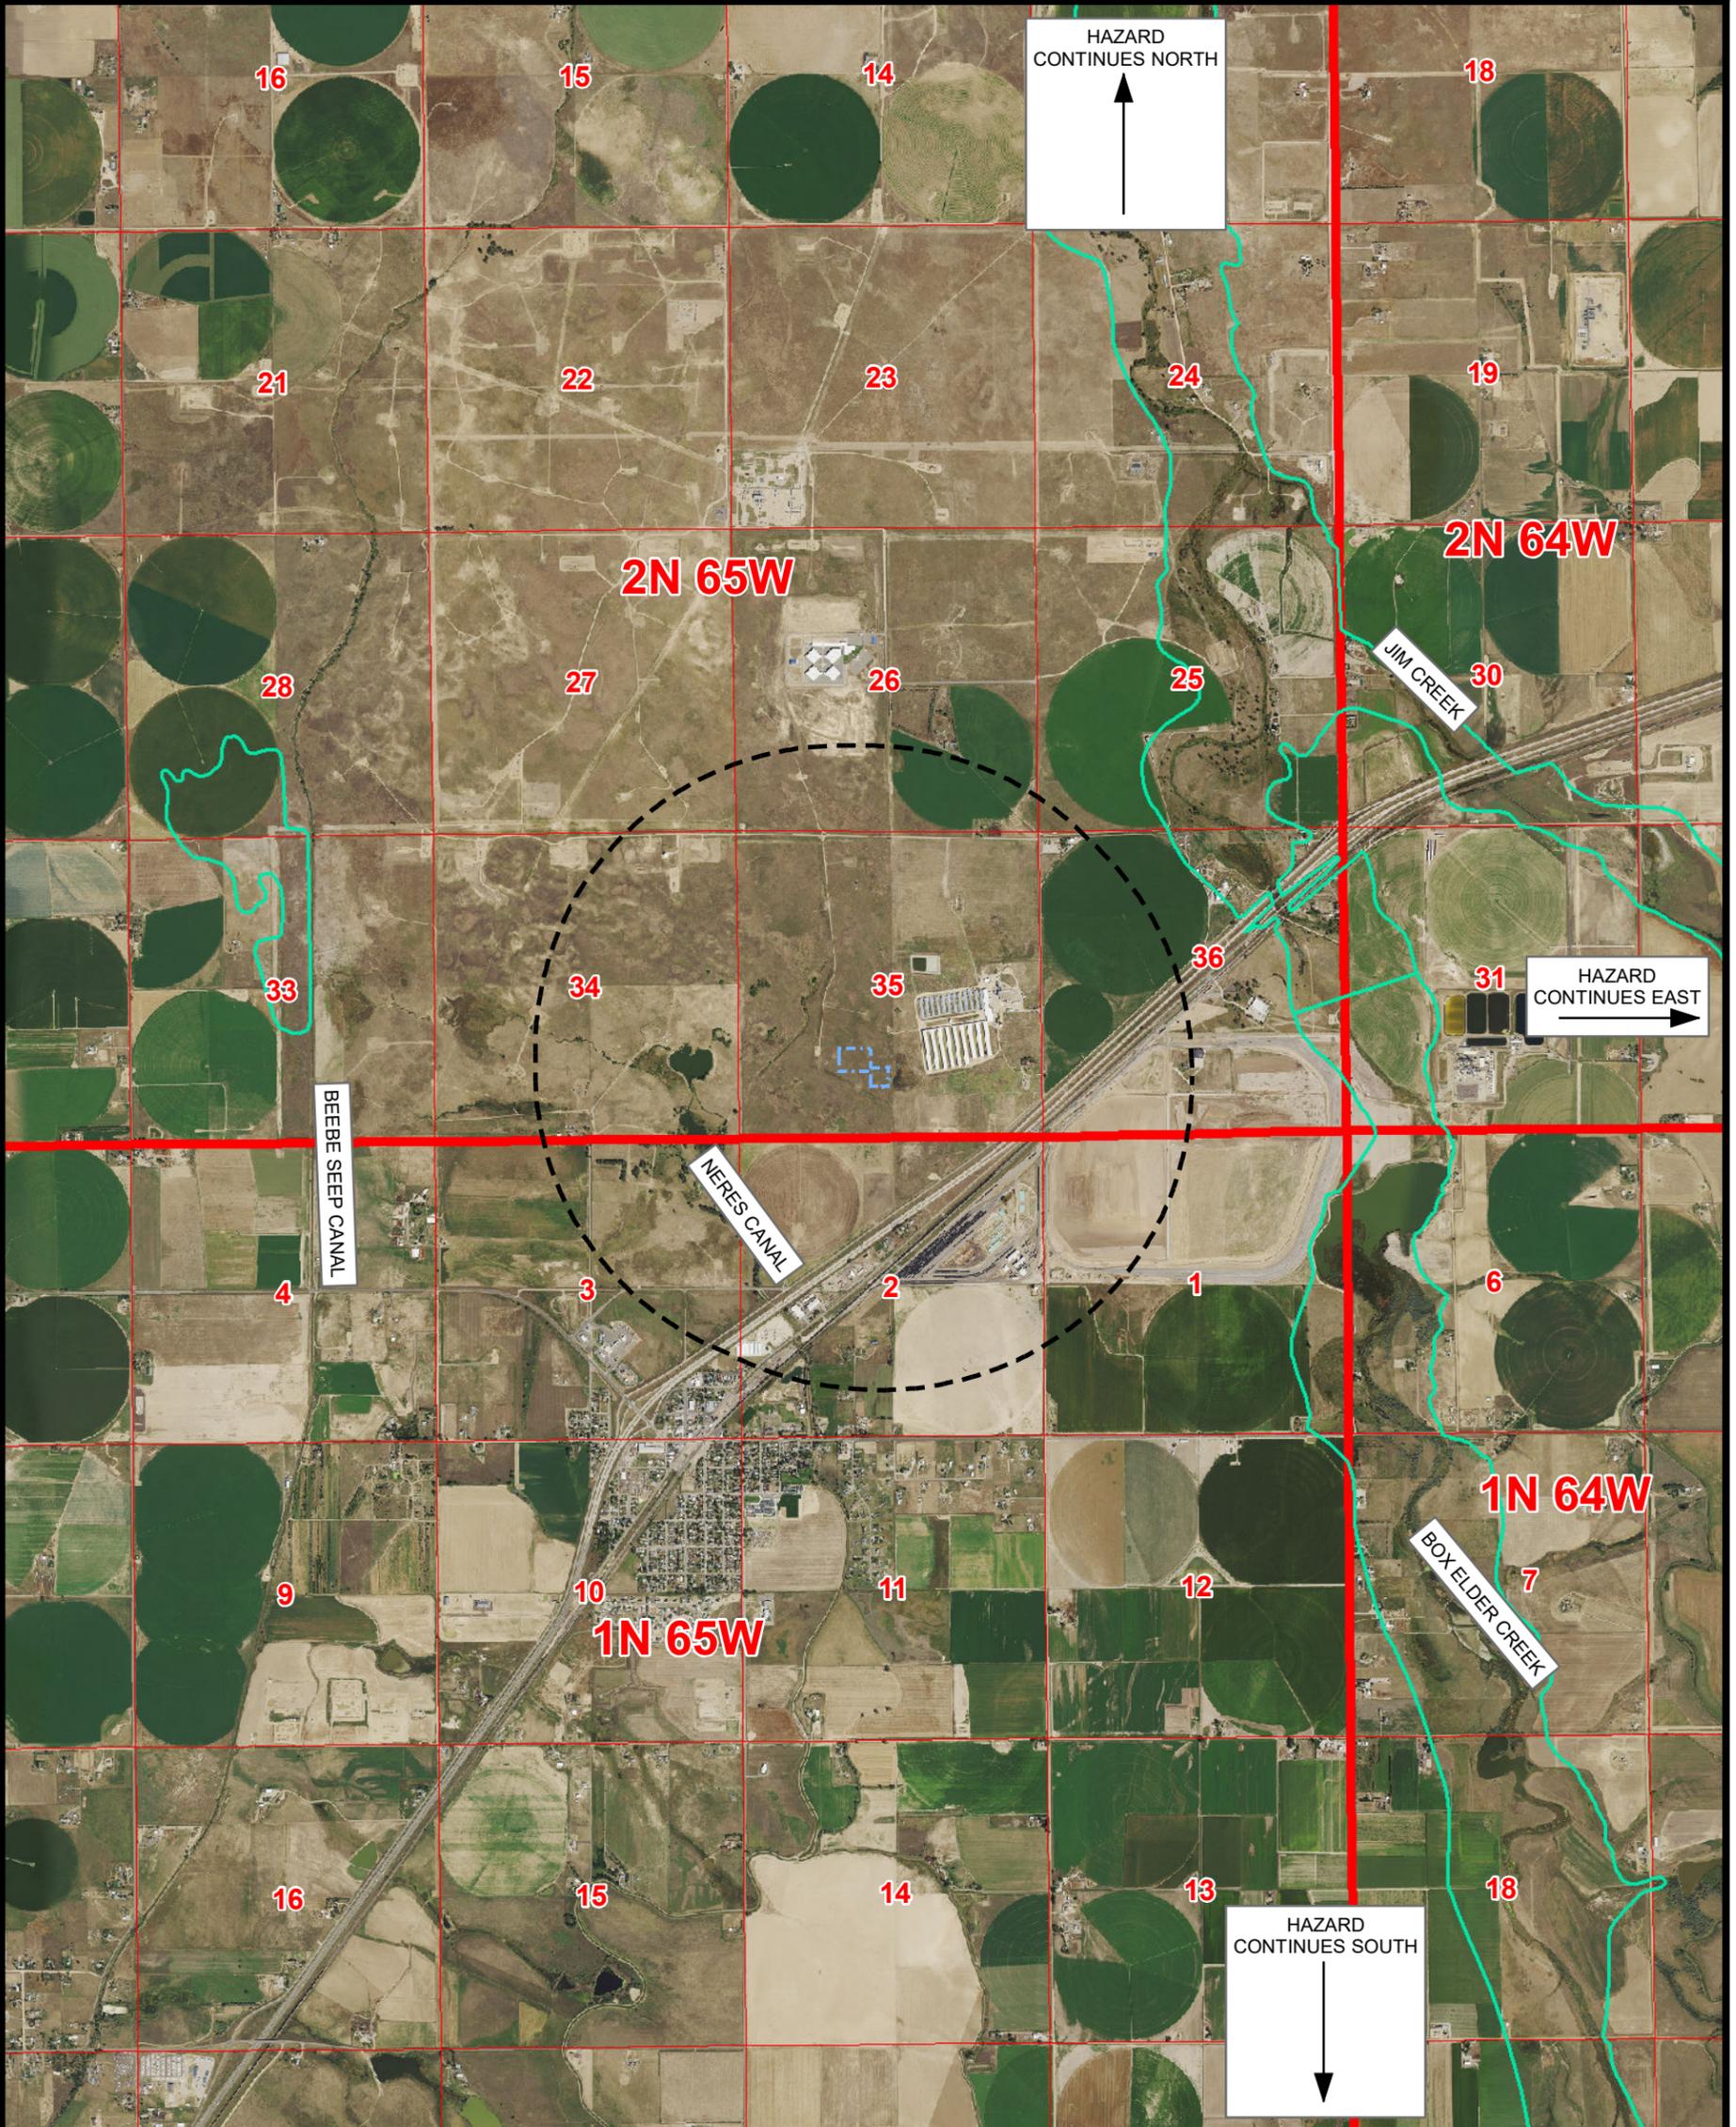
GEOLOGIC HAZARD MAP LABRISA 11-35HZ

I certify that I am a Professional Geologist, having met the educational requirements and professional work experience required by C.R.S. 23-41-208(b). I have reviewed information pertaining to the Oil and Gas location and the surrounding area and have identified no Geologic Hazards within a one-mile radius.
