LOCATION: Front Range 2

DOCUMENT: Geologic Hazards Plan

Carbon Storage Solutions seeks to develop a well that will support a Class VI Carbon Capture Sequestration program. This EPA required well will monitor pressure, temperature, and formation fluid sampling.

This Geologic Hazard Plan is intended to facilitate compliance with the Front Range 2 ECMC Rules and Regulations, Rule 304.c.(21). This document serves as the Geologic Hazards Plan for Form 2A.

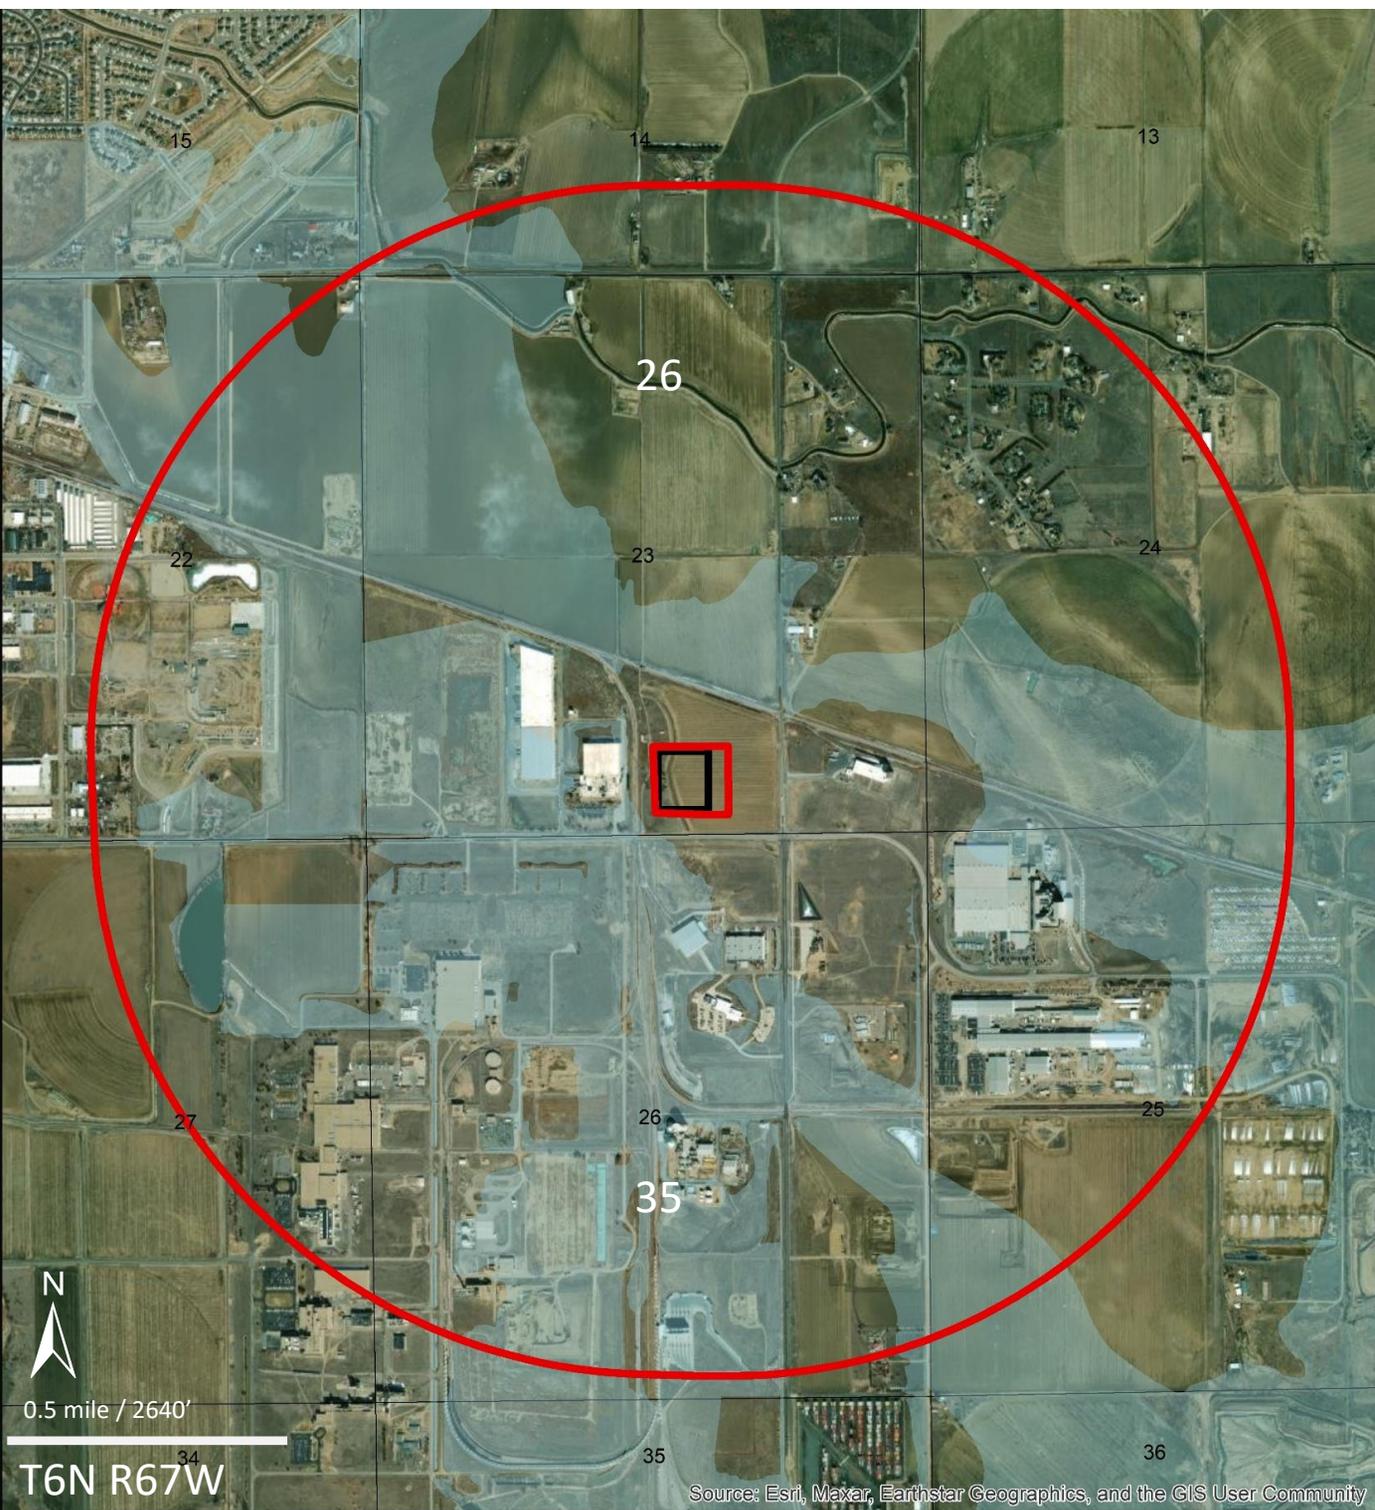
**GEOLOGIC HAZARD MAP EXHIBIT 1**

I, Julia Rausch Lemaster, certify that I am a Professional Geologist, having met the educational requirements and professional work experience required by C.R.S. § 23-41-208(b). I have reviewed information pertaining to this Drill Location and the surrounding area, and have identified the following Geologic Hazards within a 1-mile radius:

- Corrosive Soil to Steel
- Collapsible and Hydrocompressive Soil Potential

Please note:  
 100-year effective floodplain displayed on map as blue shading.

Pad with 1-mile radius

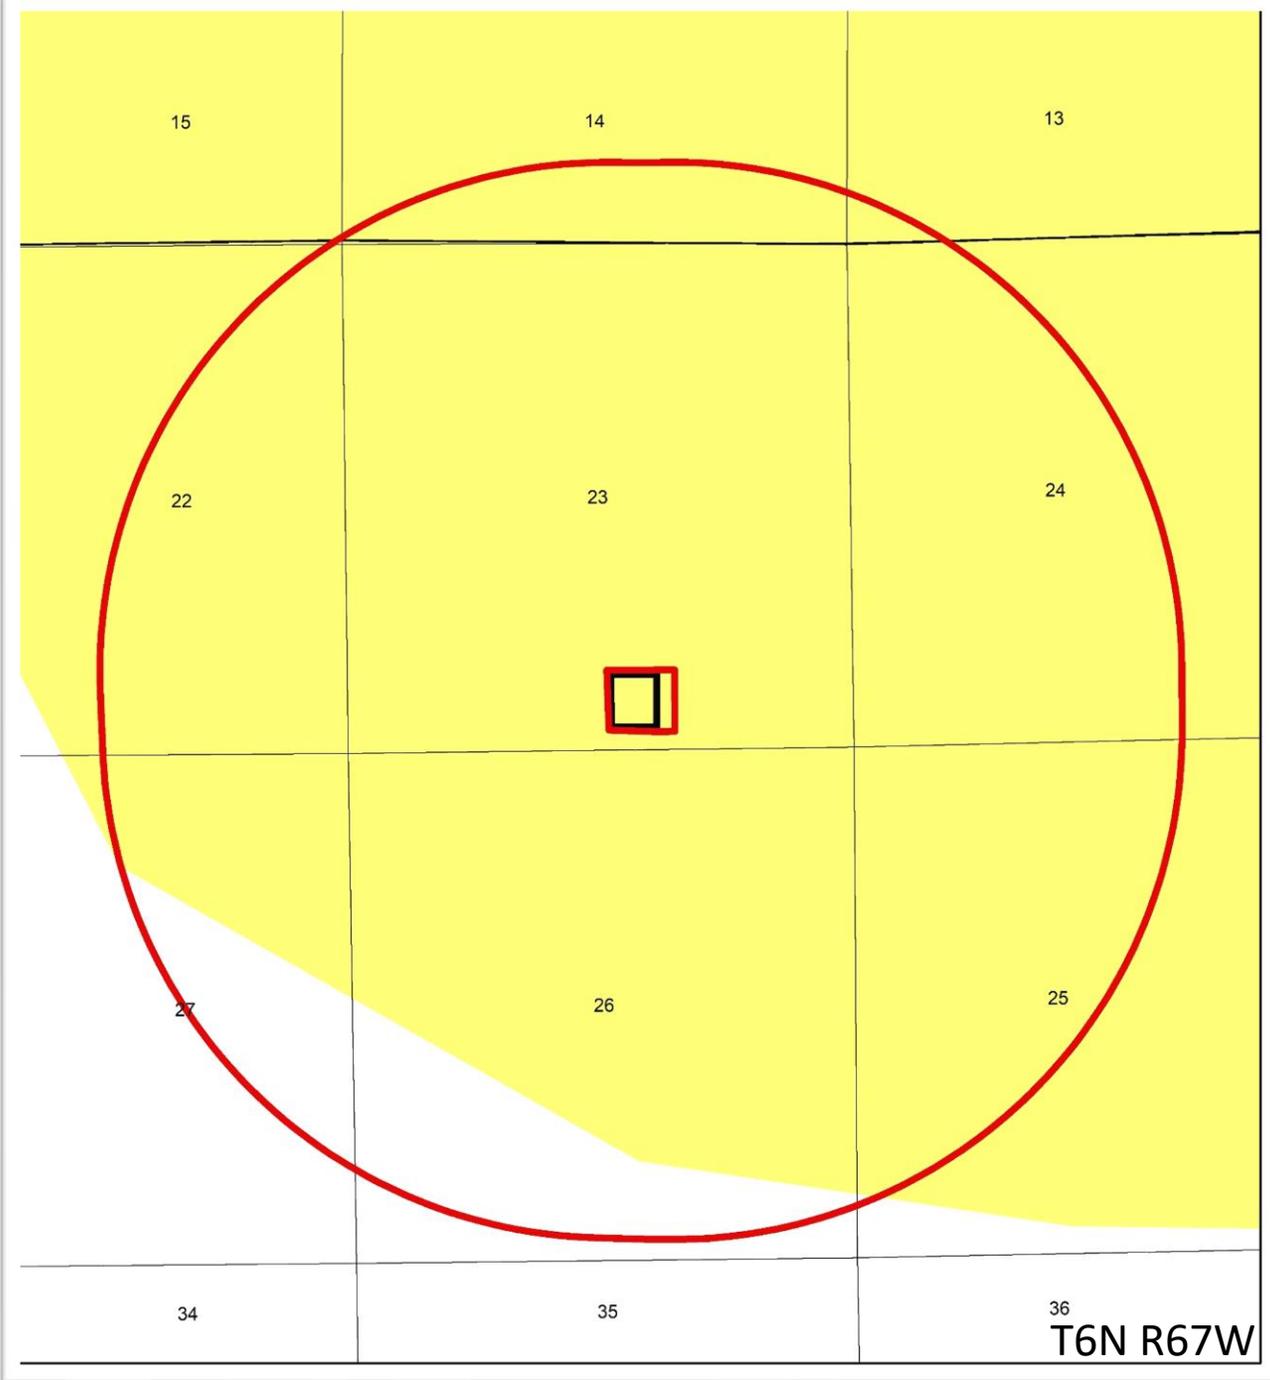
**GEOLOGIC HAZARD MAP EXHIBIT 2**

**Collapsible Soil**

Loess – can be a collapsible soil

Per analysis by other operators in the general area, there have been no known cases of subsidence due to eolian soil collapse in the area as a result of drilling operations in the greater Wattenberg Field area.

Collapsible soils are identified as a potential hazard. Prior to construction at the proposed location, topsoil is removed. During the cut and fill process, the ground is wetted and compacted. A cap of about 4-6" of road base provides additional protection from differential compaction. The grade and ditches promote flow off of the proposed location to further mitigate the risk of water saturating soils. Considering the soil composition, and the facility design and management, I determine the collapsible soil hazard is low.

Pad with 1-mile radius

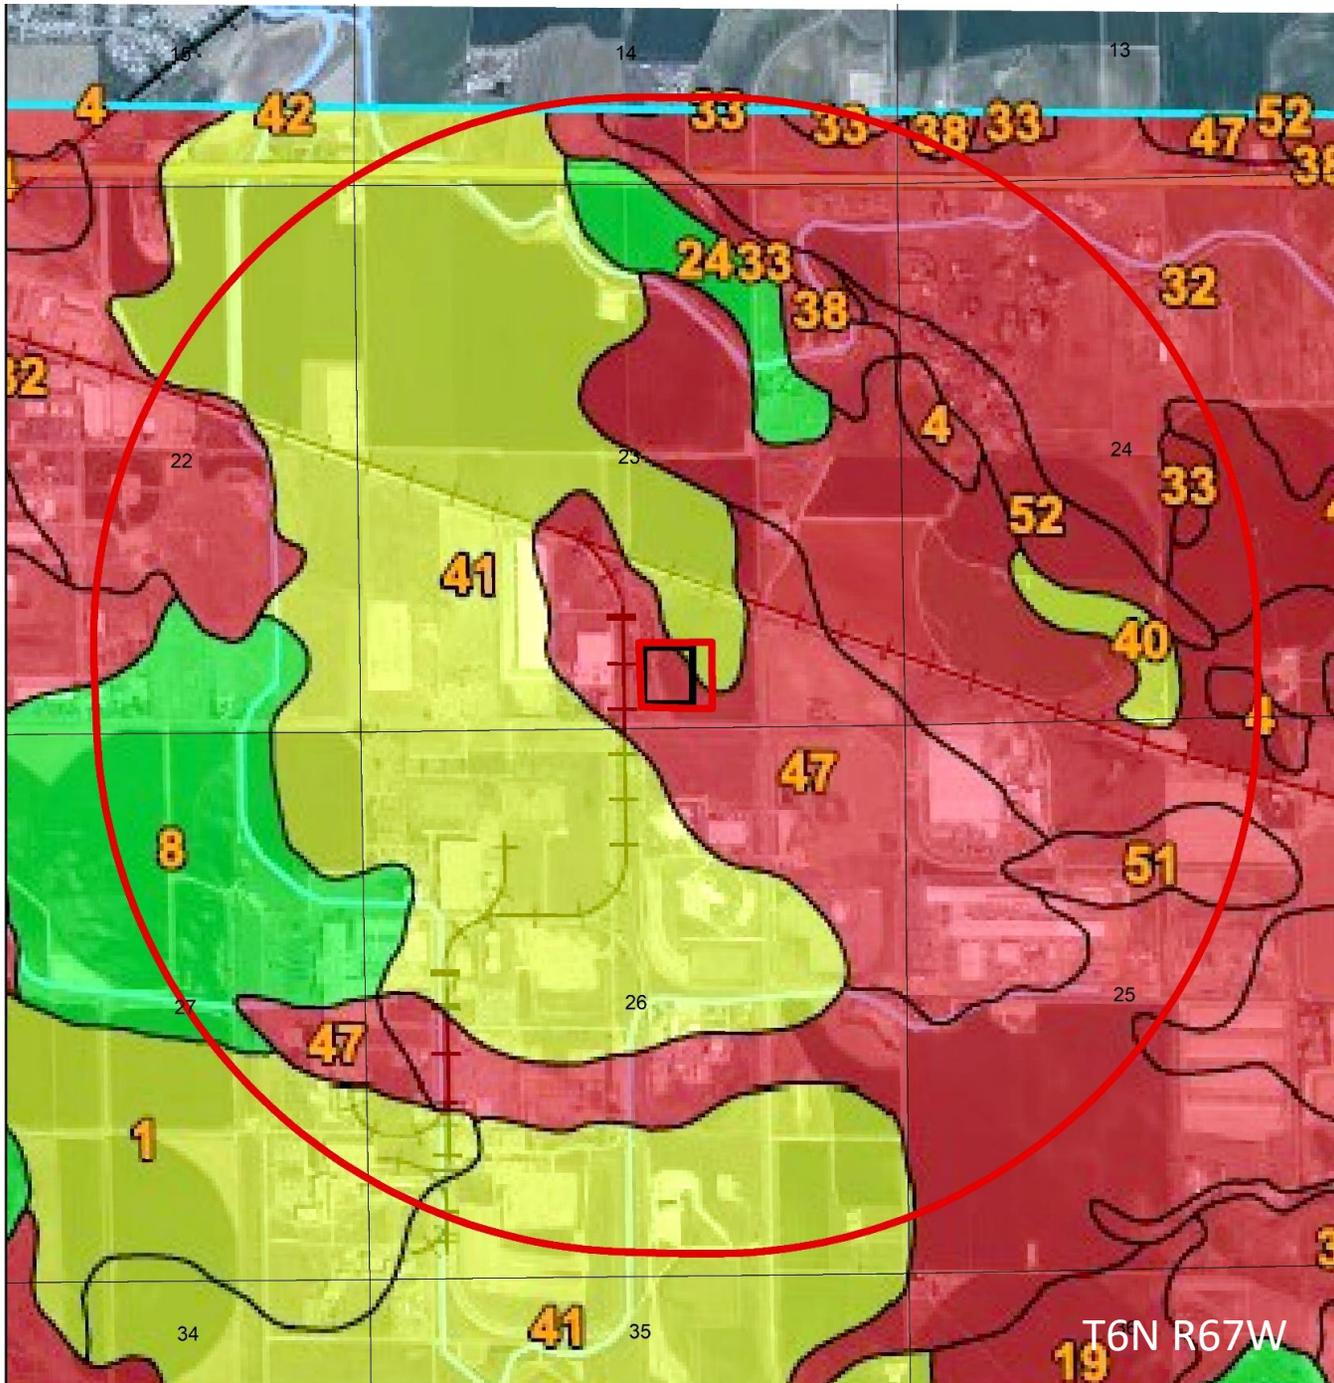
**GEOLOGIC HAZARD MAP EXHIBIT 3**

**Corrosion of Steel**

**Soil Corrosion Rating**

Corrosion to steel is identified as a potential hazard in vicinity of, but not at, the proposed location. No steel at the proposed location will be exposed to the soil because

Considering the primary soil on the location, and facility design and management, I determine the steel corrosion hazard from soil at the proposed location is insignificant.
