Hornet 0136 PAD GEOLOGIC HAZARD MAP

Site Name:
Hornet 0136

Surface Location:
**SEC 01 T 08-N, R 61-W
Weld County, Colorado**

Geologic Hazards Summary for Hornet 0136

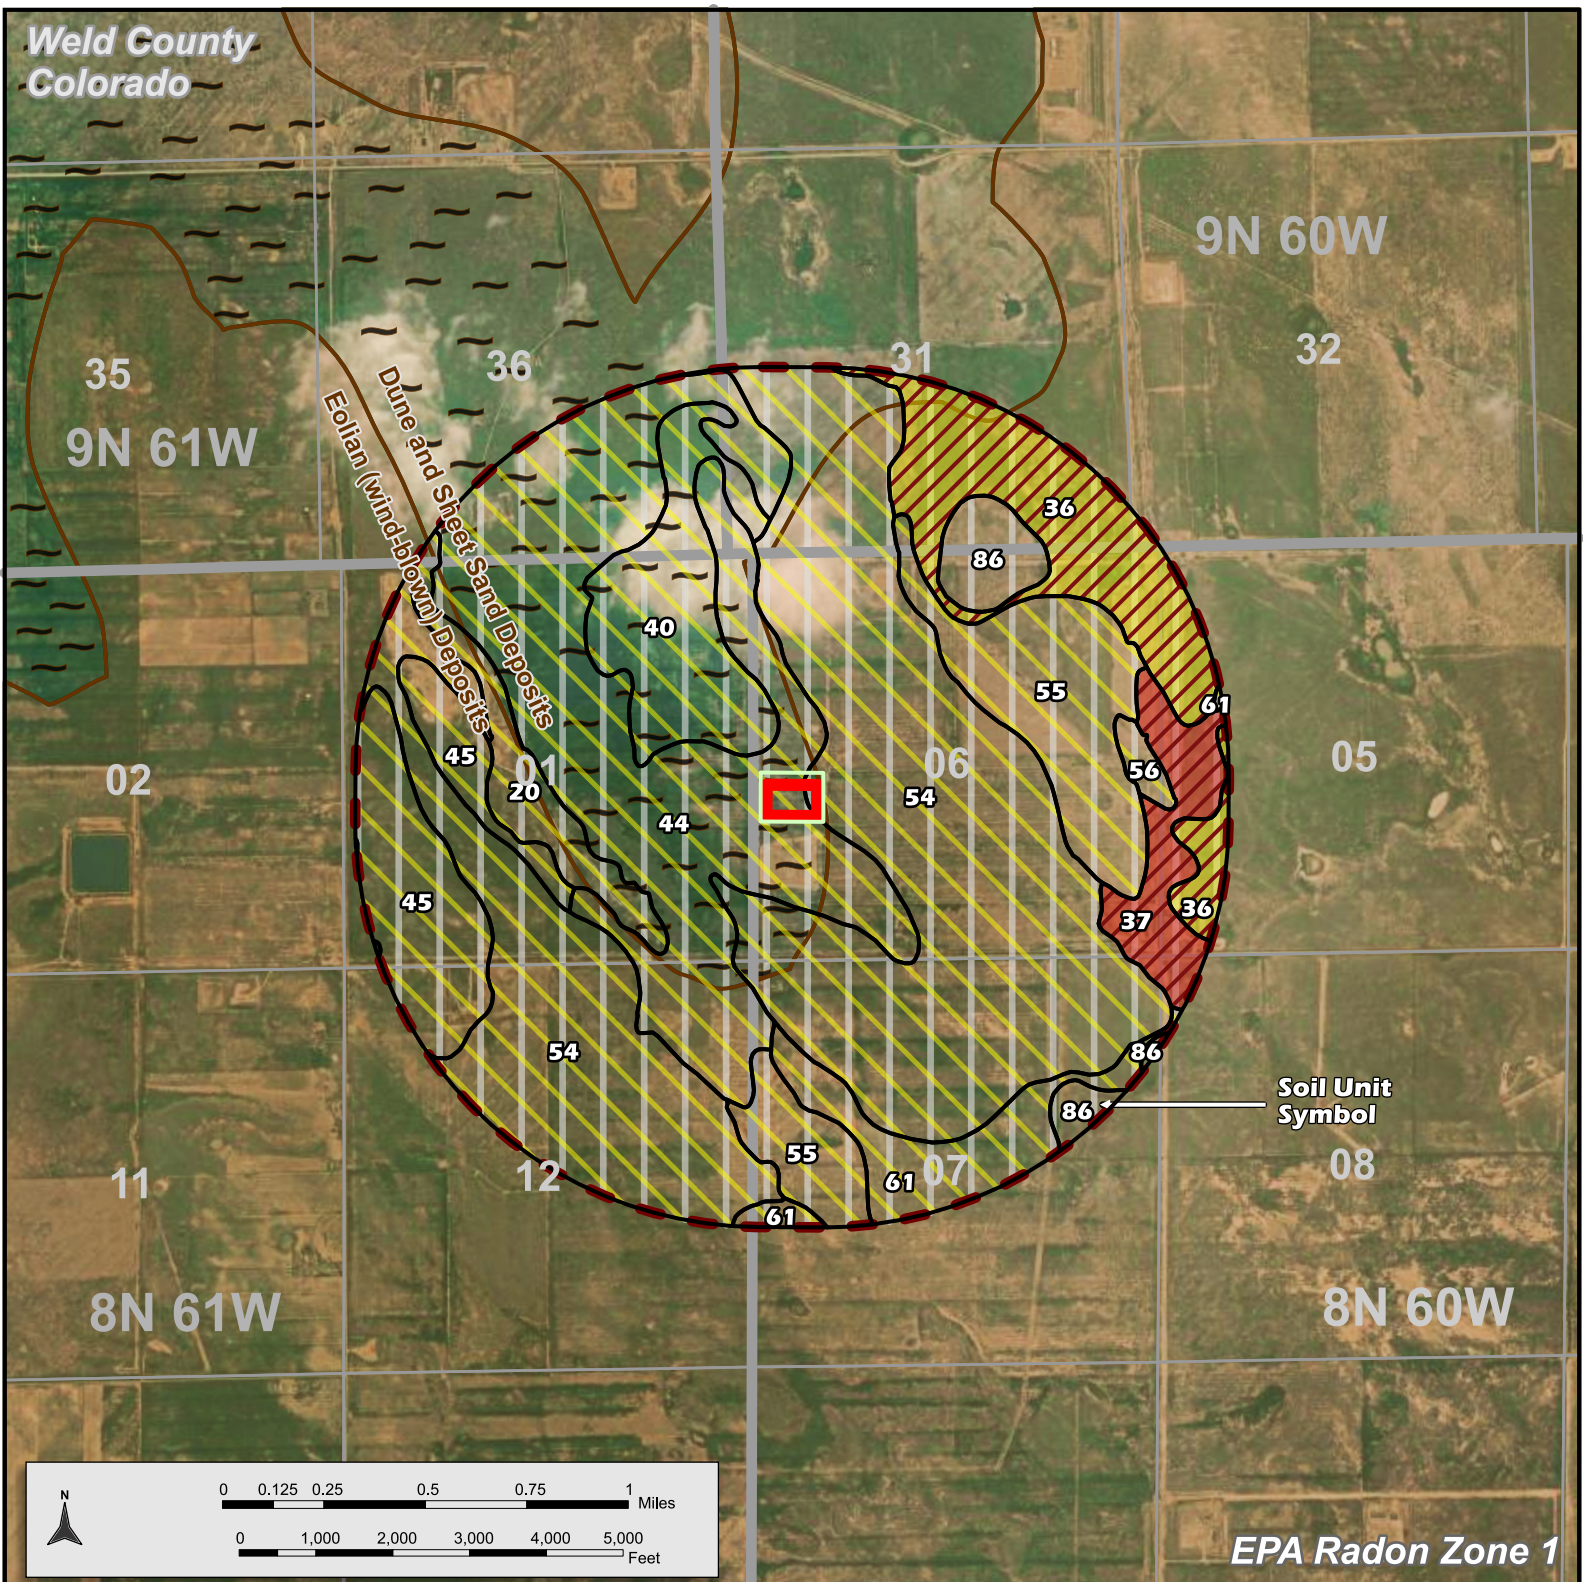
Entire map area is within:
EPA Radon Zone 1

Collapsible Soils:

CGS EG-14 Dune and sheet sand deposits

CGS EG-14 Eolian (wind-blown) loess deposits

Expansive Soils:
Plastic Index: **Low**
Liquid Index: **Low**

COVERS ENTIRE MAP AREA

Landslide, Coal Mines, Floodplain:
NOT PRESENT

Corrosion of Concrete

High	Soil Unit Symbol # 37	Soil Rating High
	Moderate	Soil Unit Symbol # 36	Soil Rating Moderate

Compressible Soils
Unified Soil Classification (Surface)

Corrosion of Steel

High	Soil Unit Symbol # 36, 37	Soil Rating High
	Moderate	Soil Unit Symbol # 20, 40, 44, 45, 54, 55, 56, 61	Soil Rating Moderate

CL - 36, 37, 40, 54, 61
SC - 44, 45, 55, 56

Based on this review of available geologic data comprised of experience, measurements, and published reports, I determine that the following hazards are present at the proposed location: soil corrosion of concrete [1], soil corrosion of steel [1], compressible soils [1], collapsible soils [1,2], and Radon (NORM) [8]. Other absent, or very low, hazards examined at the proposed location are expansive soils [1,3,4], landslides [1,6], 100-year floodplain [7], NORM & TENORM [9], induced seismicity [10], natural rate seismicity [11], and coal mine subsidence [12]. A map summary of these findings is attached.

Corrosion to concrete is identified as a potential hazard. The concrete on location will serve as a combustor base. Considering the soil composition, and Verdad's facility design and management, I determine the soil corrosion to concrete hazard is insignificant.

Corrosion to steel is identified as a potential hazard at the proposed location. No steel at the proposed location will be exposed to the soil because 1) all steel equipment on location will have impervious liners, 2) steel flowlines will have protective lining, and 3) imported gravel or road base will separate the natural soil from steel. Considering the primary soil on the location, and facility design and management, I determine the steel corrosion hazard from soil at the proposed location is insignificant.

Compressible soils are identified as a potential hazard. Prior to construction at the proposed location, topsoil is removed. During the cut and fill process, the ground is wetted and compacted. A cap of about 4-6" of road base provides additional protection from differential compaction. The grade and ditches promote flow from the proposed location to further mitigate the risk of water saturating soils. Considering the soil composition, and Verdad's facility design and management, I determine the compressible soil hazard is low.

Collapsible soils are identified as a potential hazard. Prior to construction at the proposed location, topsoil is removed. During the cut and fill process, the ground is wetted and compacted. A cap of about 4-6" of road base provides additional protection from differential compaction. The grade and ditches promote flow from the proposed location to further mitigate the risk of water saturating soils. Considering the soil composition, and Verdad's facility design and management, I determine the collapsible soil hazard is low.

Radon hazard is identified as a potential geo hazard on the map. However, there are no inhabited structures, or structures occupied throughout the working day, planned at the location. Considering the EPA radon zone, and the lack of inhabited structures, the radon hazard at the proposed location, I determine the radon hazard at the proposed location is insignificant.
