GEOLOGIC HAZARD PLAN CATAMOUNT OUTPOST 33-8 PAD

La Plata County, Colorado

Completion Date: May 19, 2025

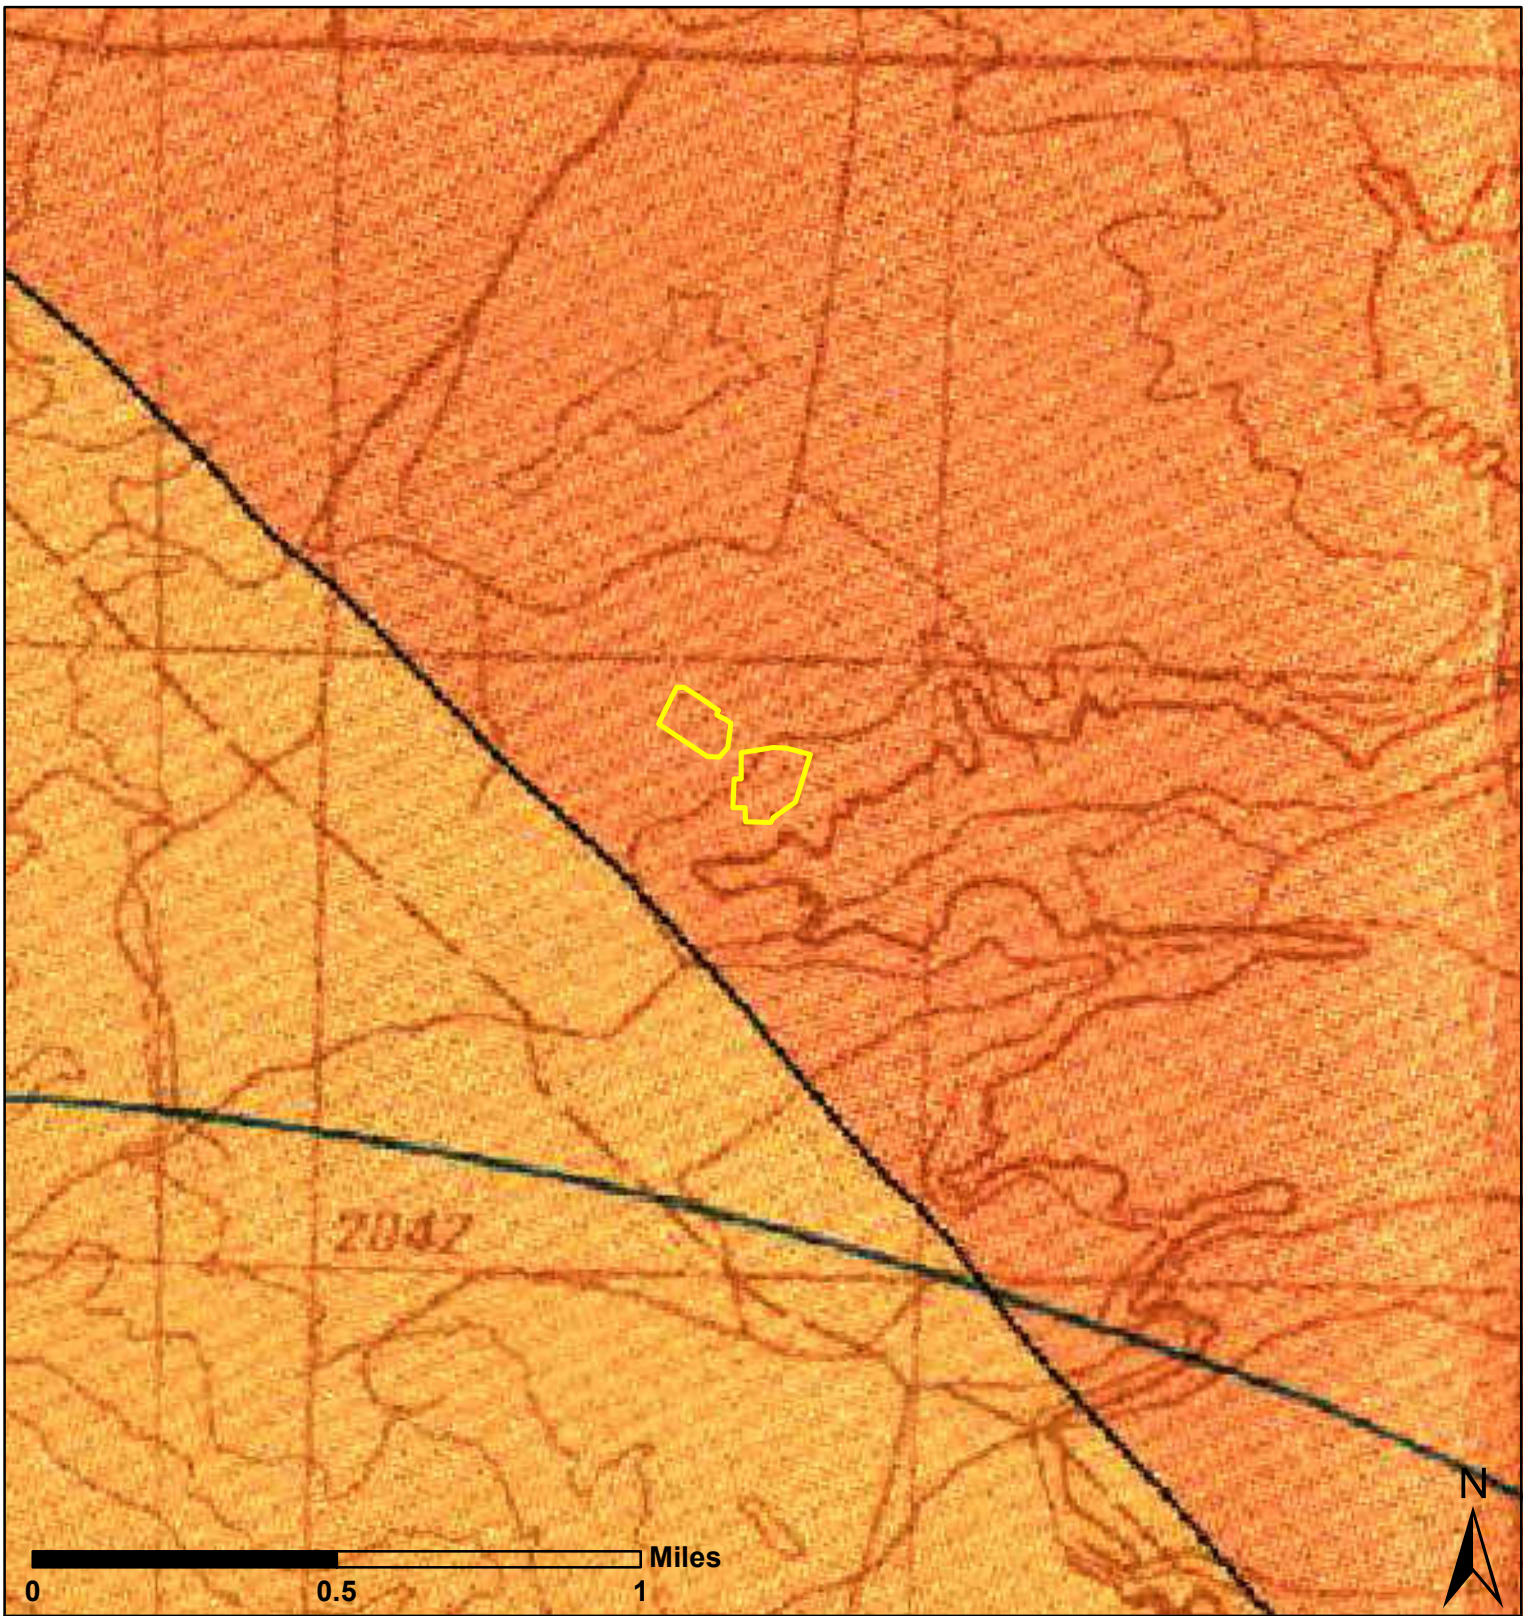
</p> <p>Mapping by: E. Millar, 5/19/2025 Coordinate System: NAD 1983 UTM Zone 13 N</p> <p>Location: Section 26 T33N R8W NMPM</p>	<p>Figure 2 Geologic Map Outpost Pad Geologic Hazard Plan Catamount Energy Partners LLC</p>
--	--	---

Notes: Basemap is the Geologic and Structure Contour Map of the Southern Ute Indian Reservation and Adjacent Areas (Condon, 1990).

The surficial geology in the vicinity of the project consists of the San Jose and Animas Formations, undivided (Tsa). The San Jose Formation consists of brown, gray, and grayish-yellow, lenticular, medium- to thick-bedded, crossbedded, local arkosic, conglomeratic to fine-grained sandstone; red, gray, and brown sandy shale; and gray to white tuff beds. The formation is fluvial and lacustrine in origin. The formation conformably overlies the Animas Formation. The Animas Formation consists of olive, brown, gray, red, green, and purple conglomerate, tuffaceous sandstone, lithic tuff, and shale with local carbonaceous to coaly mudstone beds. The formation is volcanogenic and fluvial in origin (Condon, 1992). There are no rock outcrops present at the ground surface in the vicinity of the proposed Outpost 33-8 Pad. A geologic map of the project area is included as Figure 2.

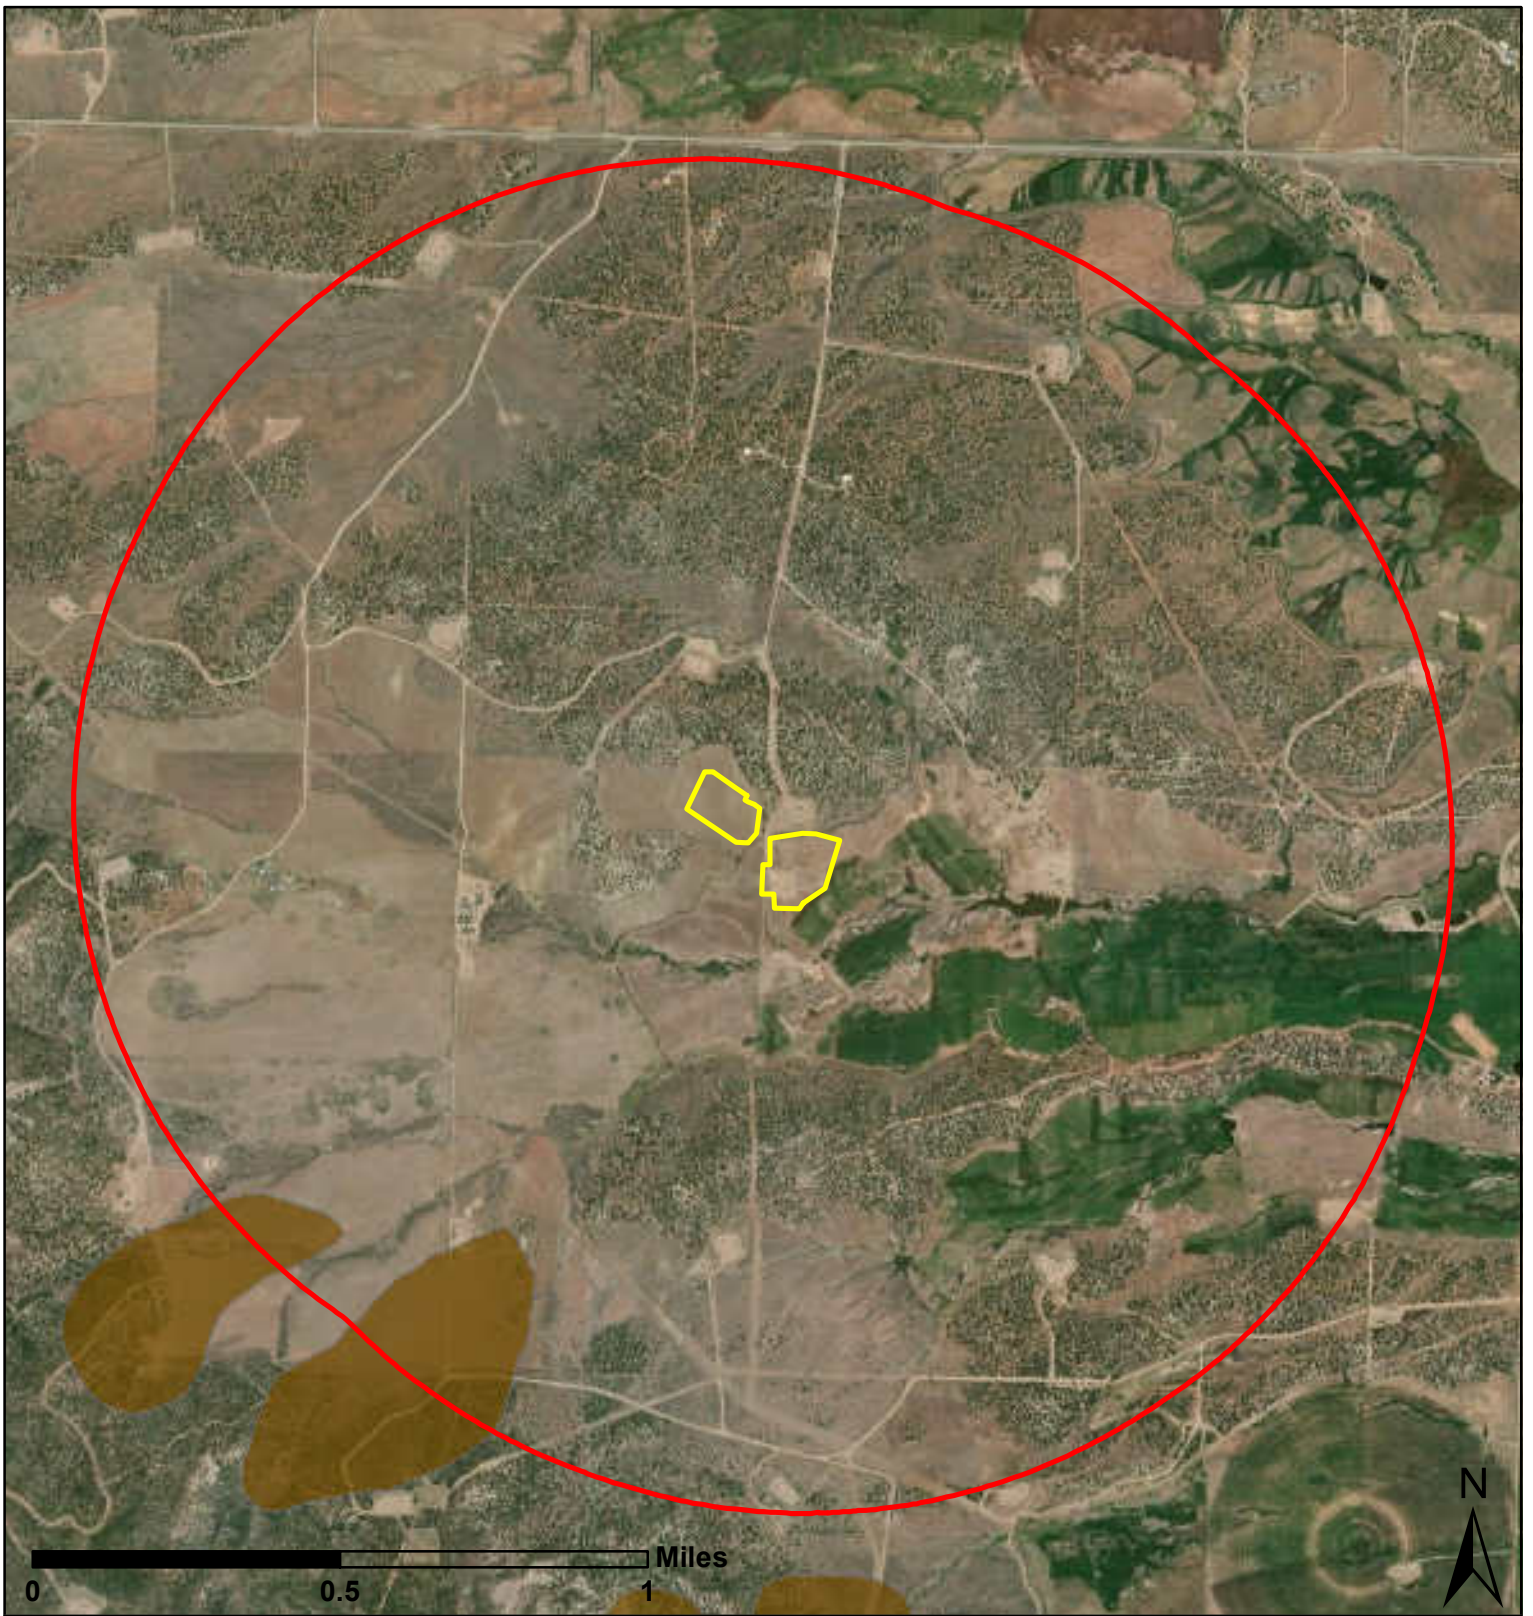
Figure 3
Landslide Hazard Map
Outpost Pad Geologic Hazard Plan
Catamount Energy Partners LLC

Notes: Landslide data from the Colorado Geological Survey.

A landslide hazard map is included as Figure 3 and indicates possible landslide areas within a one-mile radius of the project based on data from the Colorado Geological Survey (CGS; CGS, 2024). These possible landslide areas are located on the slopes of the Mesa Mountains and do not overlap with the Outpost 33-8 Pad, which is located northeast of the Mesa Mountains. The landslide areas do not pose a threat to the Outpost 33-8 Pad based on the distance and the topography that separates the pad from the landslide areas. No evidence of landslides or steep slopes are mapped by the CGS on the proposed Outpost 33-8 Pad. Site-specific review of the proposed pad indicates that the potential for landsliding or rockfalls is low based on the relatively flat topography and the

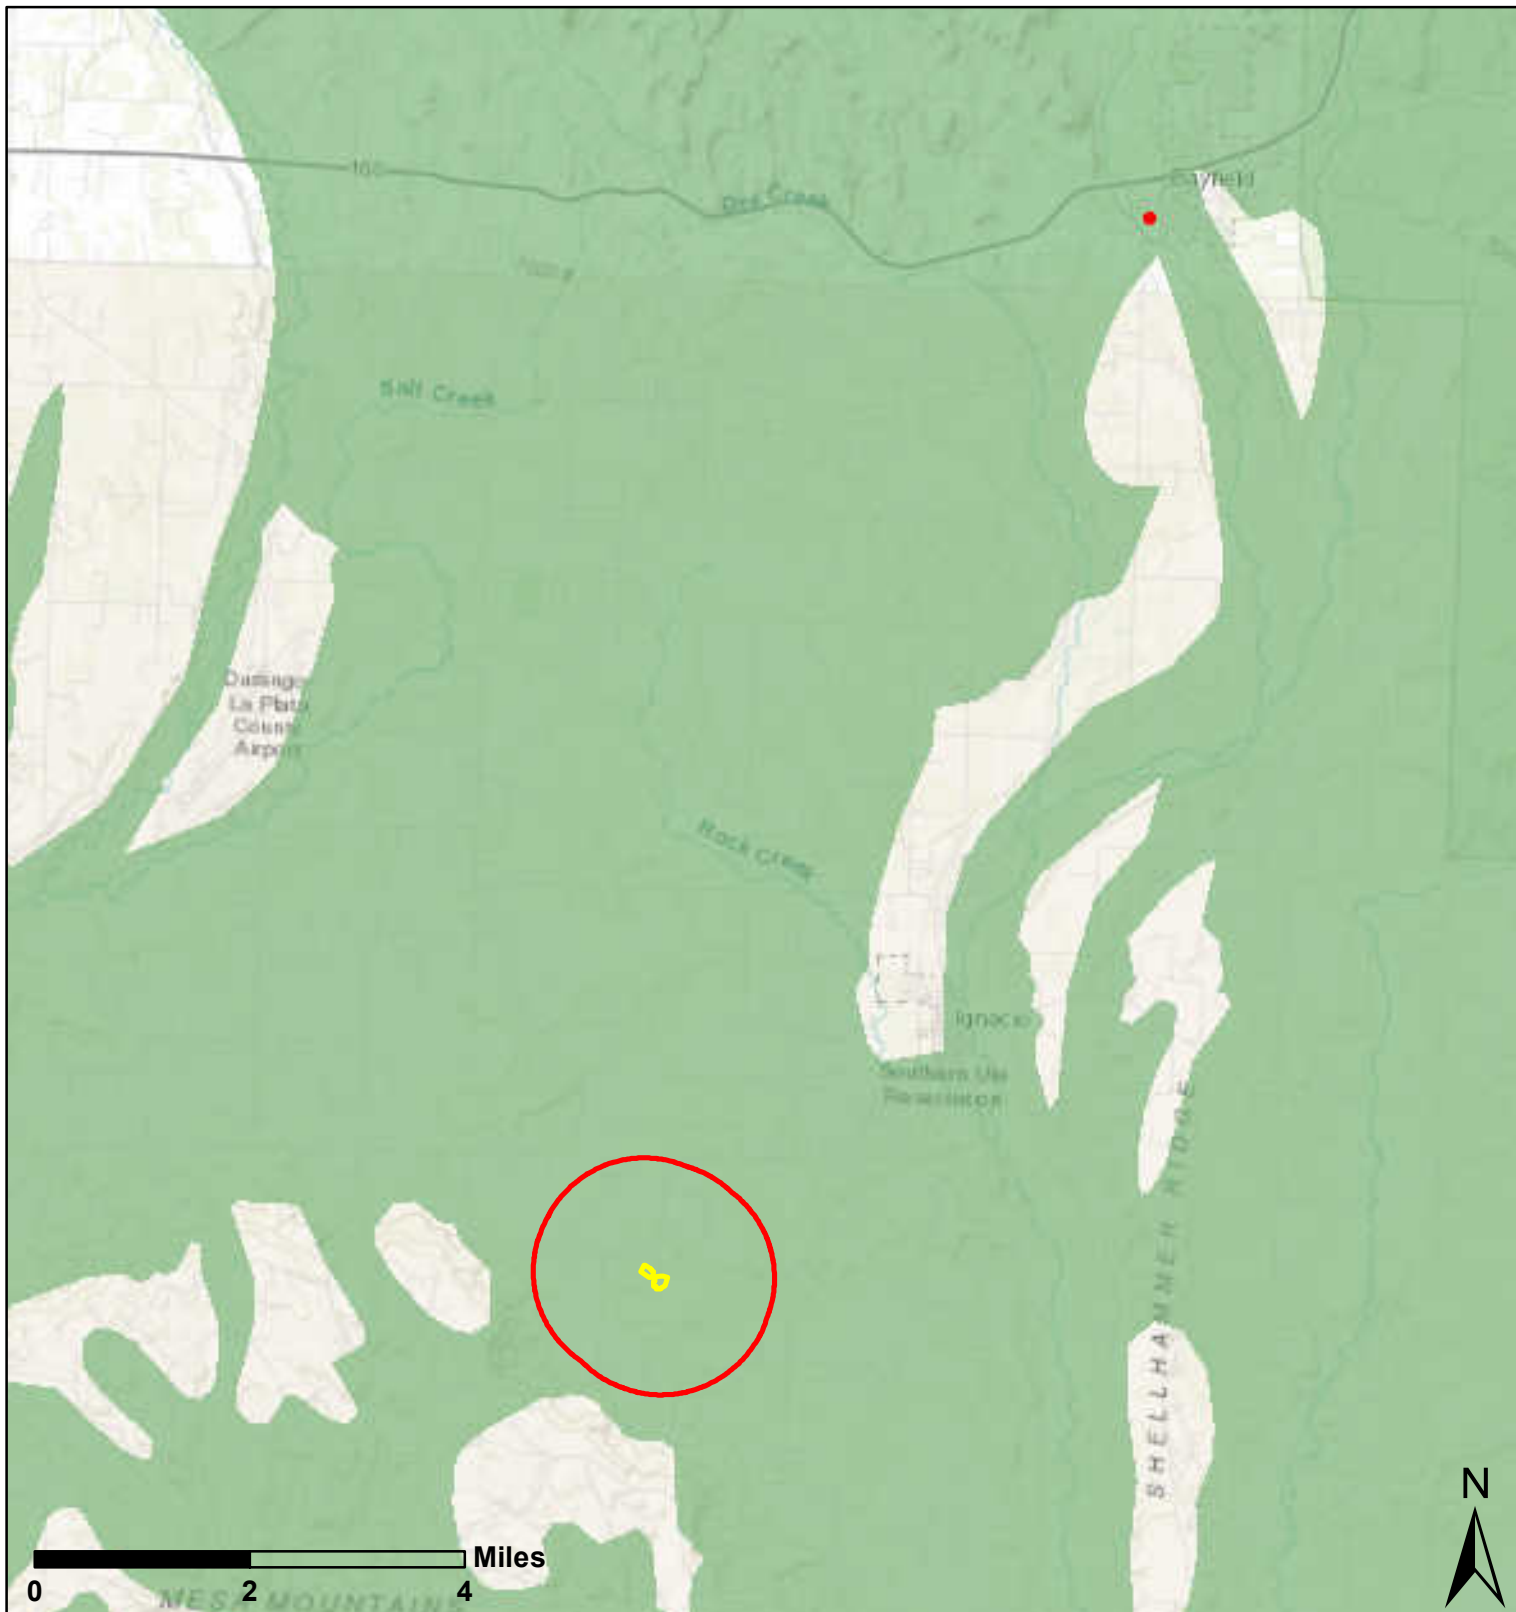
Figure 5
Collapsible Soils Map
Outpost Pad Geologic Hazard Plan
Catamount Energy Partners LLC

Notes: Collapsible soil data from the EG-14 Collapsible Soils of Colorado (White and Greenman, 2008).

Collapsible soils consist of loose, dry, low-density soils that collapse and compact under the addition of water or excessive loading. In La Plata County, collapsible soils are often fine-grained valley fill soils derived from the weathering of marine shales (La Plata County Local Hazard Mitigation Plan, 2018). Based on the *Collapsible Soils of Colorado* map viewer provided by CGS, the nearest recorded case of collapsible soil is located approximately 11 miles northeast of the Outpost 33-8 Pad near Bayfield, Colorado. There have been no recorded cases in the immediate vicinity of the project area. The risk of ground subsidence at the Outpost 33-8 Pad is considered low. A map showing the Outpost 33-8 Pad relative to the recorded case of collapsible soil near Bayfield, Colorado is included as Figure 5.

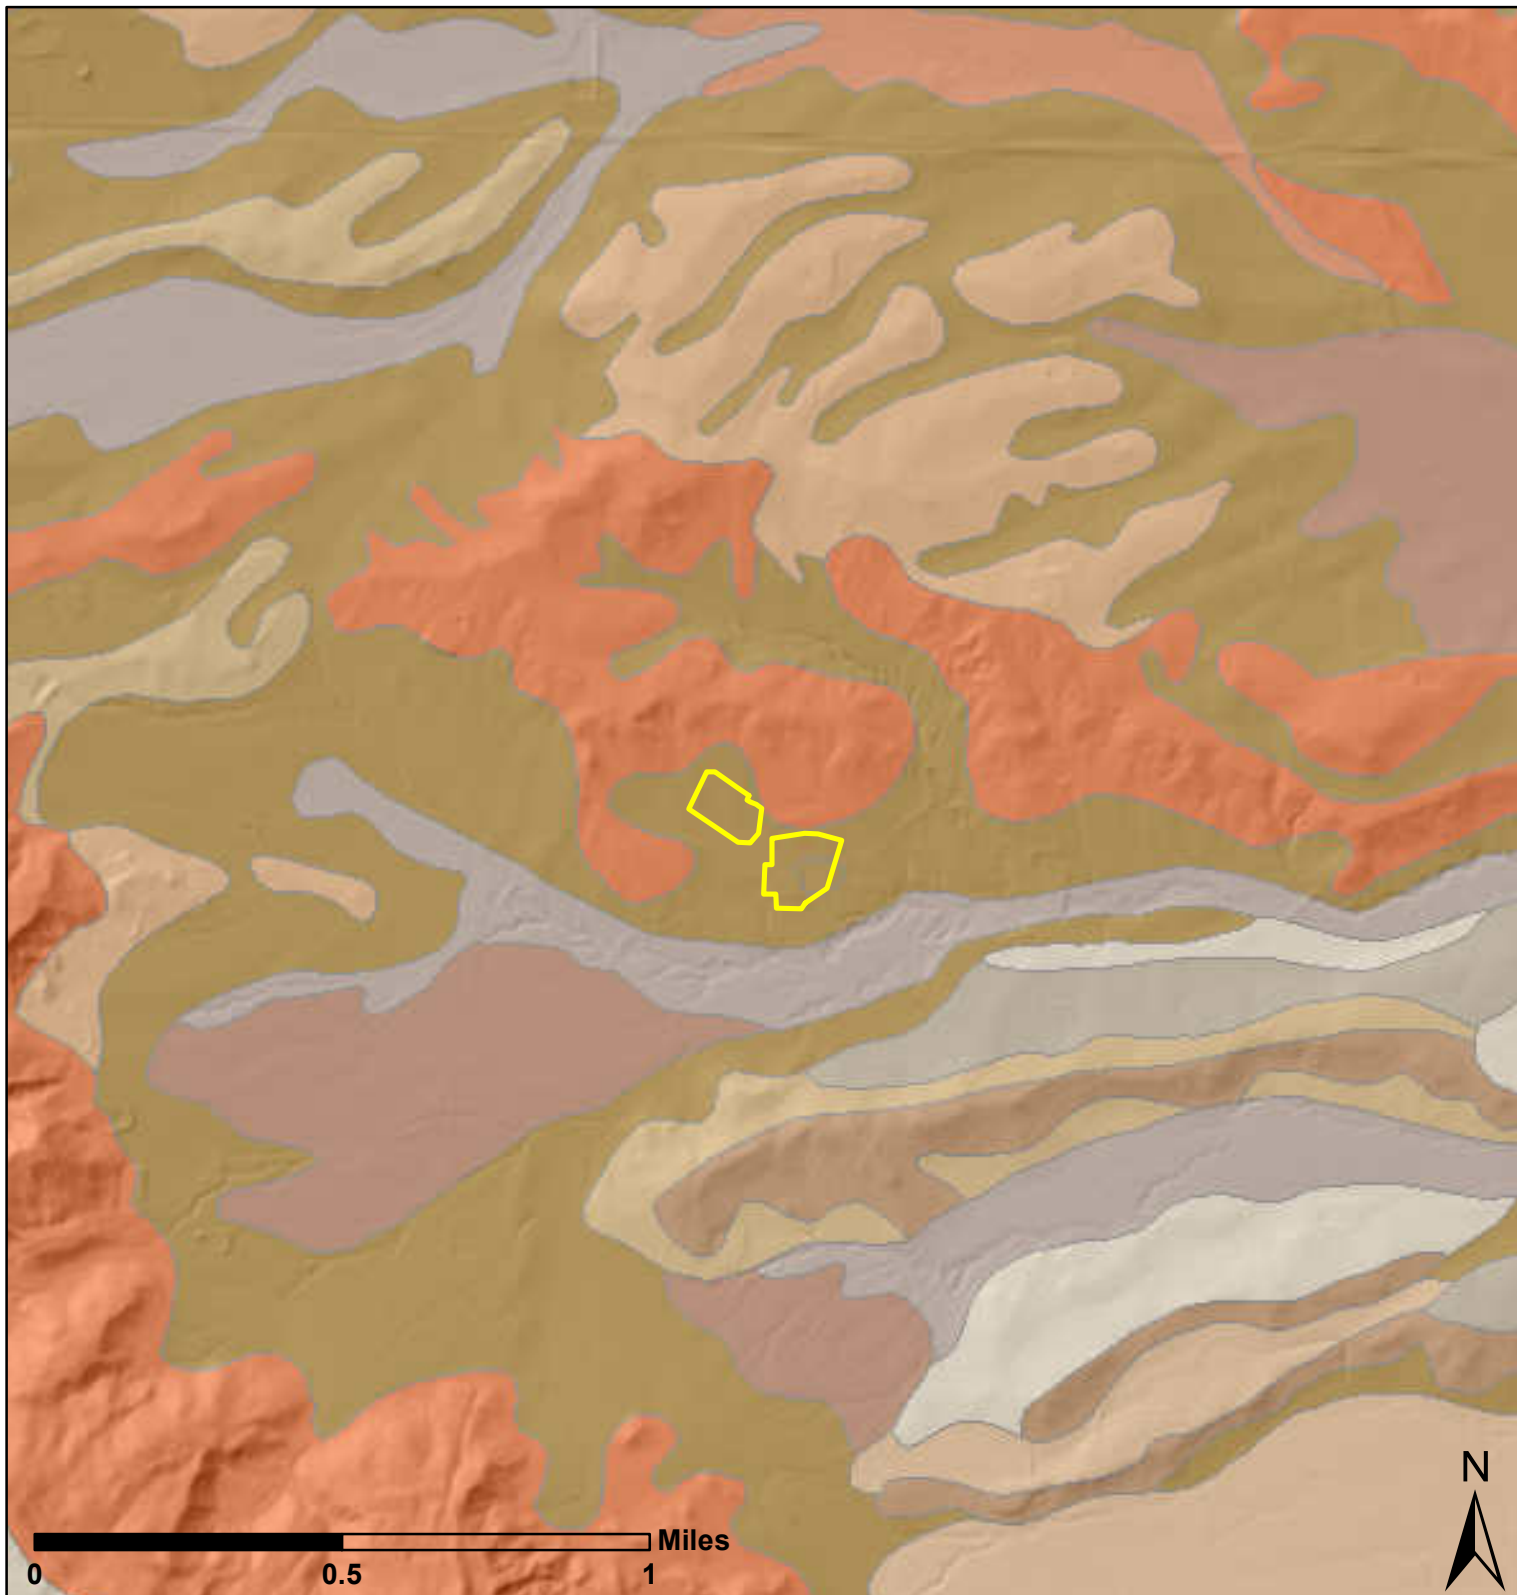
Figure 6
Soil Map
Outpost Pad Geologic Hazard Plan
Catamount Energy Partners LLC

Notes: Soil data from the NRCS. Only soil in the project area included in the legend. Water shown on the NRCS layer on the well pad removed based on field observations.

Expansive soils are characterized by clay soils that shrink and swell as they dry or become wet. Based on the Natural Resources Conservation Service (NRCS) Web Soil Survey, the Arboles clay (3 to 12% slopes) comprises 84.4% of the project area, the Zyme-Rock outcrop complex (12 to 65% slopes) comprises 1.0%, and water comprises 14.5% of the project area. However, based on field observations, there is no surface water within the footprint of the Outpost 33-8 Pad. Therefore, if the NRCS-mapped water unit is excluded, the Arboles clay (3 to 12%) comprises 99% of the project area. A soils map is included as Figure 6.

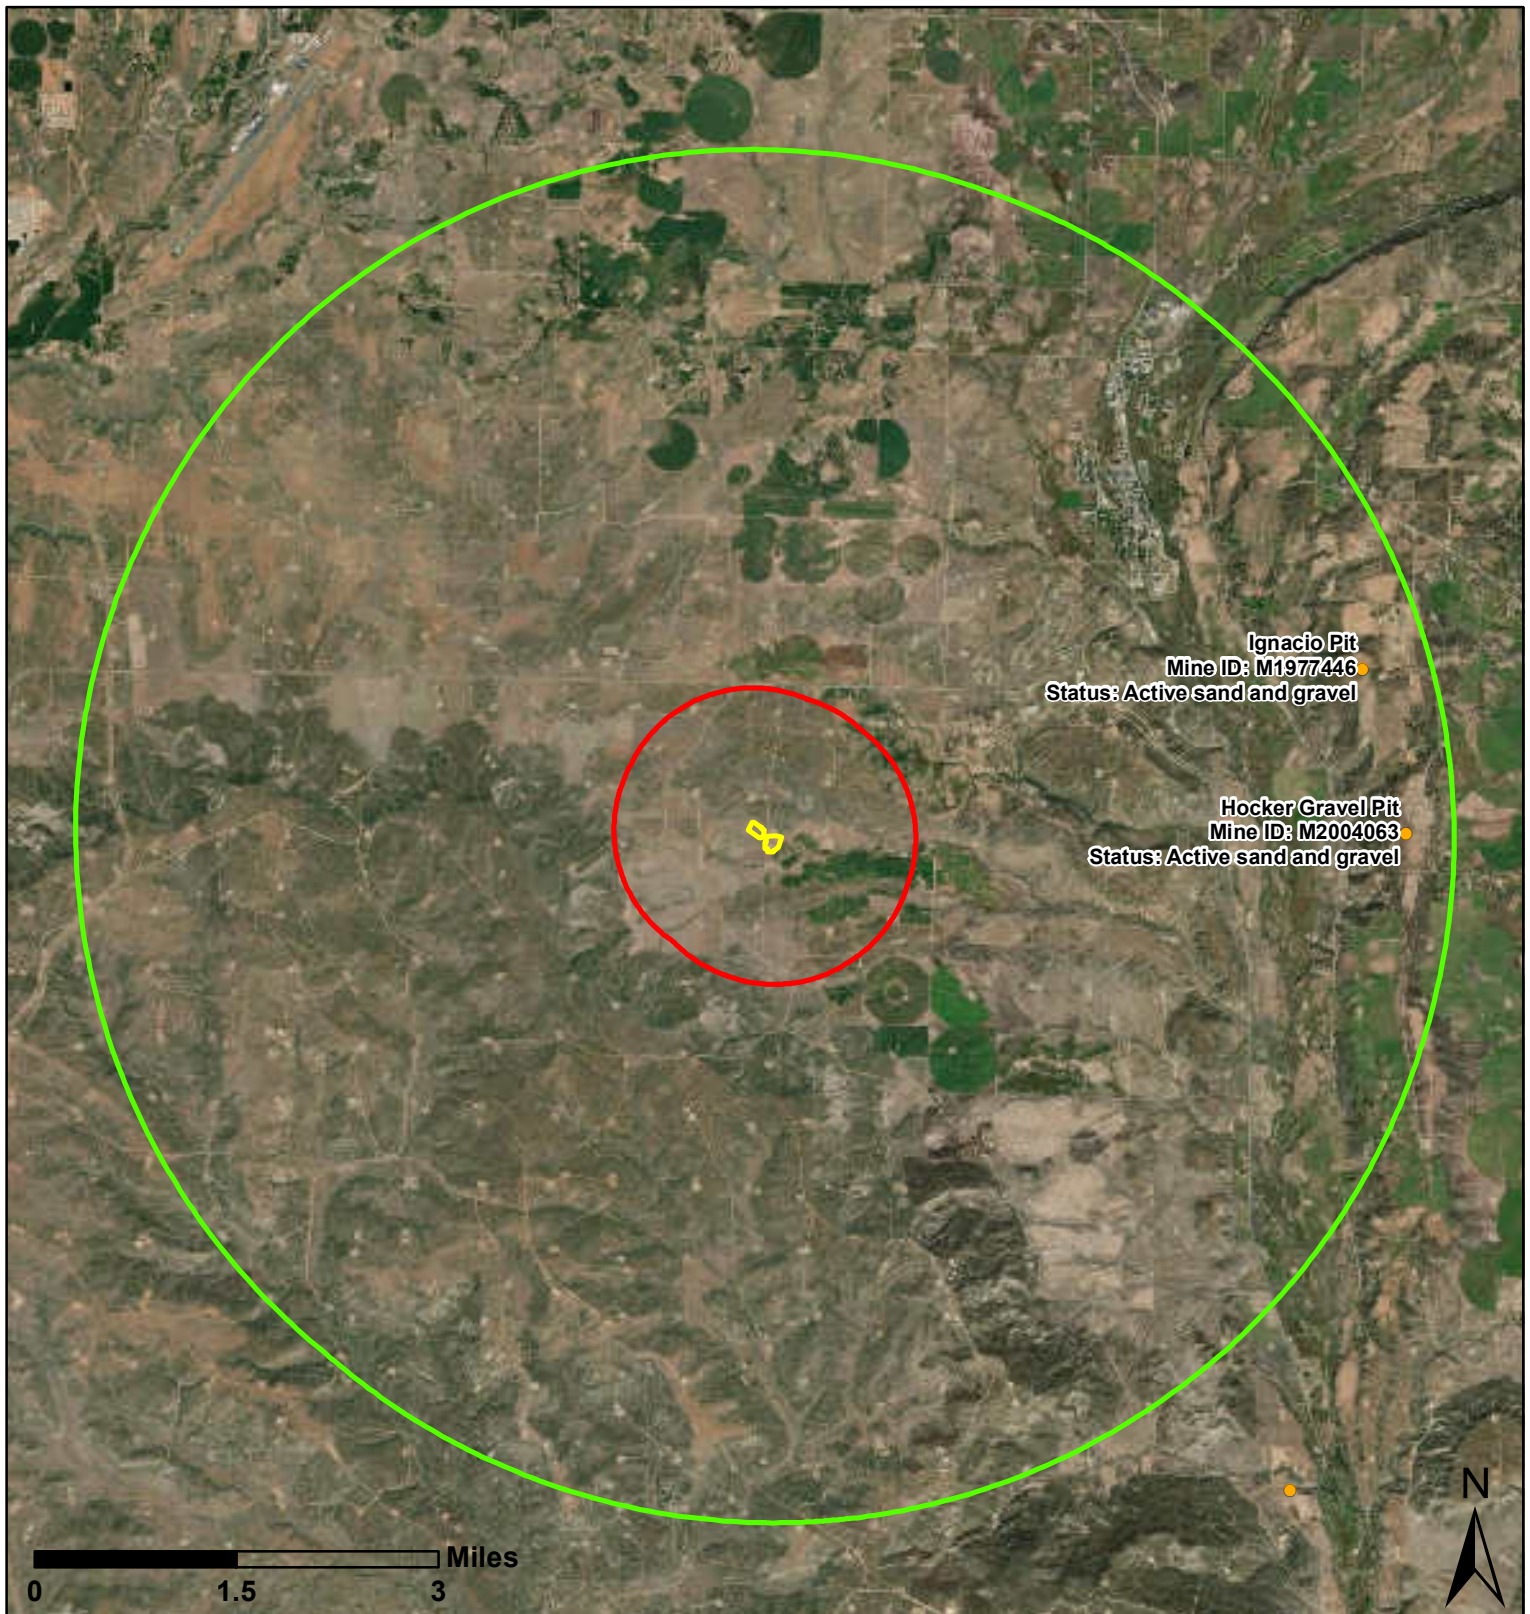
Notes: Mining data from Colorado Division of Reclamation, Mining, and Safety.
