ENPROP, INC.
VAWTER 20-2 PAD

NW1/4 SW1/4 SEC. 2 T1N R66W
6th PM WELD COUNTY COLORADO

CONSTRUCTION LAYOUT DRAWING

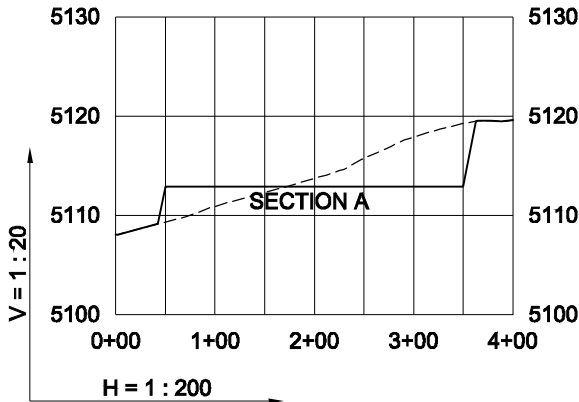
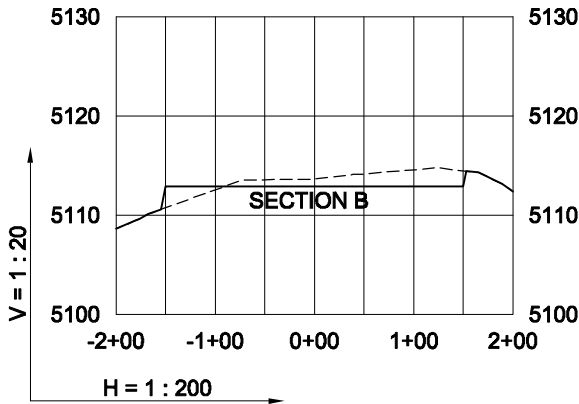
2 of 2

----- Existing Ground
 _____ Proposed Grade
