Steil Surveying Services, LLC

WELL LOCATION CERTIFICATE THIS MAP DOES NOT REPRESENT A BOUNDARY SURVEY

SECTION 21
TOWNSHIP 3 NORTH
RANGE 64 WEST

SKETCH - GUTTERSEN D21-28D

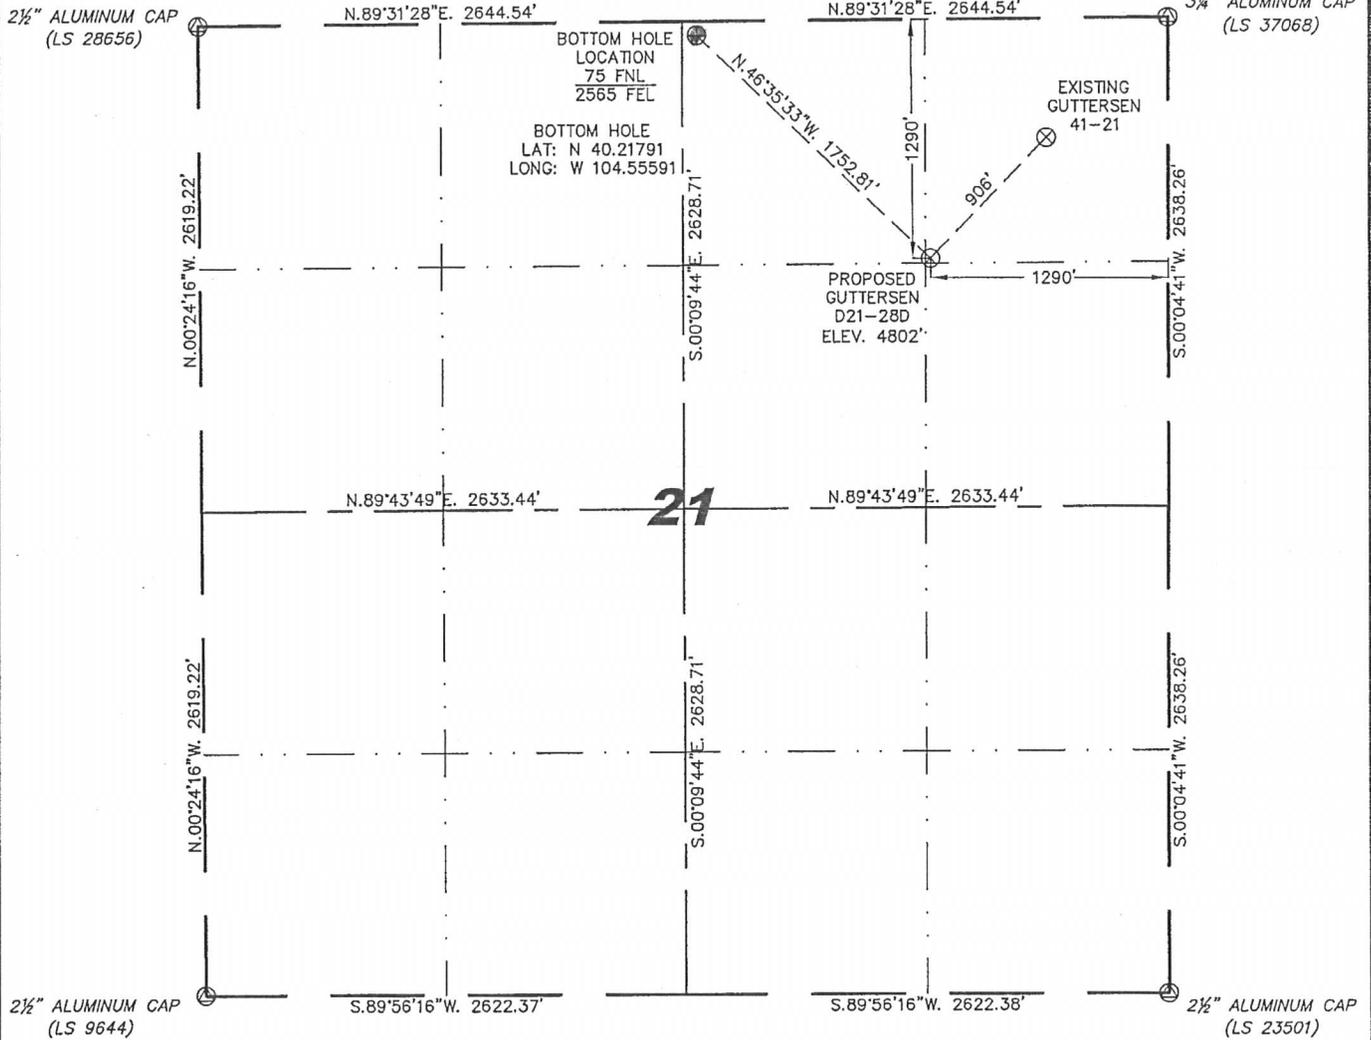
IN ACCORDANCE WITH A REQUEST FROM BRIAN DeROSE - NOBLE ENERGY INC, STEIL SURVEYING SERVICES, LLC HAS DETERMINED THE LOCATION OF THE GUTTERSEN D21-28D WELL TO BE 1290' FNL, 1290' FEL, AS MEASURED AT NINETY (90) DEGREES FROM THE SECTION LINES, SECTION 21, TOWNSHIP 3 NORTH, RANGE 64 WEST, 6TH PRINCIPLE MERIDIAN, WELD COUNTY, COLORADO.

LATITUDE & LONGITUDE (NAD 83 SURFACE HOLE):
 LATITUDE: N 40.21457'
 LONGITUDE: W 104.55139'
 PDOP: 2.0
 QUARTER-QUARTER: NE/4NE/4
 NEAREST PROPERTY LINE: 1290' NORTH

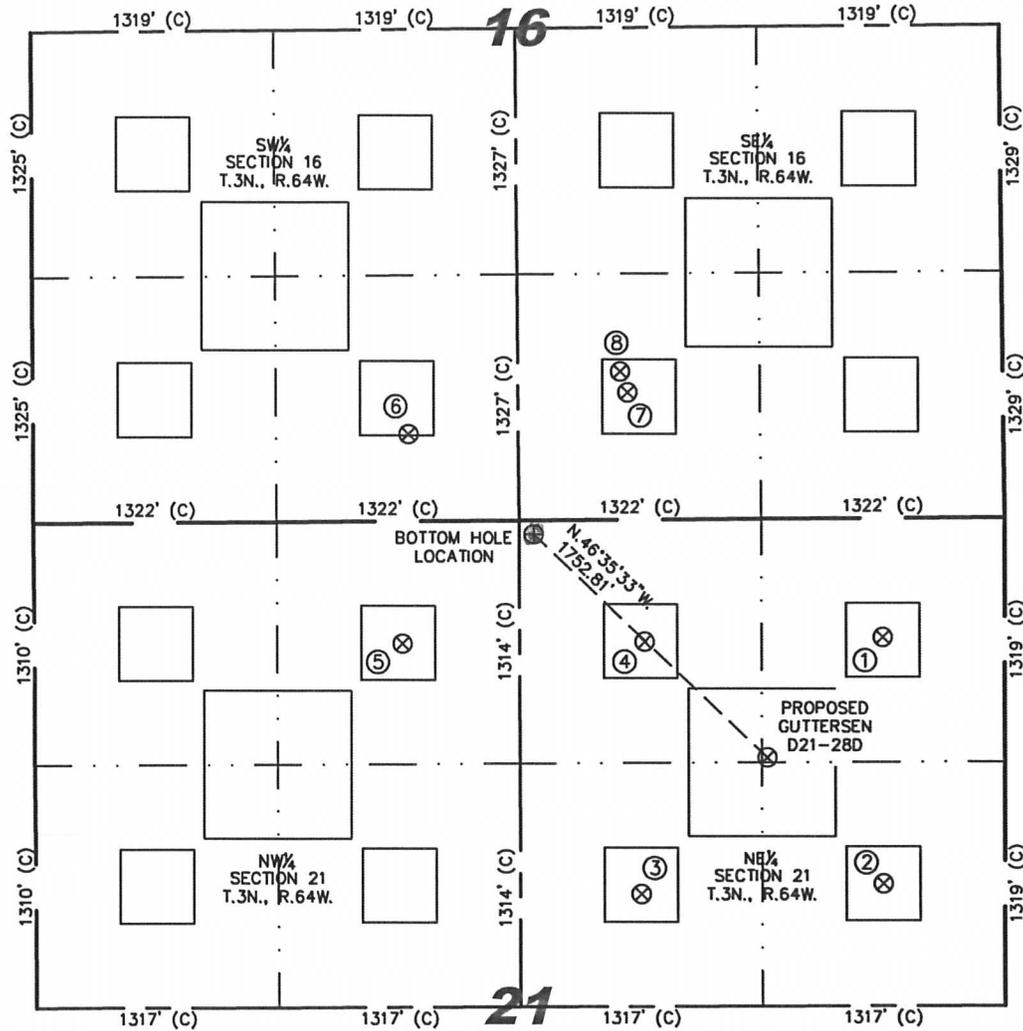
① GUTTERSEN 41-21 NE/NE SEC. 21 644' FNL 661' FEL EL 4796' N 40.21633 W 104.54911 PDOP 2.1	② GUTTERSEN 21-42 SE/NE SEC. 21 1975' FNL 657' FEL EL 4806' N 40.21268 W 104.54916 PDOP 2.5	③ GUTTERSEN 32-21 SW/NE SEC. 21 2023' FNL 1975' FEL EL 4805' N 40.21256 W 104.55388 PDOP 2.1	④ GUTTERSEN 21-31 NW/NE SEC. 21 660' FNL 1958' FEL EL 4794' N 40.21630 W 104.55376 PDOP 2.0	⑤ HSR-GUTTERSEN 3-21 NE/NW SEC. 21 661' FNL 2004' FWL EL 4807' N 40.21630 W 104.55849 PDOP 2.8	⑥ SPIKE STATE GWS D16-14 471' FSL 2045' FWL EL 4786' N 40.21941 W 104.55832 PDOP 2.5	⑦ SPIKE STATE GWS D16-15 SW/SE SEC. 16 687' FSL 2044' FEL EL 4798' N 40.22000 W 104.55403 PDOP 3.3	⑧ GUTTERSEN STATE D16-15X SW/SE SEC. 16 800' FSL 2083' FEL EL 4797' N 40.22031 W 104.55417 PDOP 3.3
---	--	---	--	---	--	---	--
