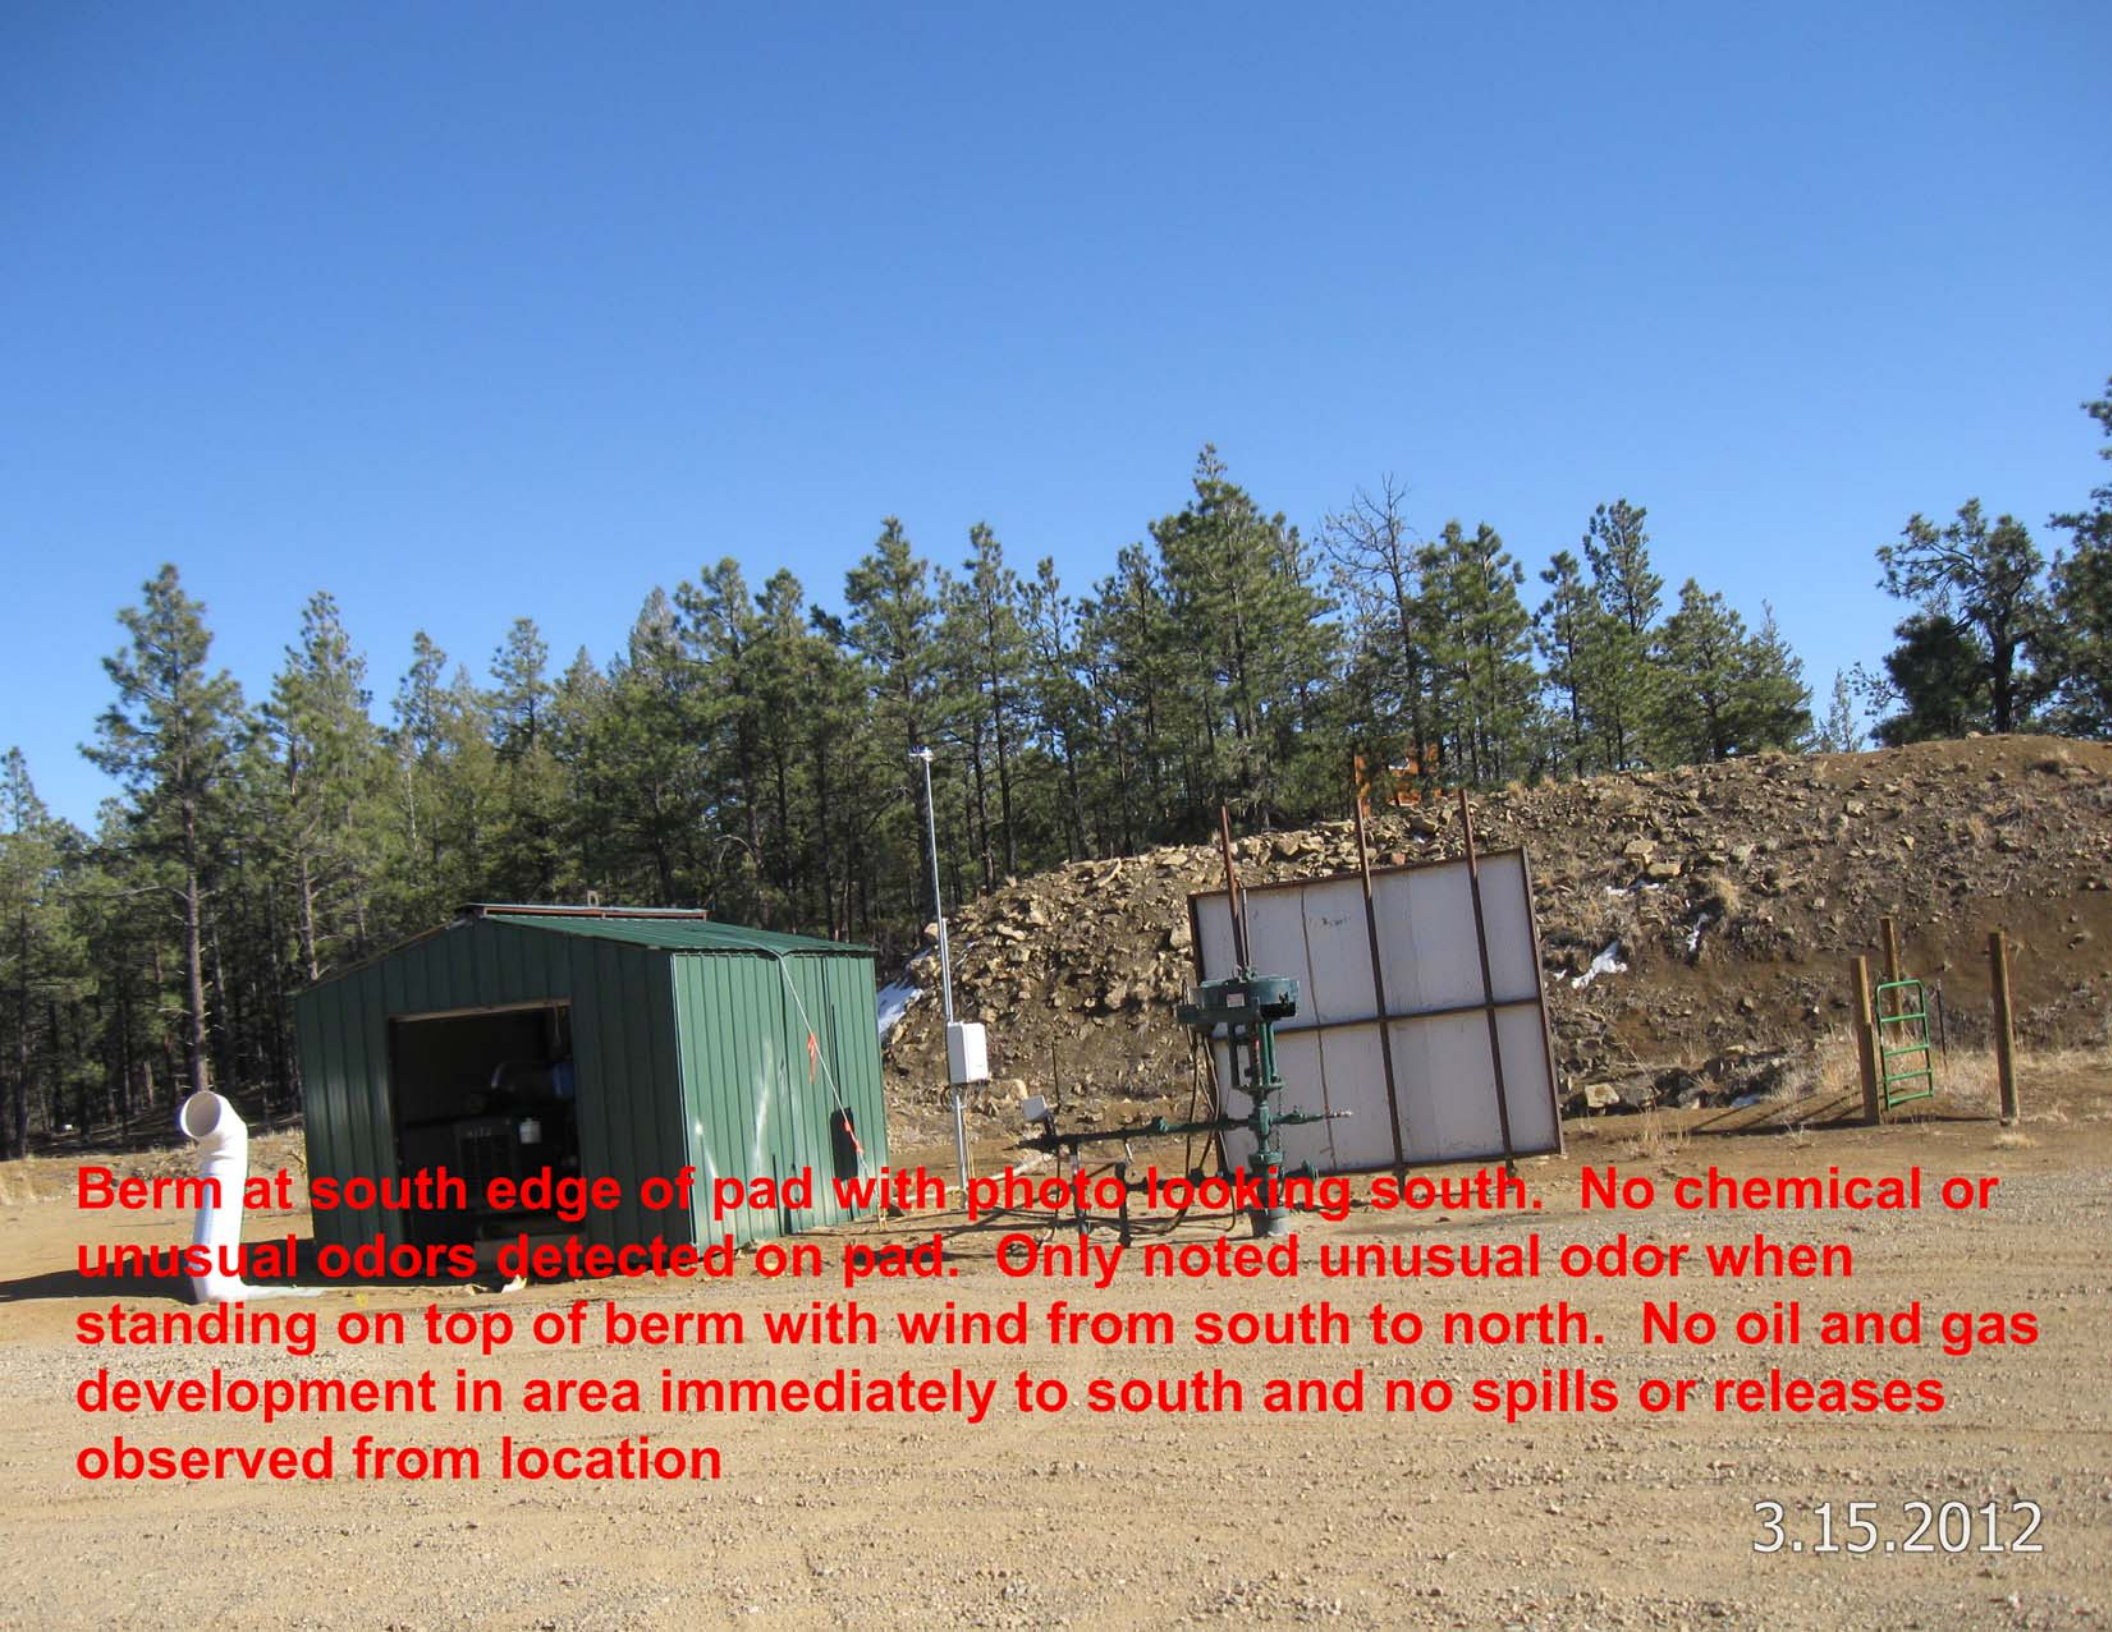
3.15.2012

**Berm at south edge of pad with photo looking south. No chemical or unusual odors detected on pad. Only noted unusual odor when standing on top of berm with wind from south to north. No oil and gas development in area immediately to south and no spills or releases observed from location**
