WELL LOCATION CERTIFICATE: BOOTH 27-26

SECTION 26, TOWNSHIP 7 NORTH, RANGE 65 WEST, 6TH P.M.

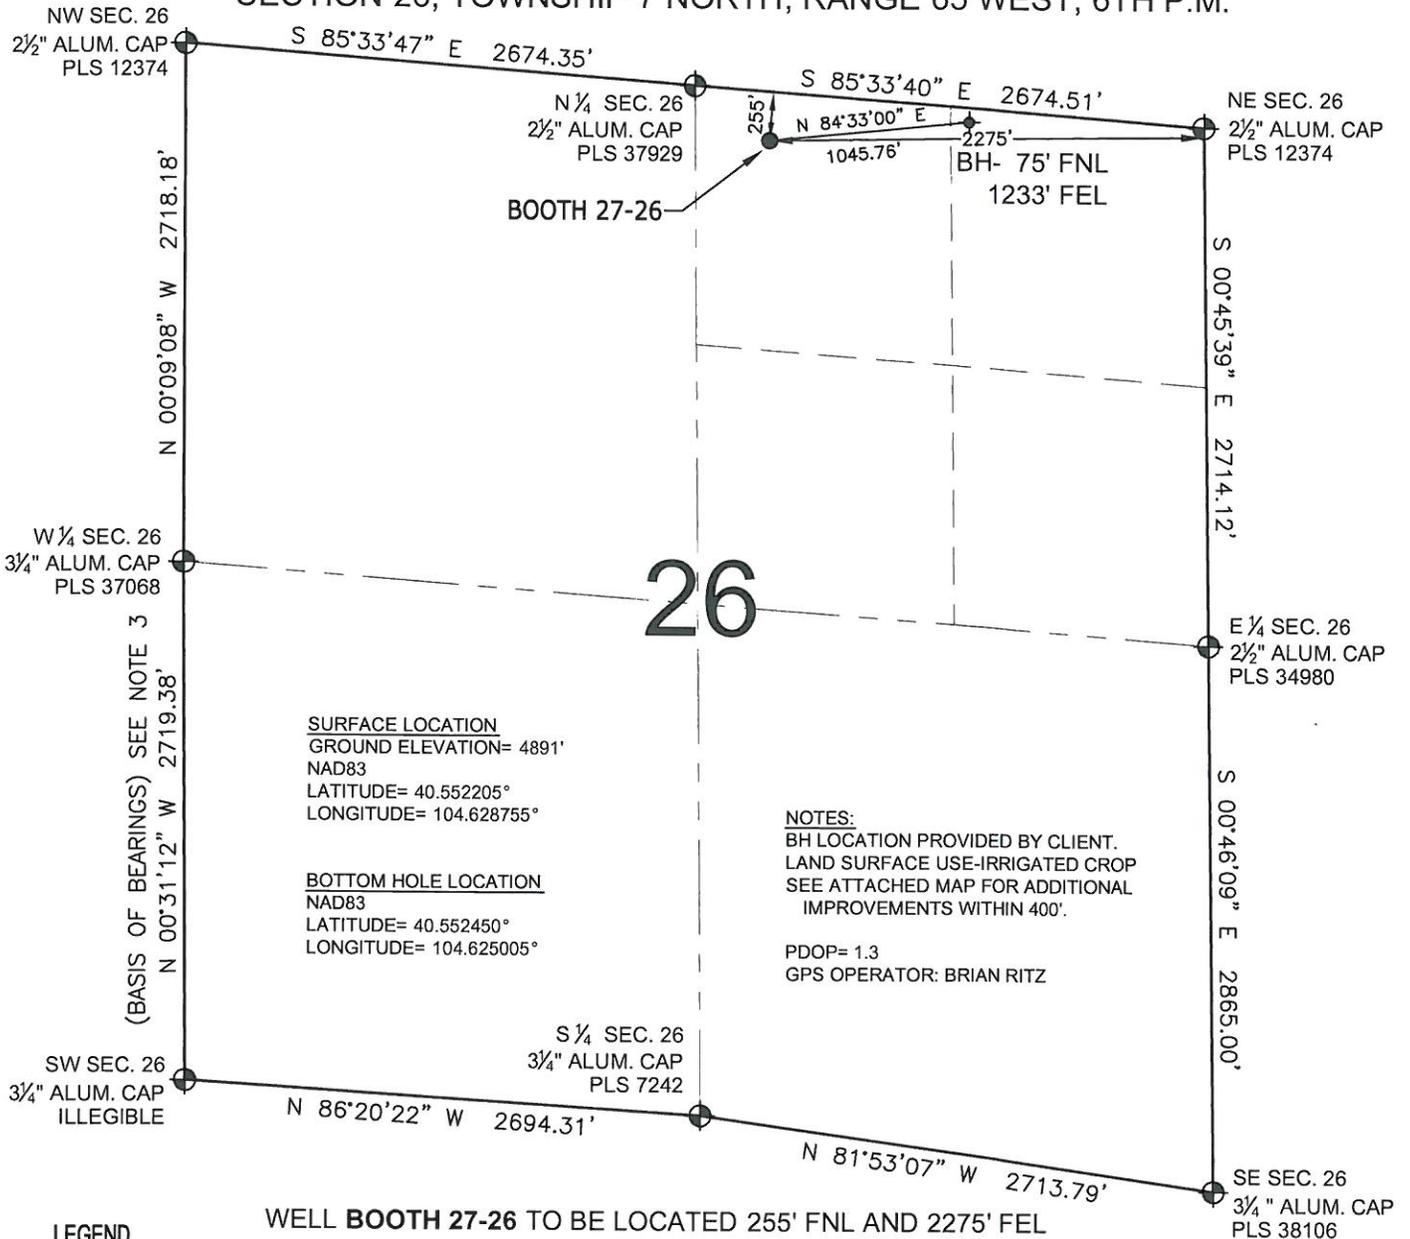
SURFACE LOCATION
 GROUND ELEVATION= 4891'
 NAD83
 LATITUDE= 40.552205°
 LONGITUDE= 104.628755°

BOTTOM HOLE LOCATION
 NAD83
 LATITUDE= 40.552450°
 LONGITUDE= 104.625005°

NOTES:
 BH LOCATION PROVIDED BY CLIENT.
 LAND SURFACE USE-IRRIGATED CROP
 SEE ATTACHED MAP FOR ADDITIONAL
 IMPROVEMENTS WITHIN 400'.
