# WELL LOCATION CERTIFICATE BENSON AC14-65HN

SECTION 14, TOWNSHIP 7 NORTH, RANGE 63 WEST OF THE 6TH PRINCIPAL MERIDIAN

# SITE SKETCH BENSON AC14-65HN

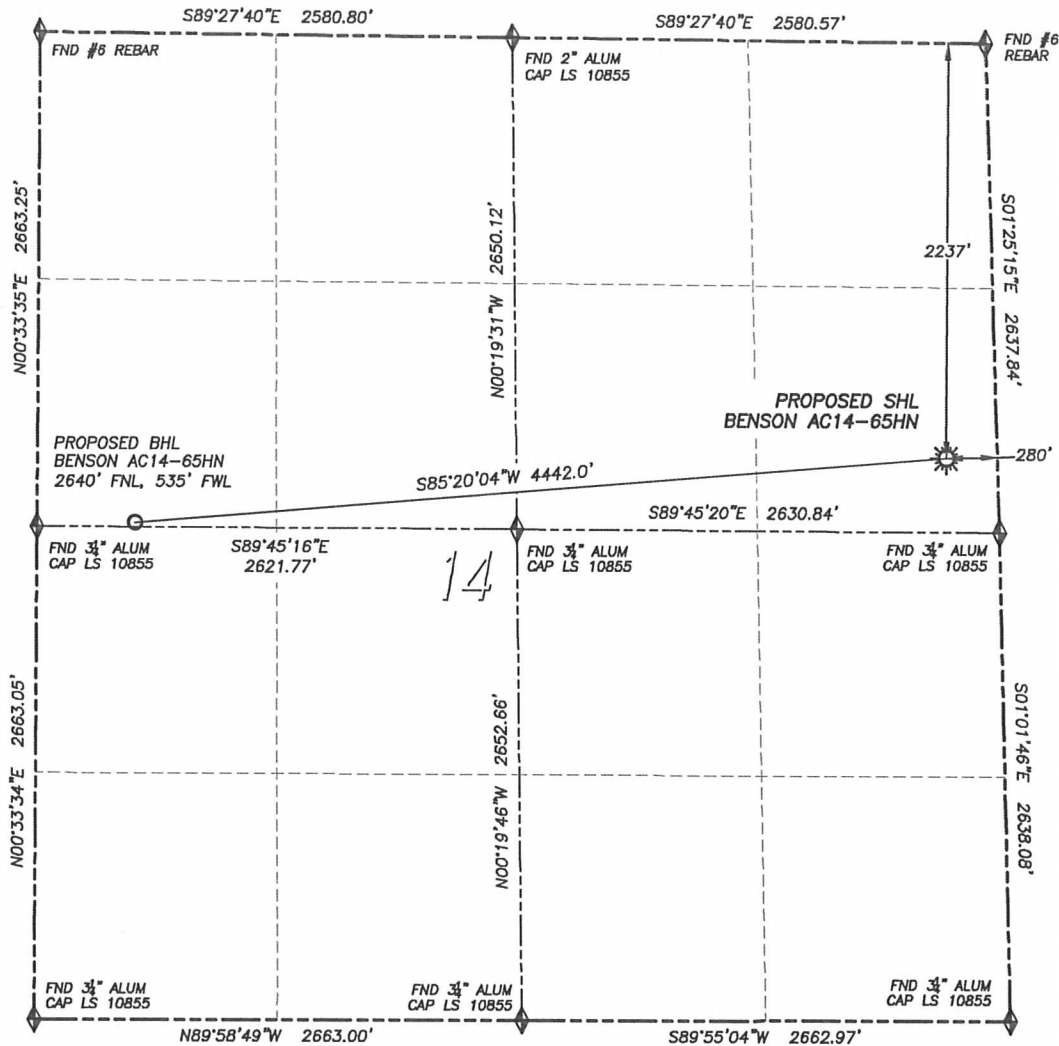
SURFACE HOLE:

LATITUDE: N40.57500°

LONGITUDE: W104.39500°

ELEVATION: 4828'

FOOTAGE: 2237' FNL, 280' FEL

BOTTOM HOLE:

LATITUDE: N40.57401°

LONGITUDE: W104.41094°

FOOTAGE: 2640' FNL, 535' FWL

IN ACCORDANCE WITH A REQUEST FROM BRIAN JAMES OF NOBLE ENERGY INC., DALEY LAND SURVEYING, INC. HAS DETERMINED THE SURFACE LOCATION OF THE BENSON AC14-65HN WELL TO BE 2237' FNL, 280' FEL, AS MEASURED AT NINETY (90) DEGREES FROM THE SECTION LINES OF SECTION 14, TOWNSHIP 7 NORTH, RANGE 63 WEST OF THE 6TH PRINCIPAL MERIDIAN, WELD COUNTY, COLORADO. THE BOTTOM HOLE LOCATION, PROVIDED BY THE CLIENT IS TO BE 2640' FNL, 535' FWL.

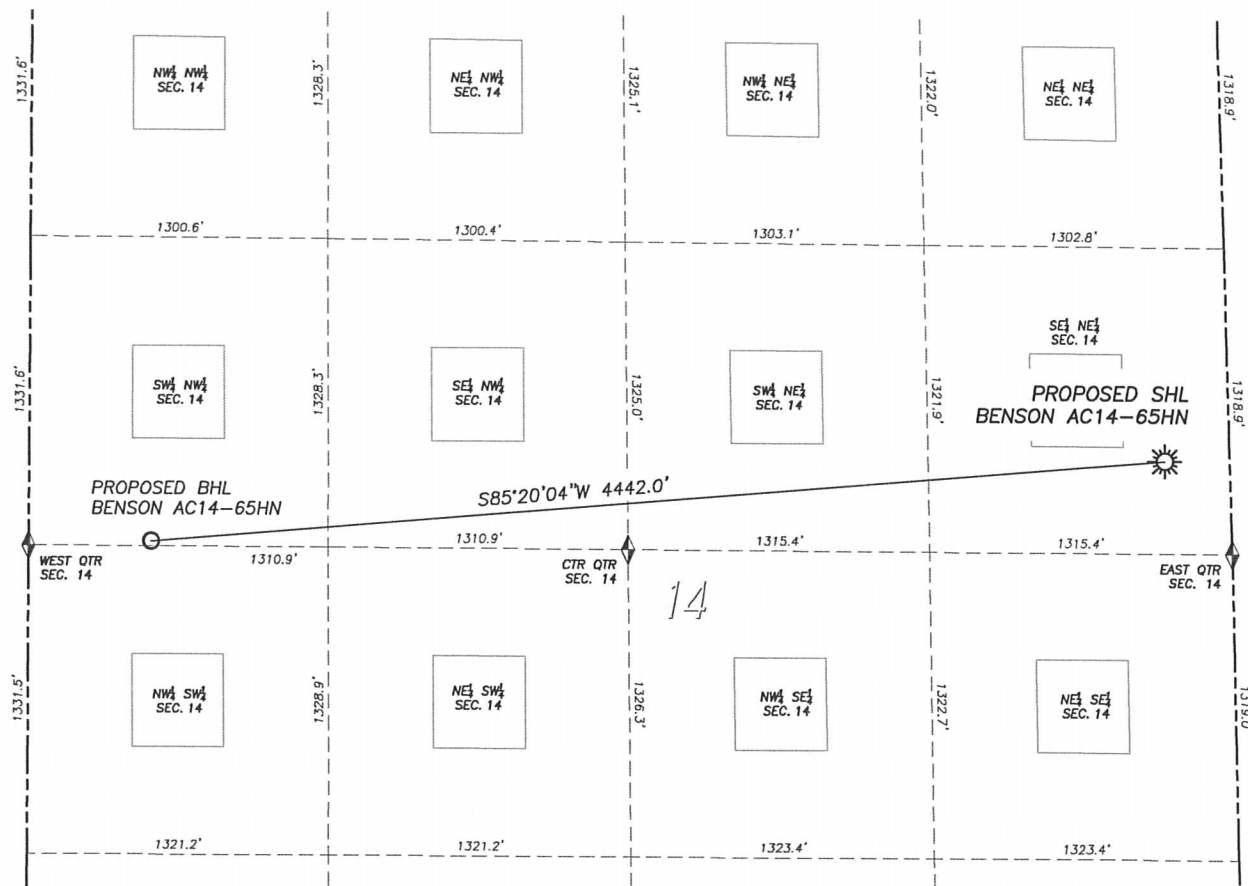
THERE ARE NO WELLS IN THIS HALF SECTION
