YF #4 Well Pad Form 2A Kinder Morgan CO2 Company, LP

INTRODUCTION

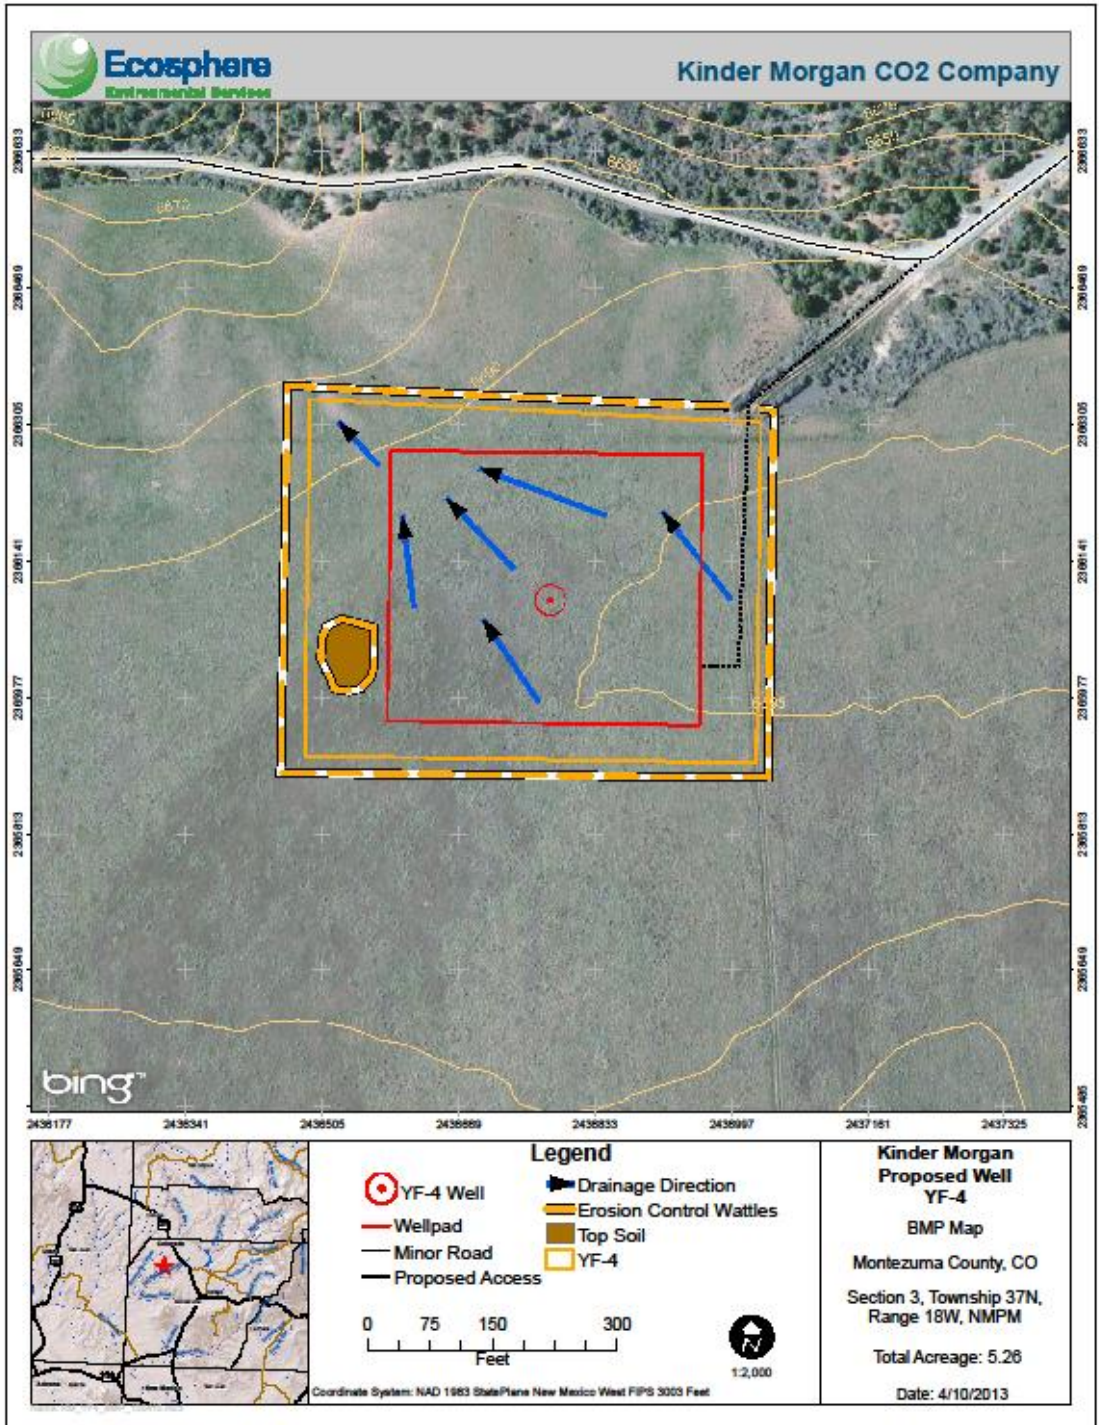
PROJECT BMP MAP

These non-structural BMPs are not shown on the BMP map, because they will be applied to the entire project area beginning with construction and continuing until final stabilization is reached.
