# WELL LOCATION CERTIFICATE: NRC 26N-5HZ

SECTION 8, TOWNSHIP 1 NORTH, RANGE 67 WEST, 6TH P.M.

PREPARED BY:  <b>PFS</b> Petroleum Field Services, LLC 1801 W. 136th Ave. Denver, CO 80224	FIELD DATE: 10-30-13	SURFACE LOCATION: NE 1/4, NE 1/4, SEC. 8, T1N, R67W, 6TH P.M. WELD COUNTY, COLORADO
	DRAWING DATE: 11-01-13	BY: SMF CHECKED: JAH

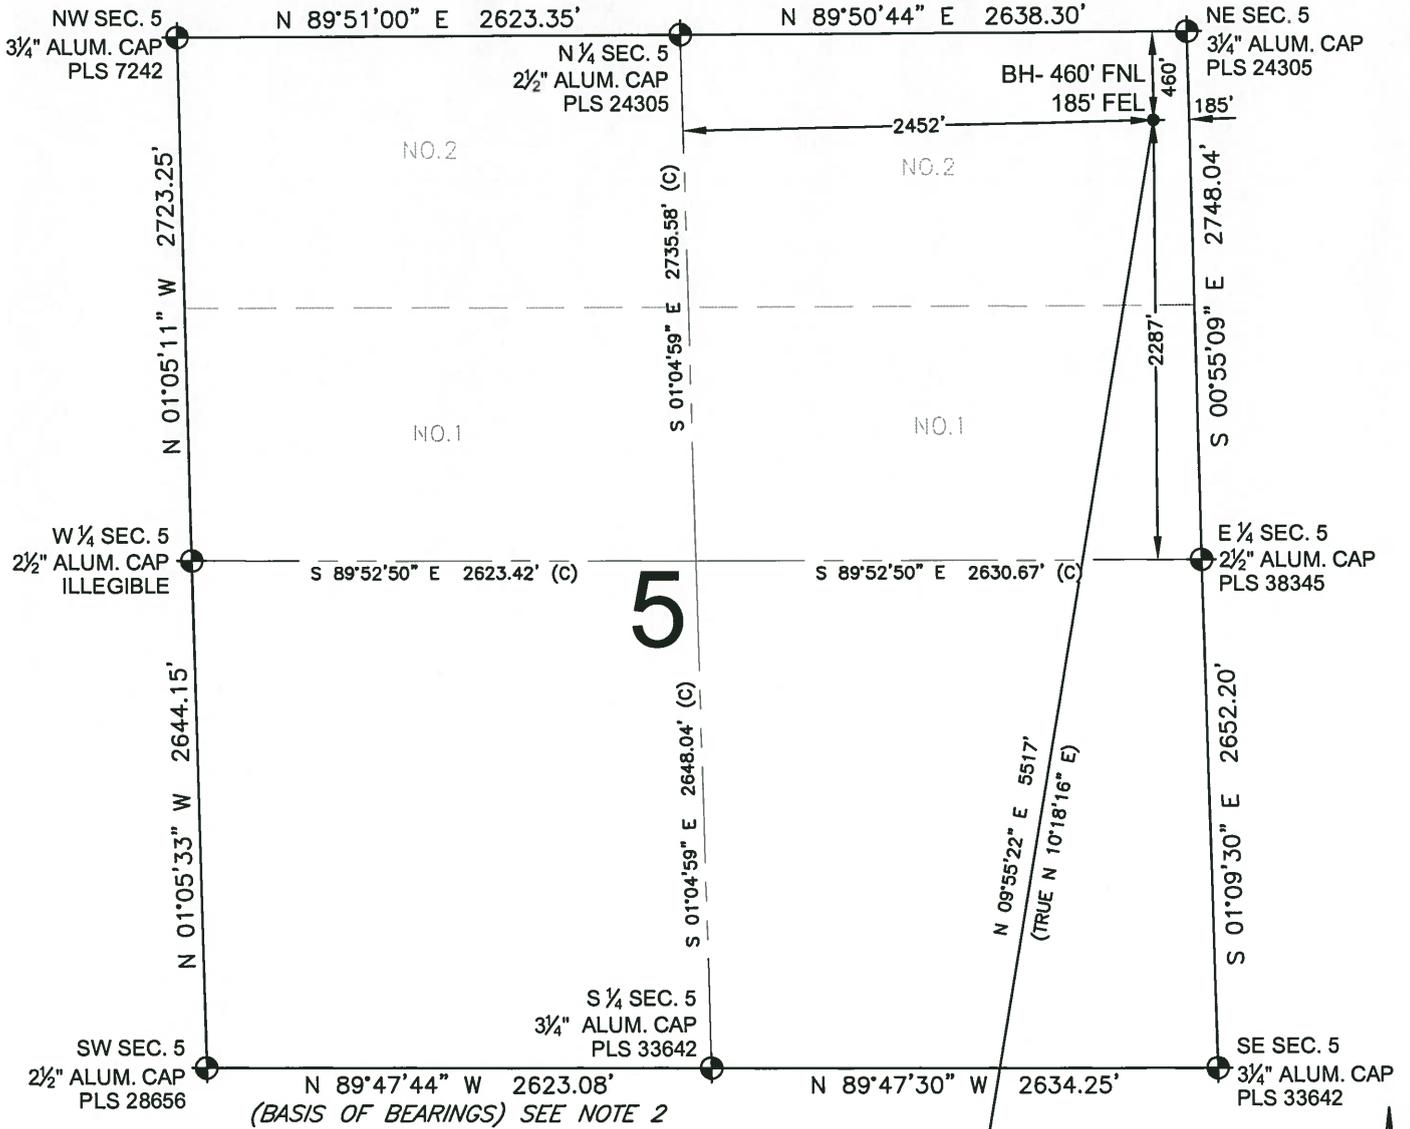
BRADLEY L. LAMAN, PLS 38345  
 COLORADO LICENSED PROFESSIONAL LAND SURVEYOR  
 SHEET 2 OF 2 FOR AND ON BEHALF OF P.F.S., LLC

SECTION 5, TOWNSHIP 1 NORTH, RANGE 67 WEST, 6TH P.M.
