Main Pass #2 4.5" Liner

Logged With 0 PSI Applied At Surface

Database File: badding35n-2hz.db
 Dataset Pathname: run2/pass5
 Presentation Format: scbl02
 Dataset Creation: Wed Jan 29 16:29:56 2014 by Log SCH 120430
 Charted by: Depth in Feet scaled 1:240

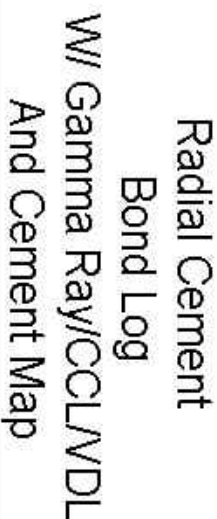
Sensor	Offset (ft)	Schematic	Description	Len (ft)	OD (in)	Wt (lb)

Tool Joint	Tool Joint Length (ft)	Tool Joint Weight (lb)	Tool Joint O.D. (in)	Tool Joint ID (in)	Tool Joint Weight (lb)	Tool Joint O.D. (in)	Tool Joint ID (in)
PTS275	2.83	2.75					
RBT-Probe (4.5040904) Prototype Probe Radli Bond Tool with Digital Telemetry	8.88	2.75	90.00				
PTS275	2.83	2.75					
GR-Probe275 (030606)	4.54	2.75	57.00				
CCL	3.63						
GR	1.56						
WVFS8	11.63						
WVFS7	11.63						
WVFS6	11.63						
WVFS5	11.63						
WVFS4	11.63						
WVFS3	11.63						
WVFS2	11.63						
WVFS1	11.63						
WVFCAL	11.63						
WVF3FT	11.63						
WVF5FT	10.63

Total Length: 19.08 ft

Total Weight: 147.00 lb

O.D.: 2.75 in
