# WELL LOCATION CERTIFICATE: HOLTON G-12HN

SECTION 12, TOWNSHIP 6 NORTH, RANGE 65 WEST, 6TH P.M.

WELL HOLTON G-12HN TO BE LOCATED 555' FNL AND 1887' FEL

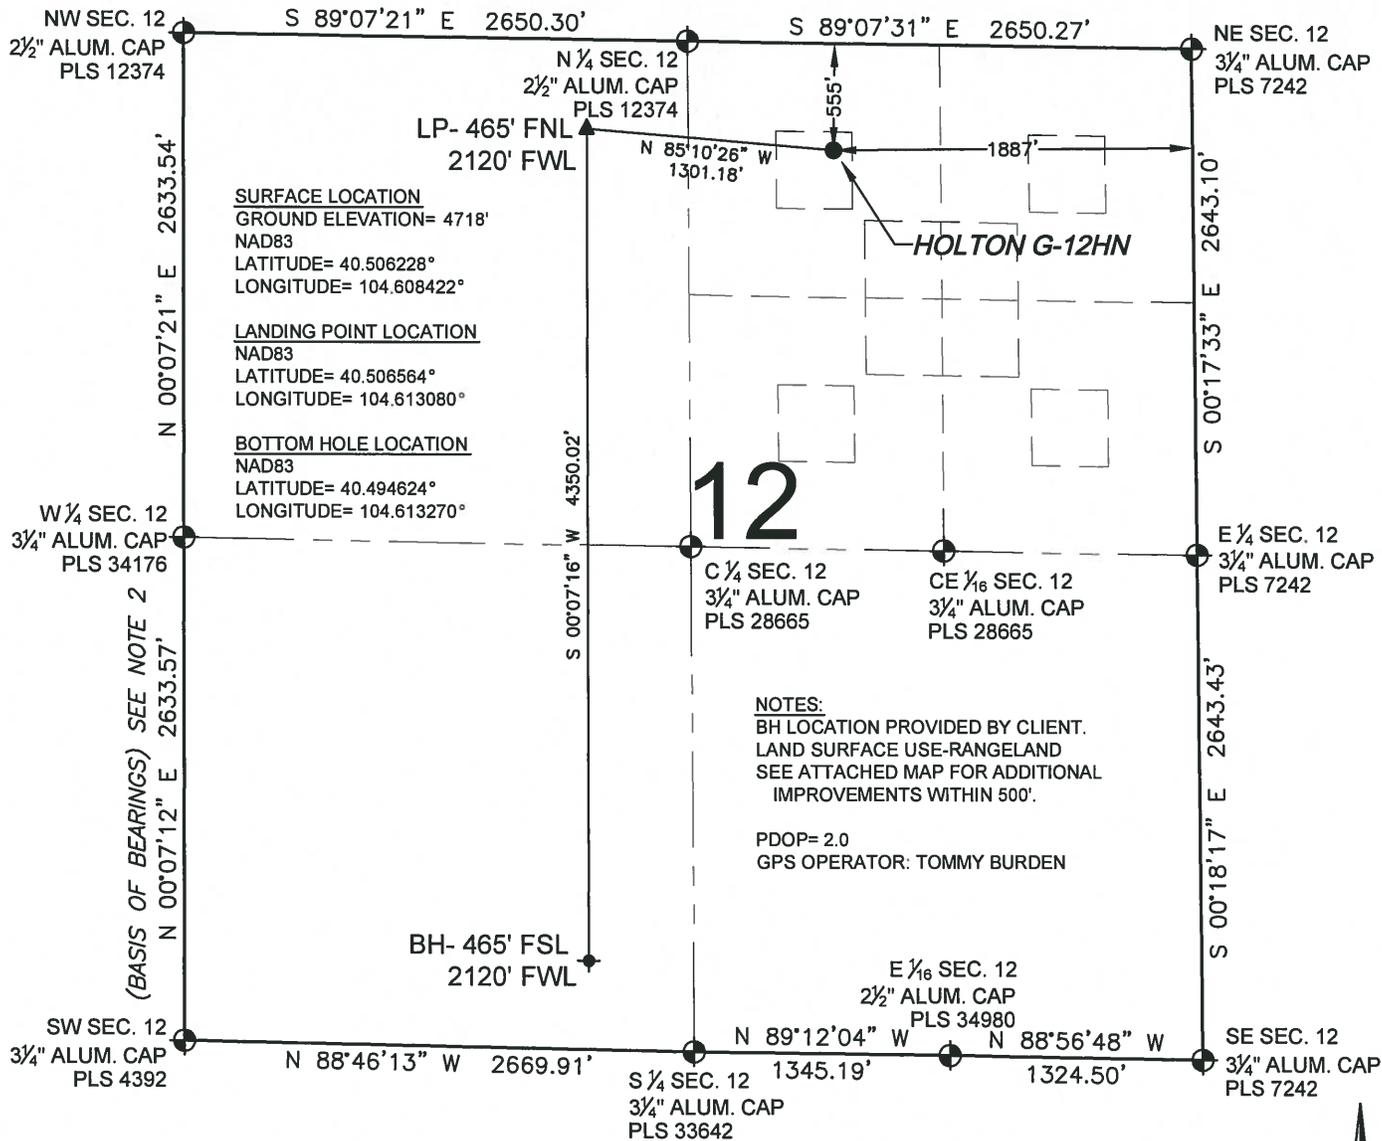
**SURFACE LOCATION**  
 GROUND ELEVATION= 4718'  
 NAD83  
 LATITUDE= 40.506228°  
 LONGITUDE= 104.608422°

**LANDING POINT LOCATION**  
 NAD83  
 LATITUDE= 40.506564°  
 LONGITUDE= 104.613080°

**BOTTOM HOLE LOCATION**  
 NAD83  
 LATITUDE= 40.494624°  
 LONGITUDE= 104.613270°
