Form 2A - Attachment H

NRCS Soils Map

Tompkins

Attachment H – NRCS Soil Survey, Rifle Area

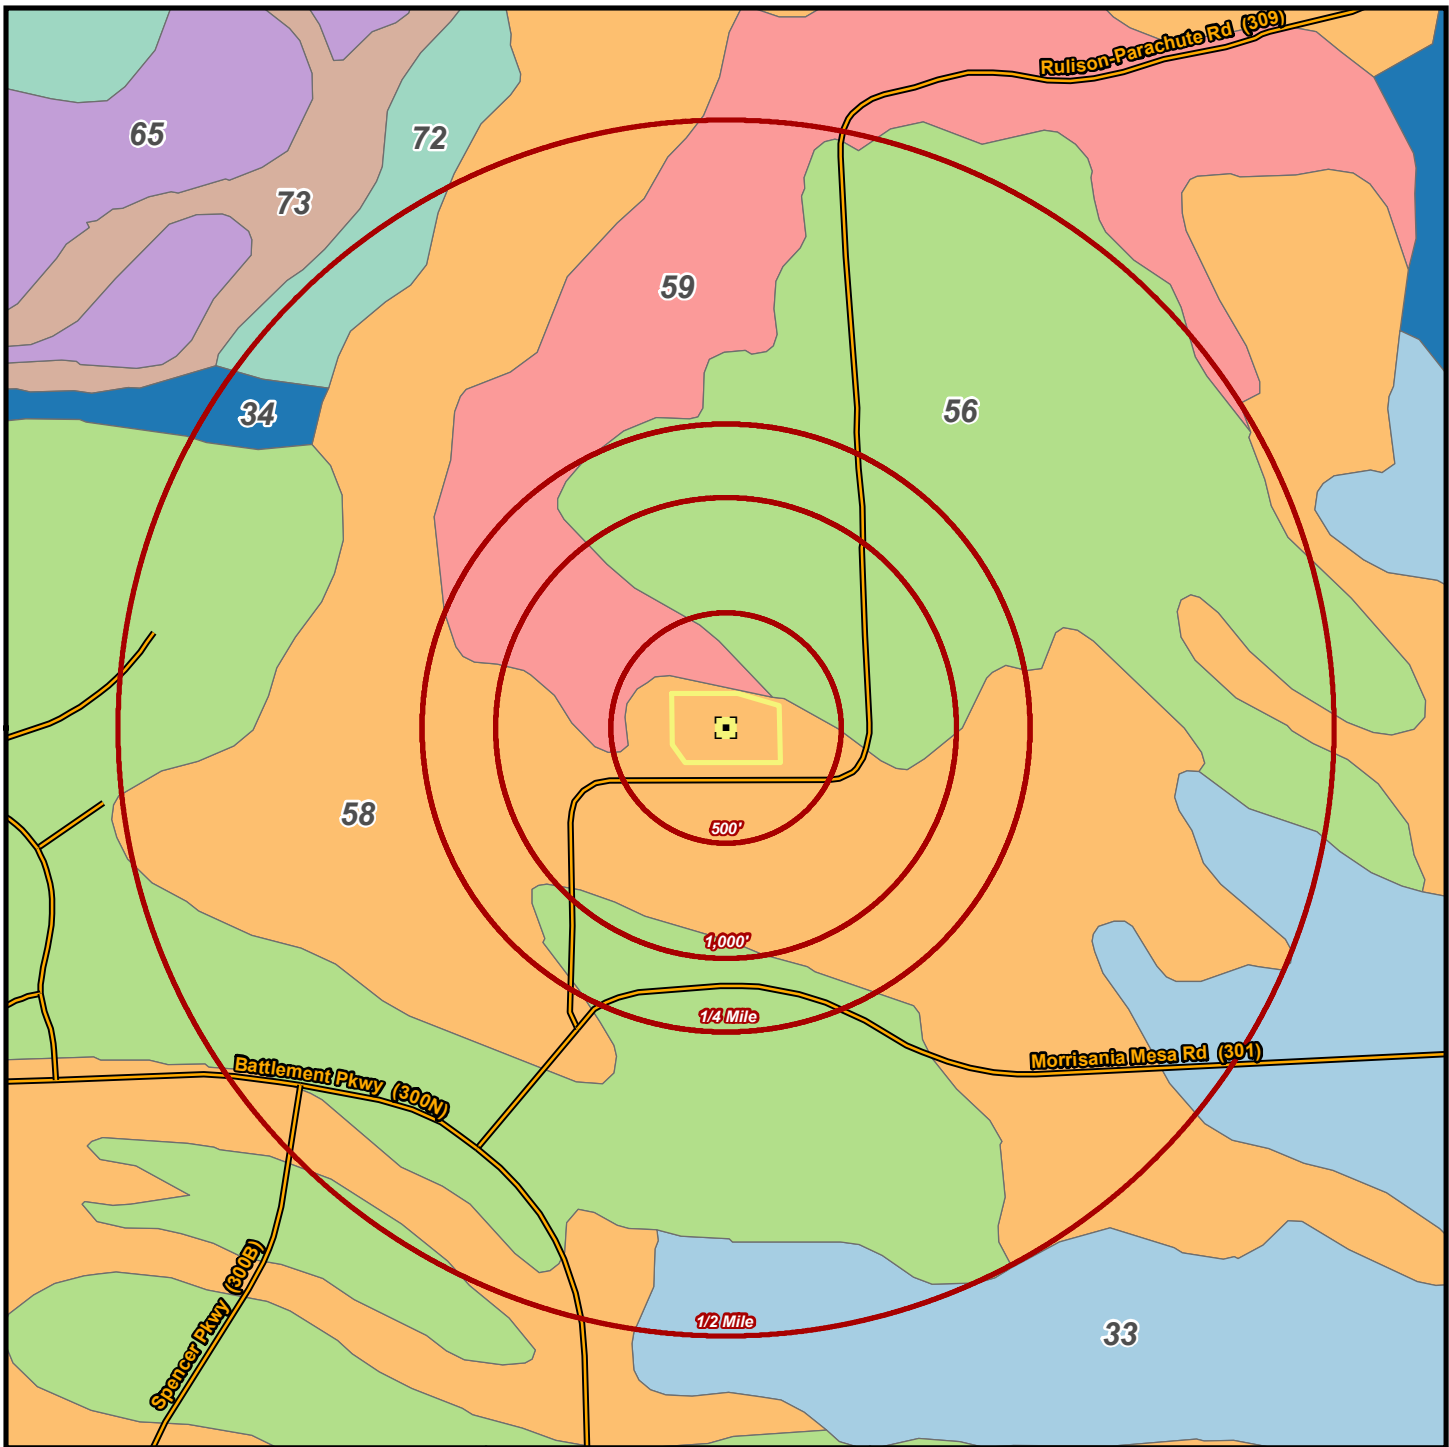
MAP SYMBOL	SERIES NAME
33	Ildefonso stony loam (6-25% slopes)
34	Ildefonso stony loam (25-45% slopes)
56	Potts loam (6-12% slopes)
58	Potts-Ildefonso complex (12-25% slopes)
59	Potts-Ildefonso complex (25-45% slopes)
65	Torrifluvents (nearly level)
72	Wann sandy loam (1-3% slopes)
73	Wann sandy loam (3-6% slopes)

- Well Pad
- Proposed Development
- County Roads
- Local Roads

Map Symbol 58 – Potts-Ildefonso complex (12-25% slopes)	
Strongly sloping to hilly soils are on mesas, alluvial fans and sides of valleys.	
Elevation	5,000 to 6,500 feet
Average Annual Precipitation	Approximately 14 inches
Average Annual Air Temp	Approximately 46 degrees F
Frost Free Days	Approximately 120 days
Permeability	Moderate to Low
Available Water Capacity	Low to Moderate
Effective Rooting Depth	60 inches
Surface Runoff	Medium
Erosion Hazard	Moderate
Native Vegetation: Mainly wheatgrasses and sagebrush with an overstory of pinyon and Utah juniper.	
The steep slopes limit community development. This soil complex is in capability subclass VIe, nonirrigated.
