GROUND WATER MONITORING REPORT

NOBLE ENERGY INC.

PREBISH #2

WELD COUNTY, COLORADO

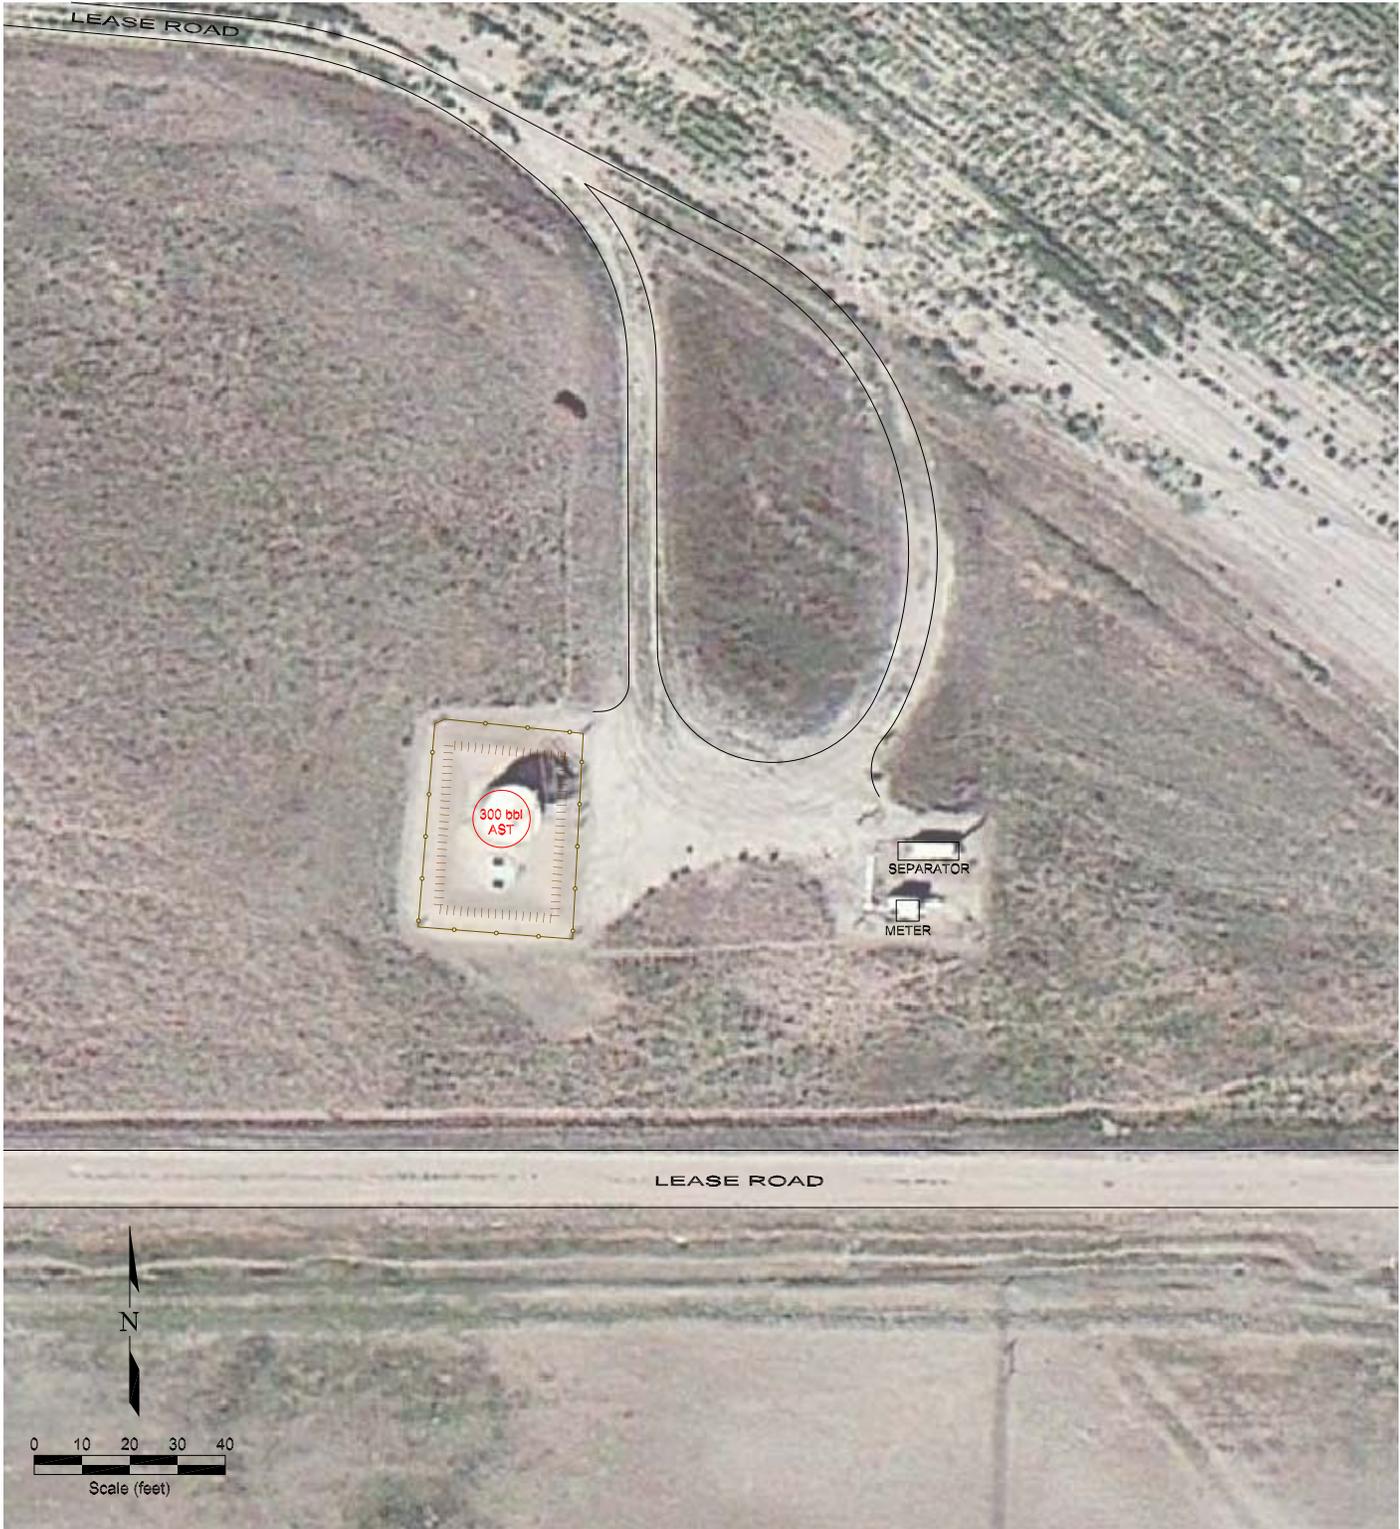
Figure 2

The facility is located in an agricultural area 0.4 miles south of County Road 44 and 0.1 miles southeast of County Road 51. The location is further described as the SW $\frac{1}{4}$ of the NW $\frac{1}{4}$ of section 20, township 4N, range 64W. A Site Map is included as Figure 2.

As a result of the excavation, six monitoring wells (MW-1, MW-2, MW-3, MW-4, MW-7 and MW-12) were destroyed. As shown on the attached figures, four additional wells (MW-14, MW-15, MW-16 and MW-17) have been installed to achieve point of compliance (POC) monitoring.

SITE MAP

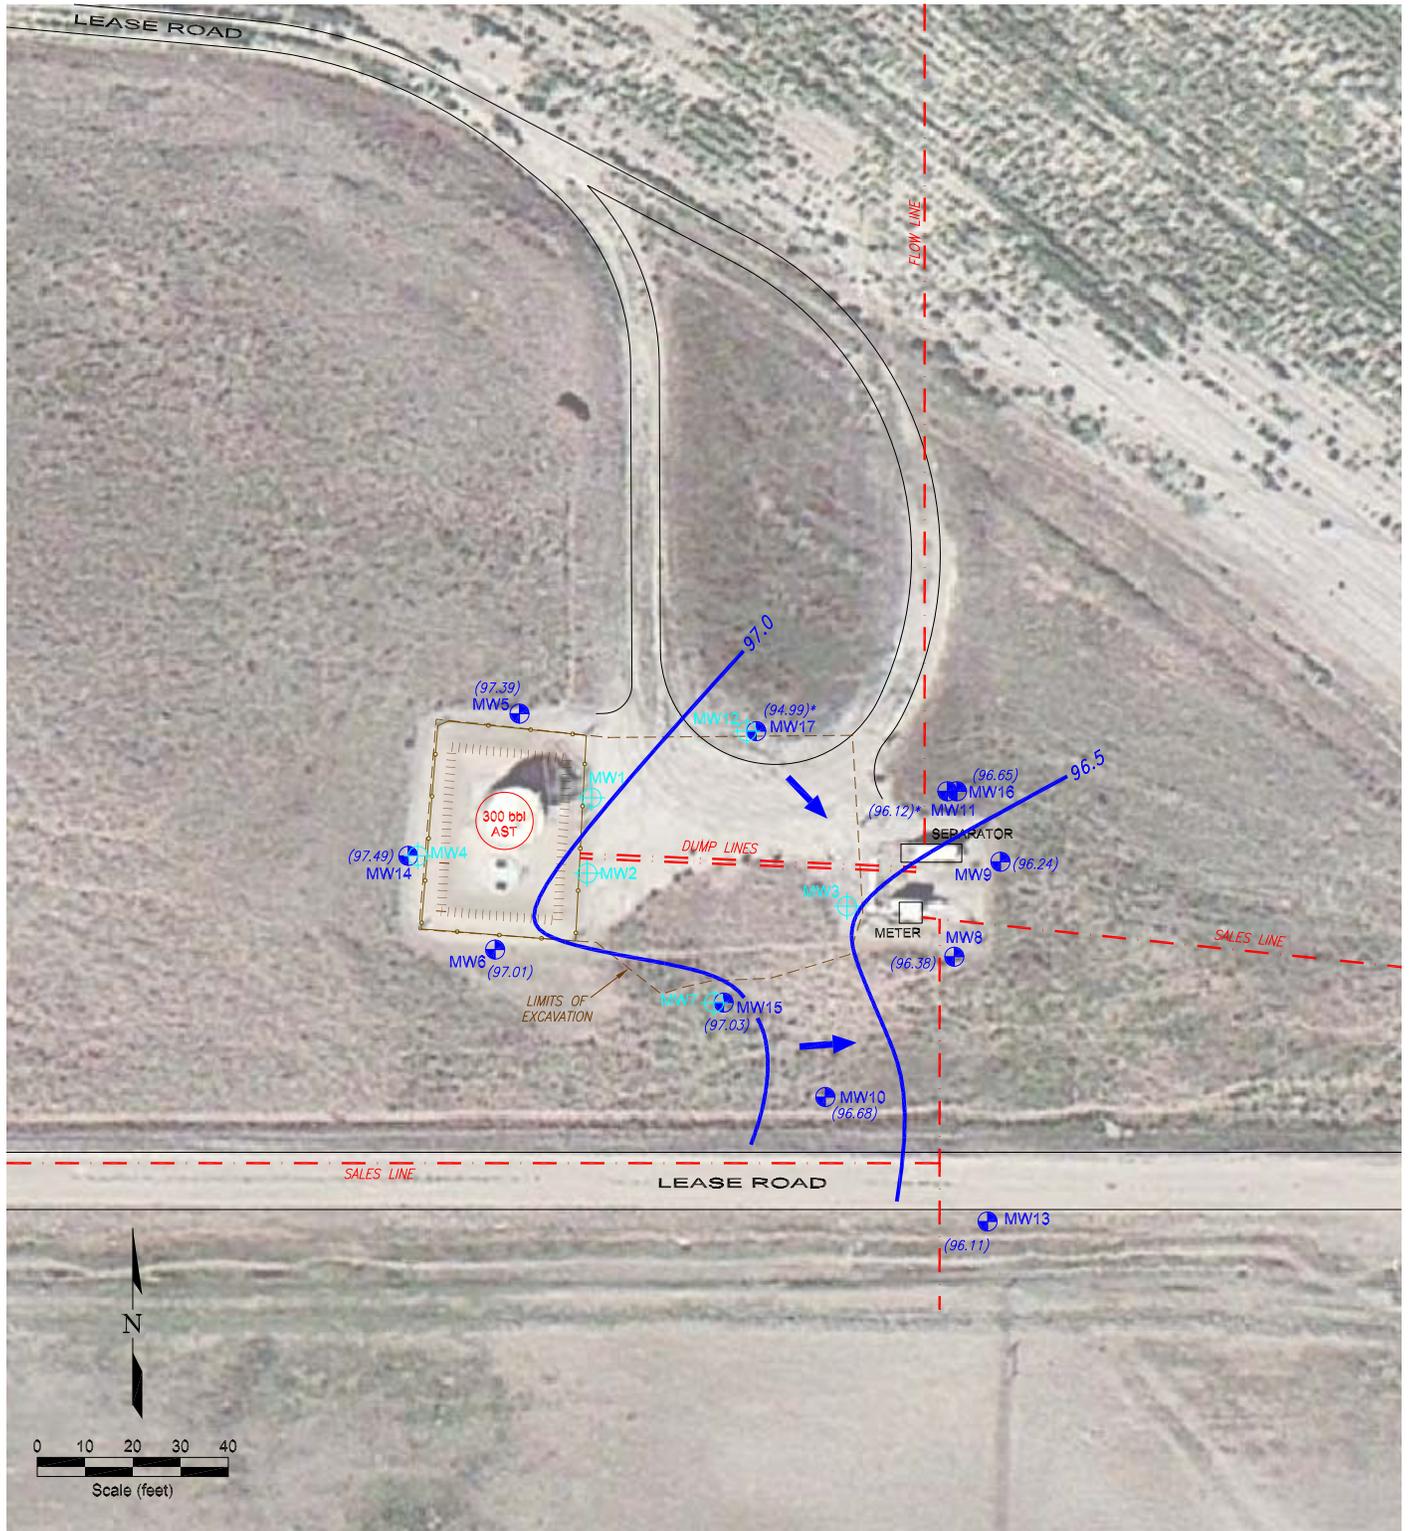
Figure 3
INFERRED GROUNDWATER CONTOUR
APRIL 25, 2014

Ground water levels were measured in the 11 remaining monitoring wells on April 25, 2014 in accordance with the Sampling Plan included in Appendix A. The data are summarized in Table 1. Water table contours inferred from the April 2014 data are illustrated on Figure 3. Based on these data, ground water is inferred to flow generally to the southeast. The water table gradient was calculated at approximately 0.009 feet per foot (ft/ft) for the April 2014 data.

Ground water samples were collected in April 2014 from the 11 available monitoring wells. The BTEX concentrations were below the COGCC Table 910-1 levels in all of the samples. The ground water flow direction has been inferred to flow to the southeast.

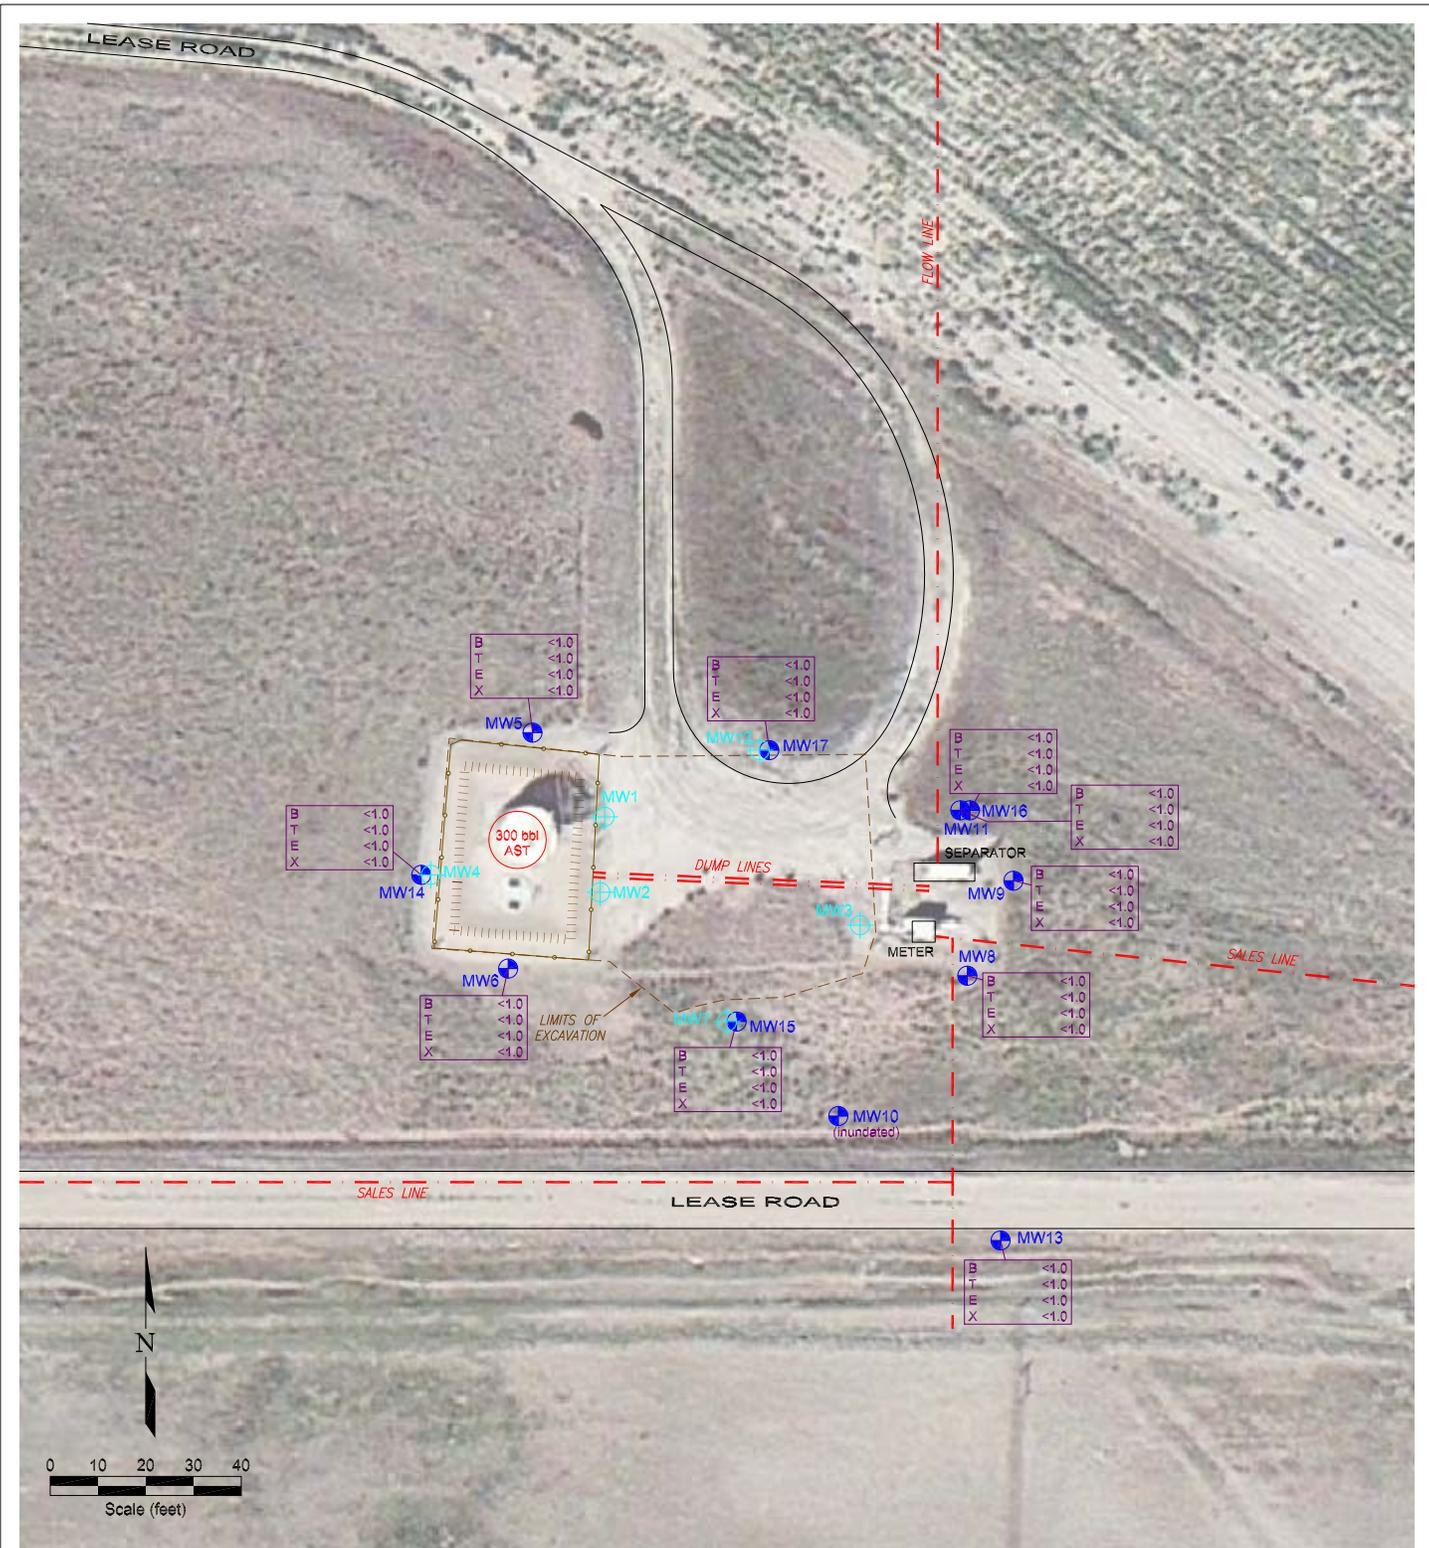
Figure 4
GROUND WATER CHEMISTRY MAP
 APRIL 25, 2014

Ground water samples were collected from the 11 monitoring wells on April 25, 2014 to monitor the magnitude and extent of ground water impacts at the site. The ground water samples were submitted to eAnalytics Laboratory in Loveland, Colorado for analyses of benzene, toluene, ethylbenzene and xylenes (BTEX) by EPA Method 8260C. The ground water chemistry data is illustrated on Figure 4.

The laboratory data indicated that the BTEX constituents were all below their respective Colorado Oil and Gas Conservation Commission's (COGCC's) limits for the ground water samples as well as the laboratory's detection limits. The ground water analytical data are summarized in Table 1. A copy of the laboratory reports, quality control data, and chain-of-custody documentation are presented in Appendix B.

Noble will continue to sample the monitoring wells on a quarterly basis to evaluate the ground water quality at this location. After four consecutive quarters of COGCC-compliant BTEX concentrations, Noble will request closure of this site.
