Garfield County, Colorado

OPERATOR: Coachman Energy Operating Company, LLC

Multi Well Plan for Coachman Energy Operating Company, LLC
21B Pad in NE1/4, Section 21, T.6S., R.91W., 6TH P.M.

Sht 1J
of 9

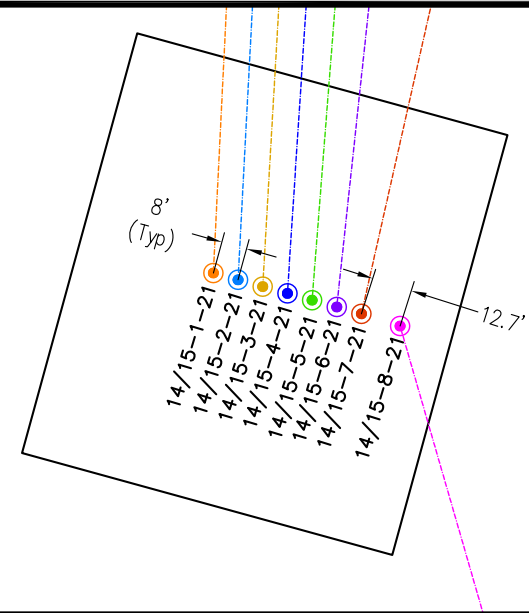
Surface Hole Detail
1" = 60'

Well Surface Hole to Bottom Hole Line Table		
Well Line #	Direction	Length
Federal 14/15-1-21	N02°49'E	2171'
Federal 14/15-2-21	N03°01'E	1844'
Federal 14/15-3-21	N03°18'E	1518'
Federal 14/15-4-21	N03°43'E	1192'
Federal 14/15-5-21	N04°28'E	866'
Federal 14/15-6-21	N06°07'E	540'
Federal 14/15-7-21	N11°44'E	216'
Federal 14/15-8-21	S16°08'E	119'
