Fwd: Ursa - Lundgren Centralized E&P Facility - Pit Closure Update

Please upload email to: REM Number 8407 and Facility ID: 149019

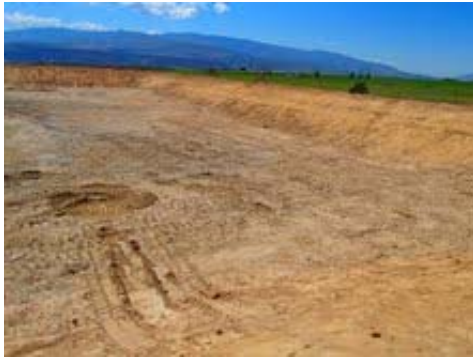
Ursa - Lundgren Facility - Western Wall.JPG
1103K

To complete the excavation, Ursa is wanting to remove a section of the western wall to allow truck and equipment access. The soils moved from the western wall will still remain on location, only moved to allow access of equipment. I've attached a photograph of the western wall to help illustrate and to convey that reclamation activities have not yet begun and removal of the wall is for remediation purposes.

Ursa is proposing to excavate the impacted soils and dispose of them to an offsite disposal facility (ECDC Environmental) in East Carbon, Utah.
