Form 2A - Attachment H

NRCS Map Watson Ranch B

Attachment H – NRCS Soil Survey, Rifle Area

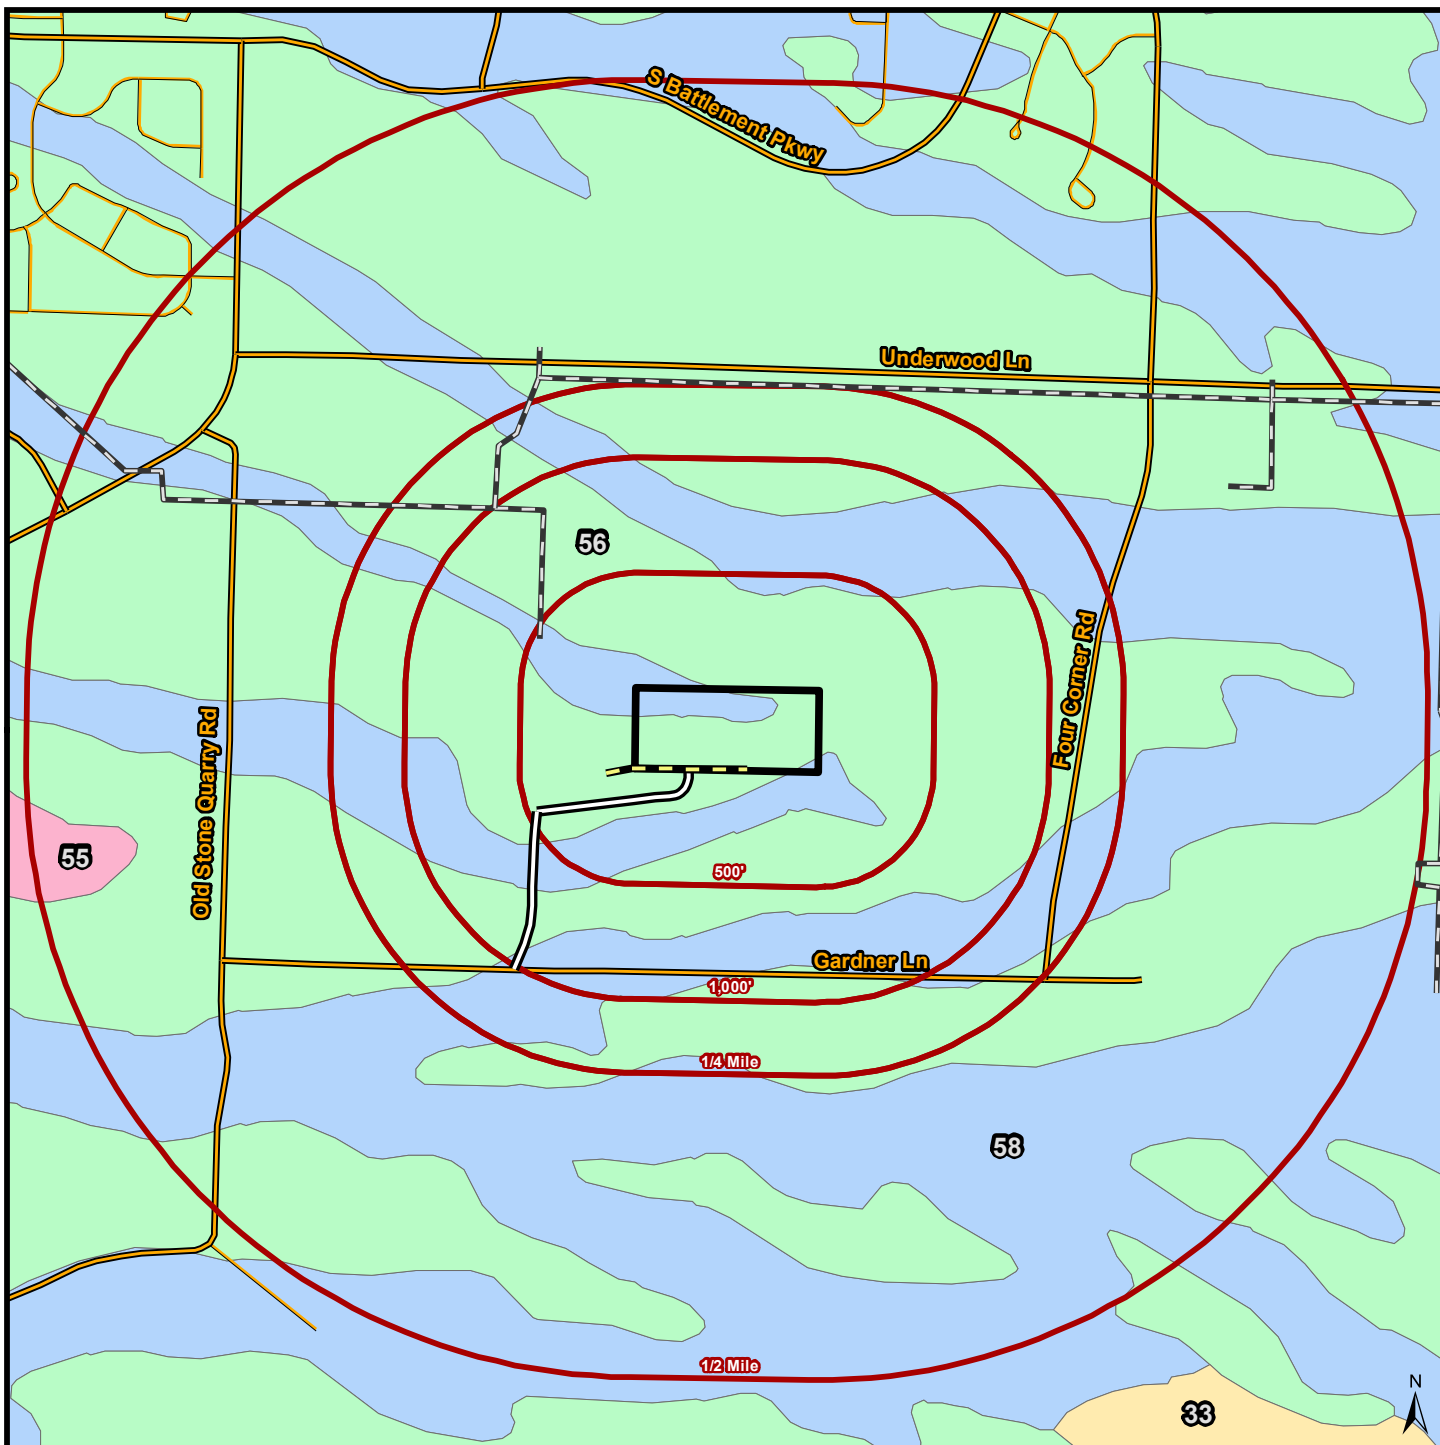
MAP SYMBOL	SERIES NAME (Slope)
33	Ildefonso stony loam (6-25%)
55	Potts loam (3-6% slopes)
56	Potts loam (6-12% slopes)
58	Potts-Ildefonso complex (12-25%)

- Proposed Development
- Proposed Access
- Proposed Pipeline
- Pipeline Tie-in
- County Roads
- Local Roads

Map Symbol 56 – Potts loam (6-12% slopes)	
Deep, well drained, moderately sloping soils found on mesas, benches and sides of valleys.	
Elevation	5,000 to 7,000 feet
Average Annual Precipitation	Approximately 14 inches
Average Annual Air Temp	Approximately 46 degrees F
Frost Free Days	Approximately 120 days
Permeability	Moderate
Available Water Capacity	High
Effective Rooting Depth	60+ inches
Surface Runoff	Slow
Erosion Hazard	Moderate
Native Vegetation: Mainly wheatgrass, needleandthread, and sagebrush.	
Development is limited by low strength and shrink-swell potential. This soil is in capability subclasses IIIe, irrigated and IVe, nonirrigated.

Map Symbol 58 – Potts-Ildefonso complex (12-25% slopes)	
Strongly sloping to hilly soils found on mesas, alluvial fans, and sides of valleys.	
Elevation	5,000 to 6,500 feet
Average Annual Precipitation	Approximately 14 inches
Average Annual Air Temp	Approximately 46 degrees F
Frost Free Days	Approximately 120 days
Permeability	Moderate
Available Water Capacity	High
Effective Rooting Depth	60+ inches
Surface Runoff	Medium
Erosion Hazard	Moderate
Native Vegetation: Mainly wheatgrass, needleandthread, and sagebrush with additional pinyon, juniper, ricegrass, serviceberry, bitterbrush, and junegrass.	
Development is limited by steep slopes, runoff, gullyng, and erosion. This complex is in capability subclass Vie, nonirrigated.
