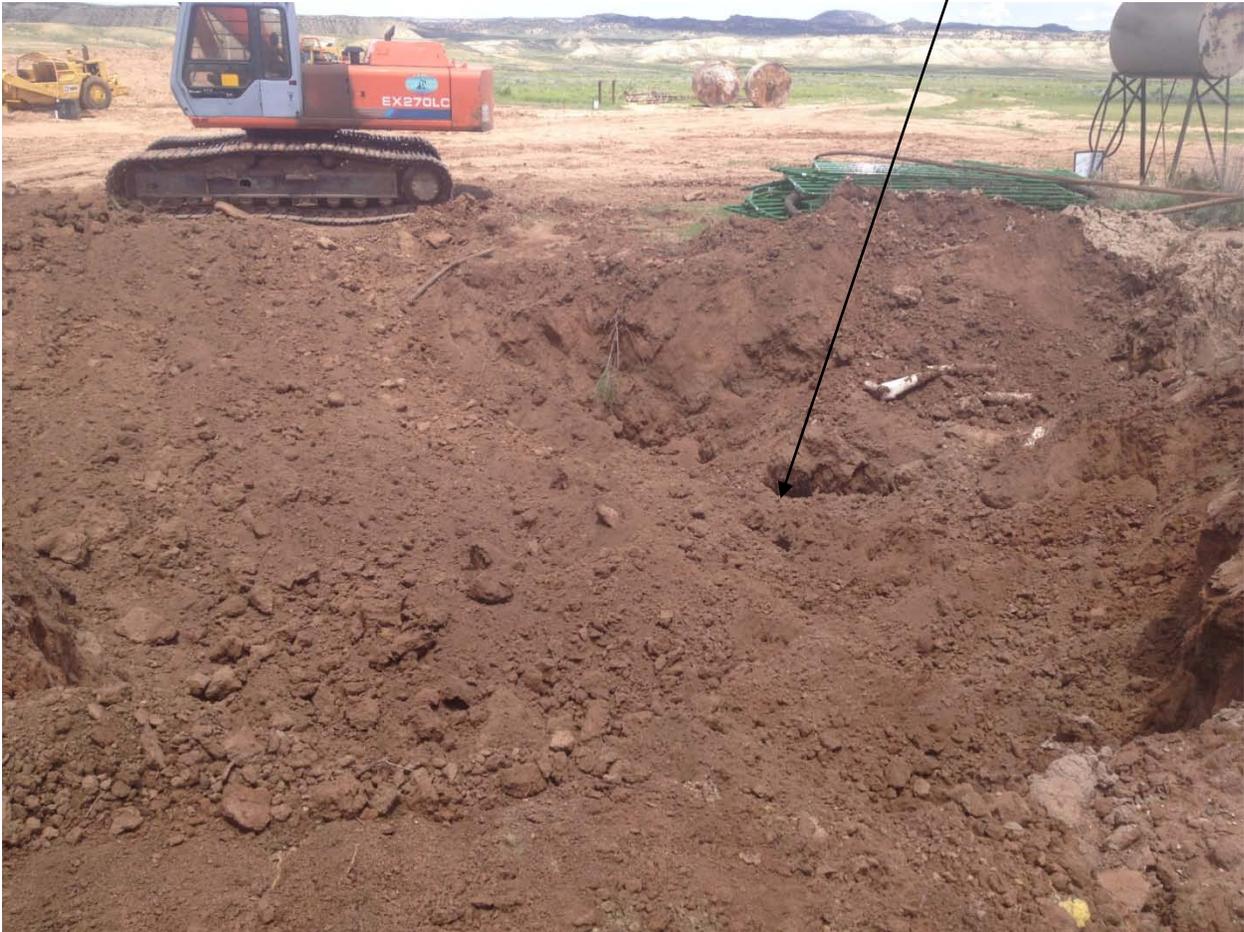
Area of old tank battery excavation

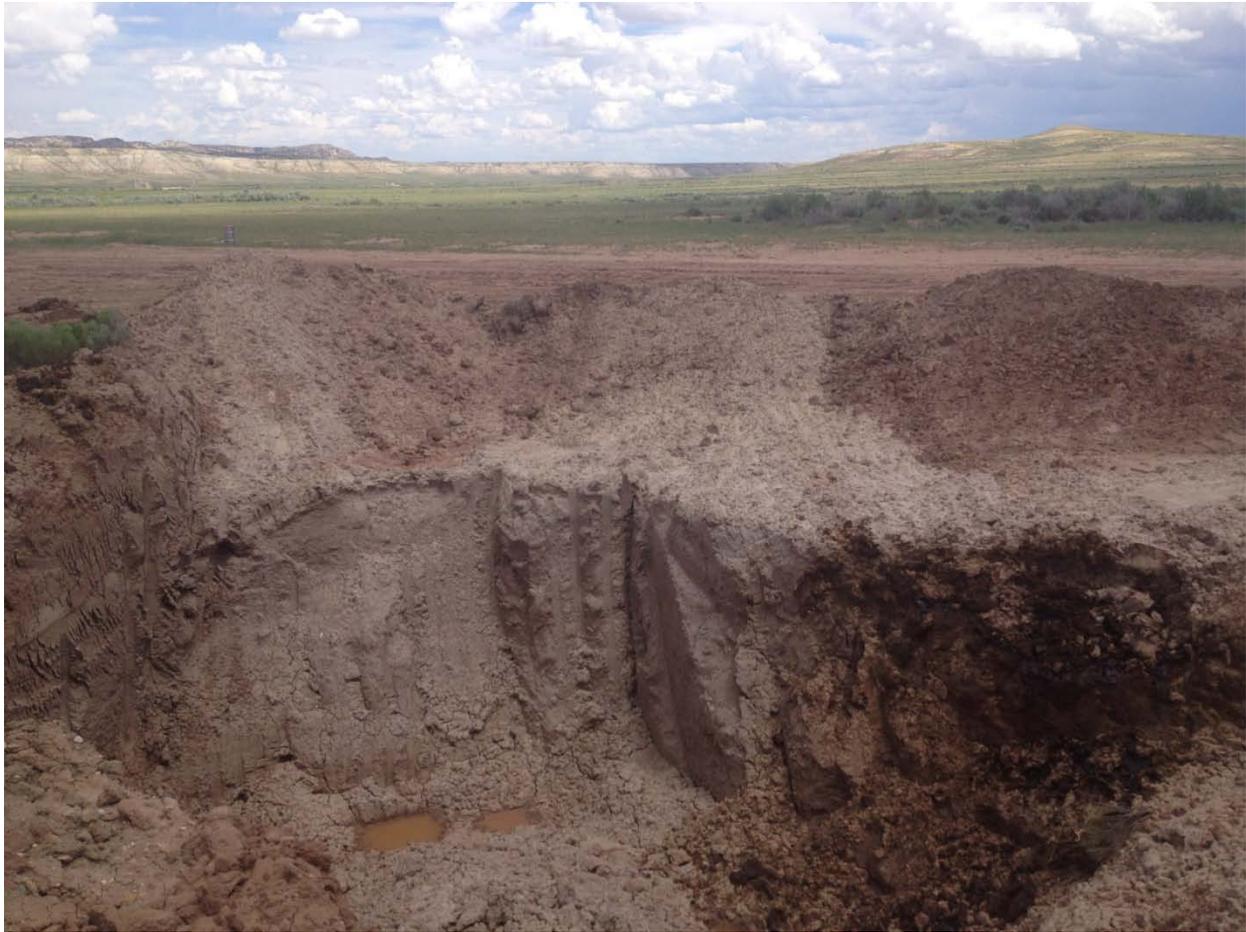
Area of old tank battery; estimated 20'x30'x10' excavation. Approximate location is 40.97974,-108.308731. picture is looking north.

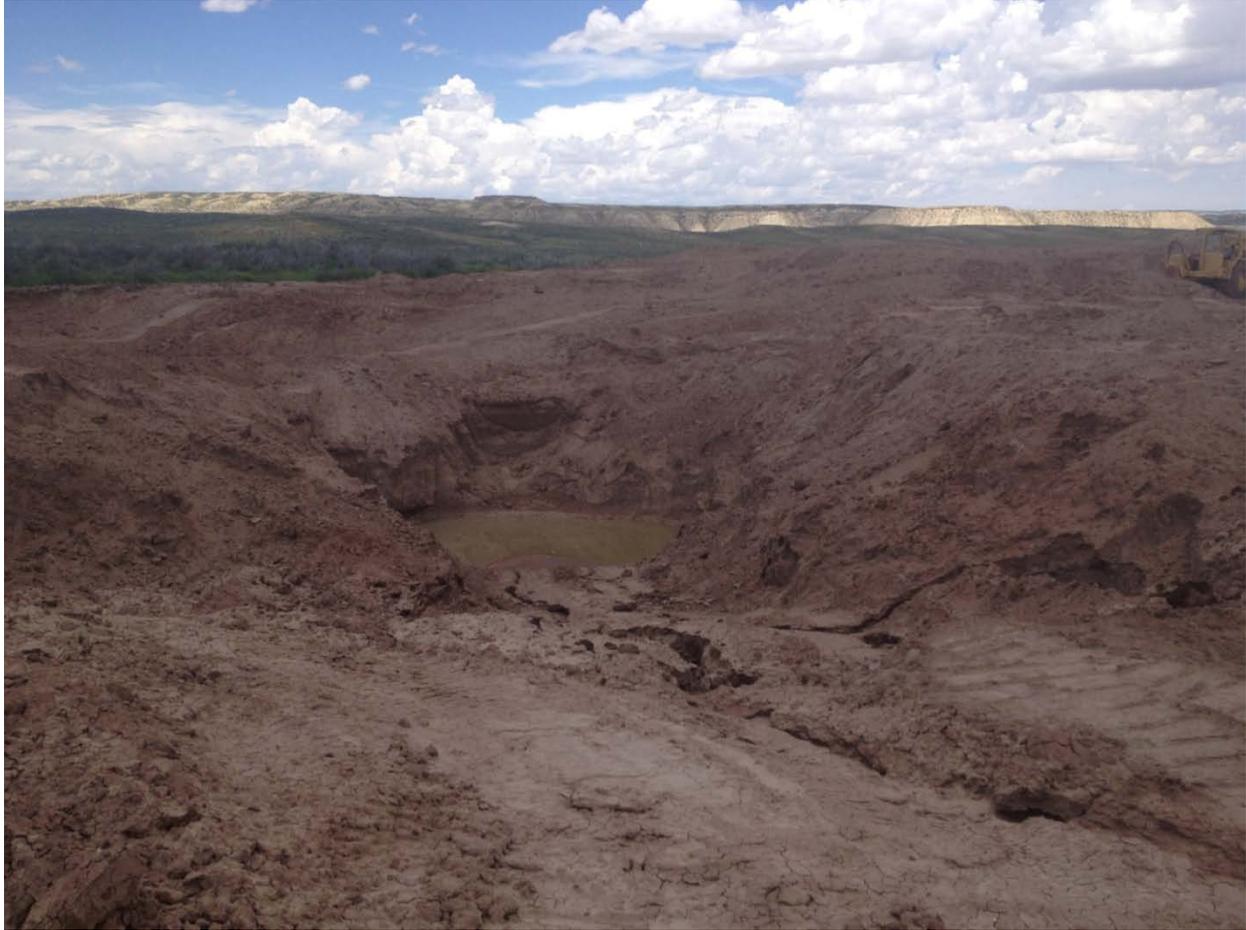
Area of pit id 100601, Approximate size 20' diameter, 15' deep. Approximate location is 40.979746, - 108.308608. Picture is looking north-west. Note; obvious hydrocarbon contamination.

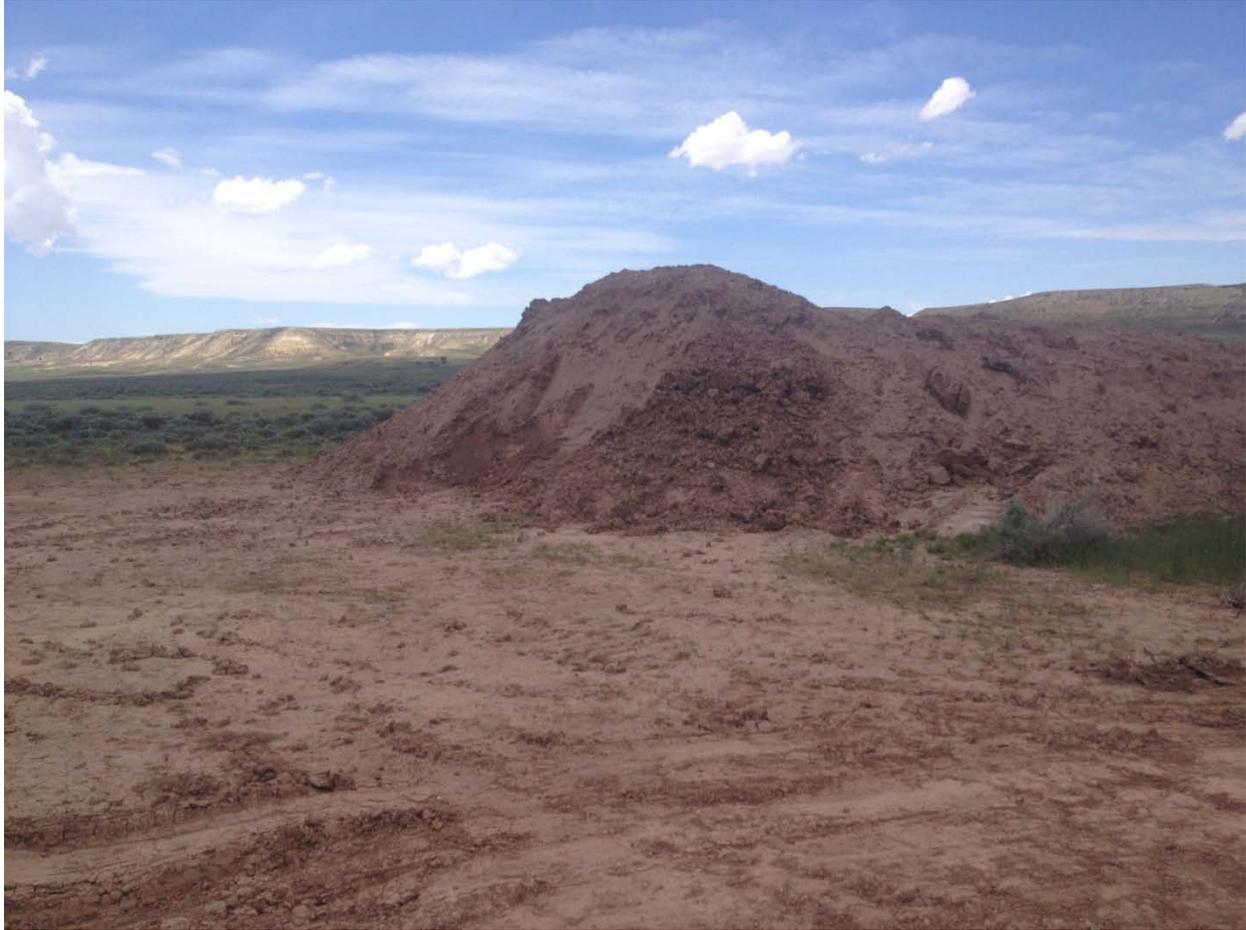
Area of pit described in Remediation project number 8333. Note; erosion at equipment access road. Estimated size is 60 diameter and 60' deep. Picture is facing north.
