RE: Status Report: Drill Pads KP 23-17 & KP 32-17 COGCC Rule 317B Post DCPS Operations Water Quality Sampling, March/April 2015

Attachment A
May 2015 Field Photographs

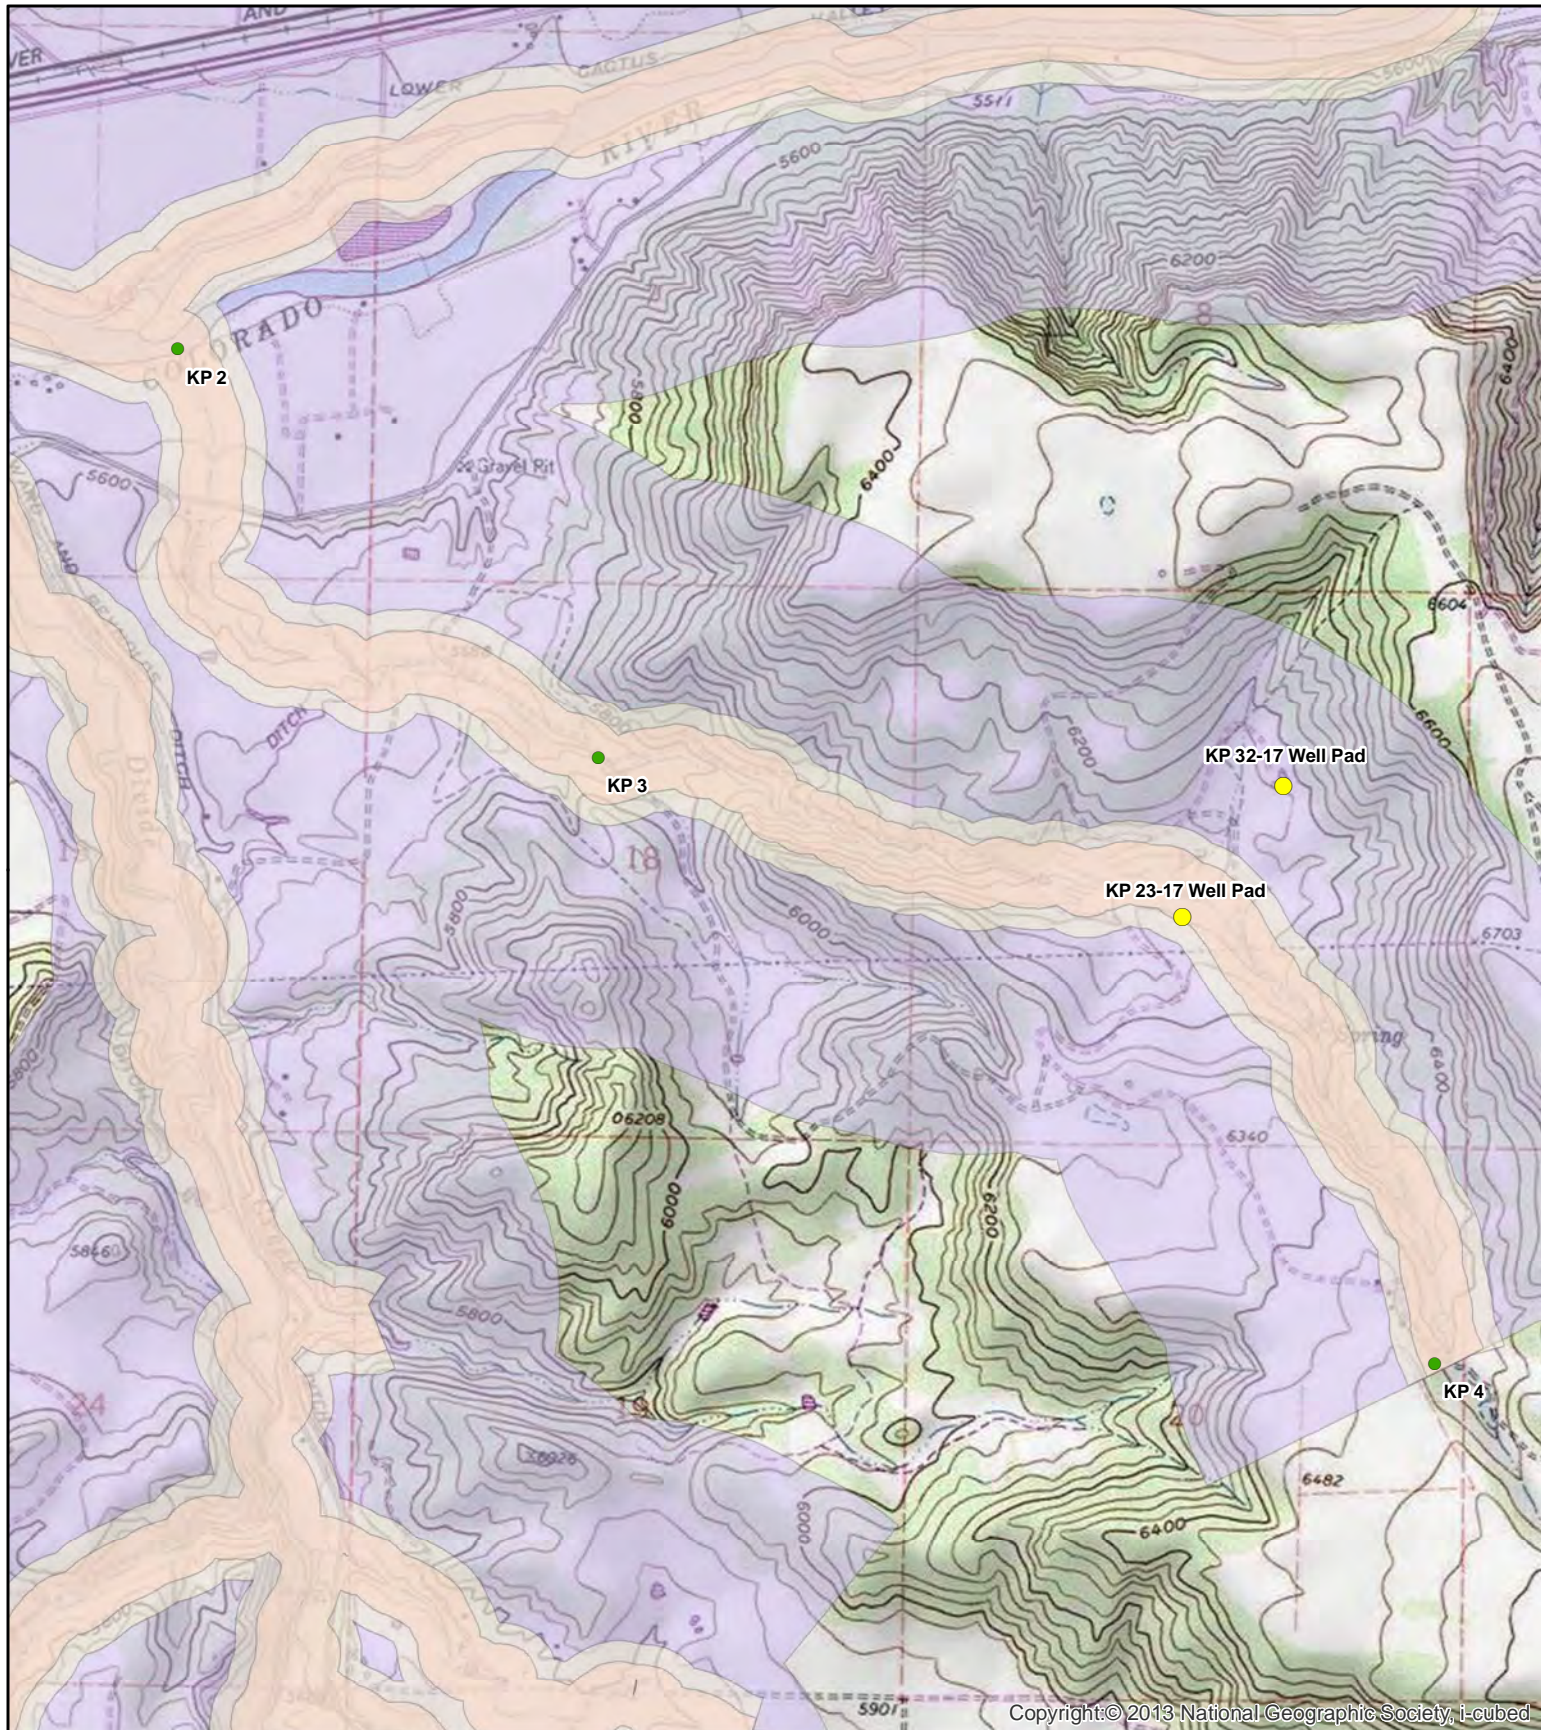
**Figure 1: March/April 2015 DCPS Operations
Rule 317B Sampling Evaluation
S 17, T6S, R91W, 6 PM**

Previously established sampling locations for the SSWSA were provided to WWL by WPX. The sampling locations were established by HRL Compliance Solutions, Inc. (HCSI). Sampling locations downgradient of the referenced WPX DCPS Operations locations are shown in Figure 1. Sampling location KP 3 (COGCC Facility ID 752549) is the nearest downgradient sampling location to the referenced WPX DCPS Operations locations and was therefore identified as the preferred sampling location.

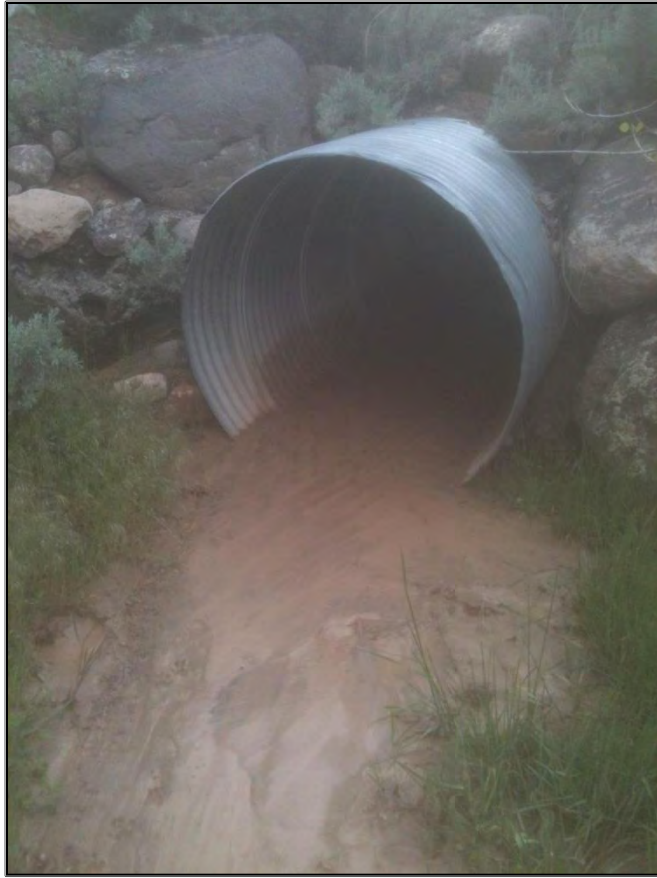
Sampling location KP 3 was visited by WWL personnel on May 18, 2015. This sampling location resides in an ephemeral drainage immediately downgradient of a culvert under the access road. No water, flowing or standing, was observed in the drainage although recent stormwater drainage was evident. The next downgradient sampling location, KP 2 (COGCC Facility ID 752548), was not visited because WPX does not have property owner consent to access this location. Photographs from the field activities are included in Attachment A. As a result of these events, no samples were collected during the March/April 2015 DCPS Operations sampling event.

Photo 1. Sampling location KP 3. (May 18, 2015)

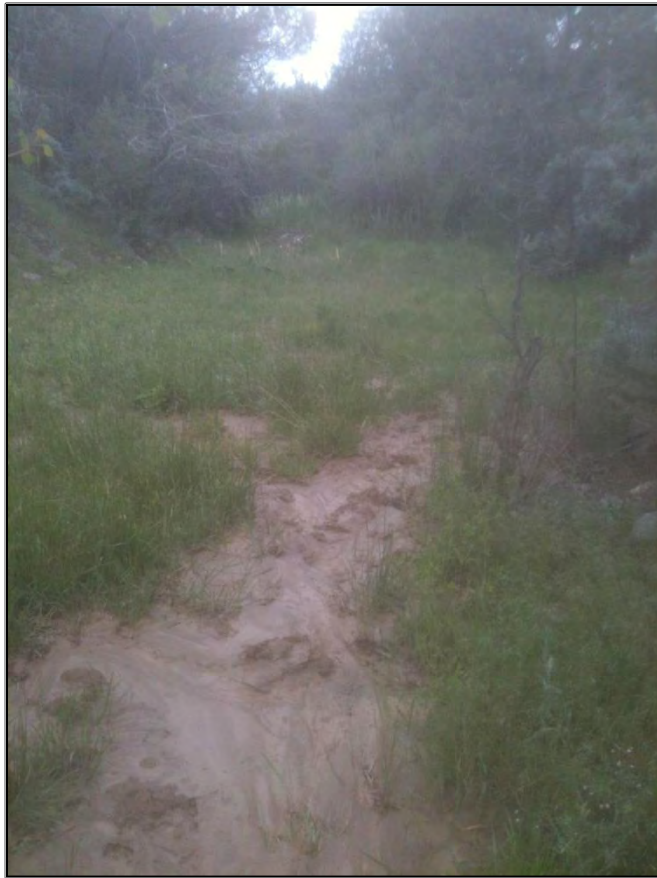
Photo 2. Drainage downstream of sampling location KP 3. (May 18, 2015)
