Re: Form 27 Site Investigation and Remediation Workplan  
Facility #100879 Husky Hill 6-6

## SITE INVESTIGATION AND REMEDIATION WORKPLAN

**Whiting Oil & Gas Corporation  
Hill 6-6 - Pit Remediation  
HRL Job #15-164**

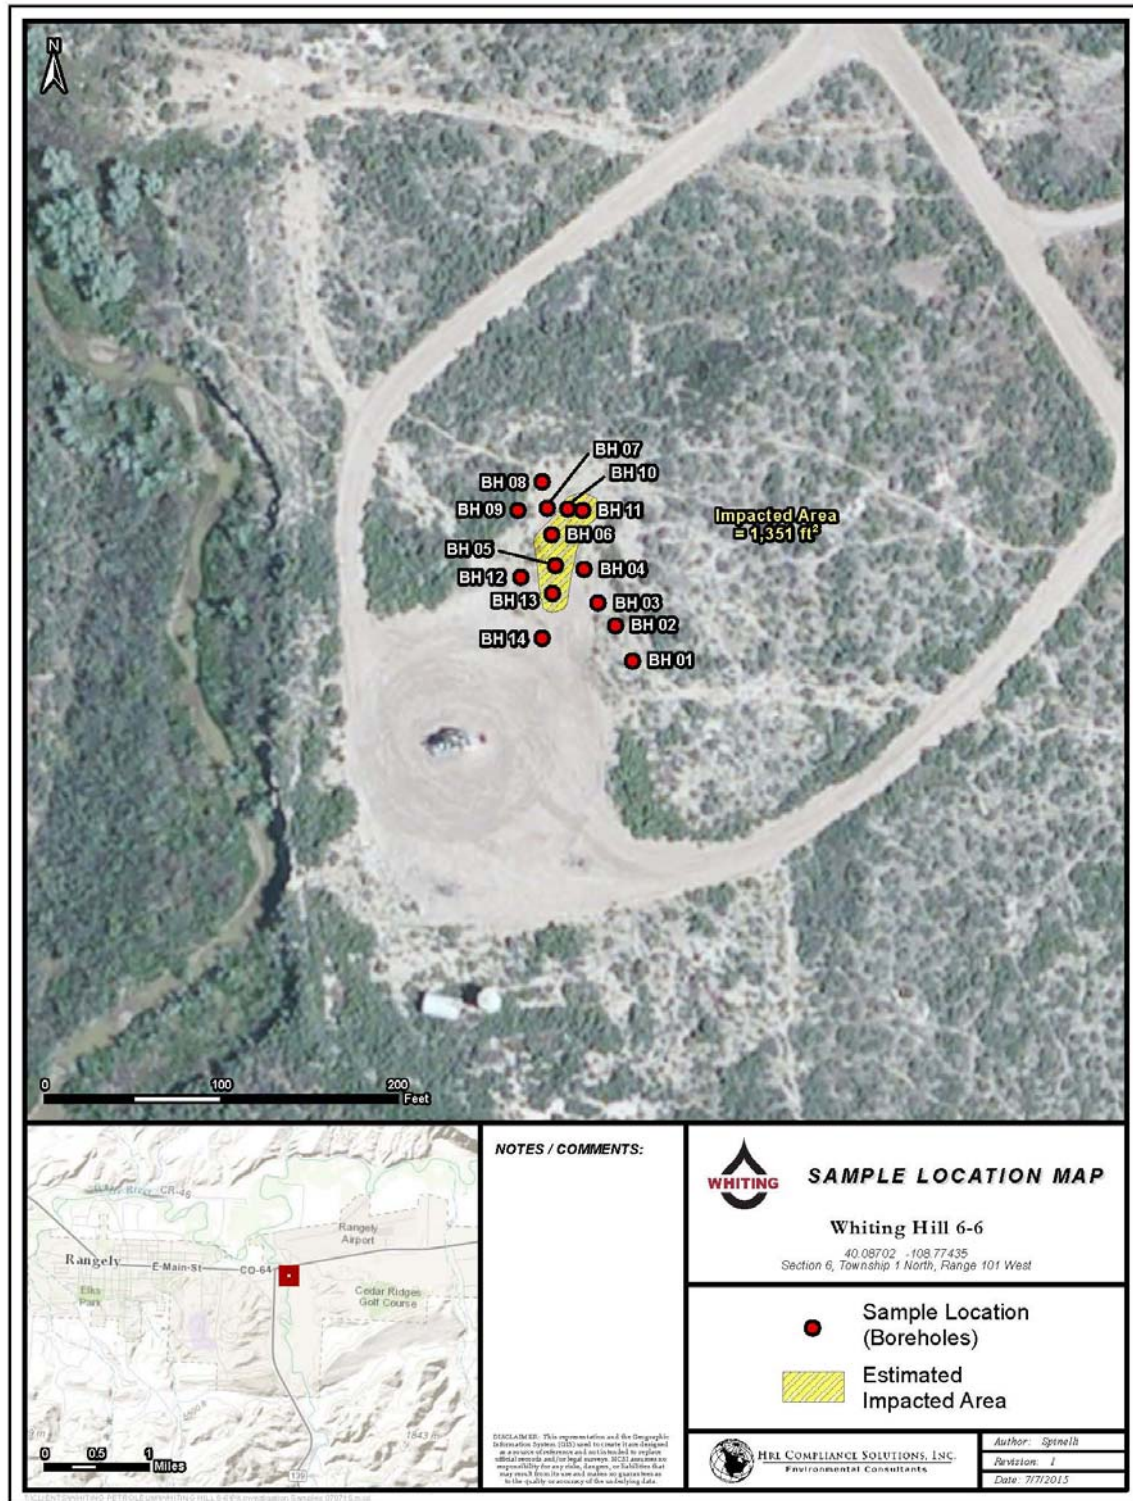
**FIGURE 1: SAMPLE LOCATION MAP**

HRL Drilling Services mobilized to the Hill 6-6 location on June 16, 2015 to conduct the site characterization. A CME 55 track mounted drill rig was utilized to advance a series of soil borings within and around the area of the pit to identify the vertical and lateral extent of hydrocarbon impacts associated with the pit. A total of fourteen (14) soil borings were advanced with samples being collected at the 4-6, 9-11, and 14-16 foot intervals. Field screen readings were collected from each sample depth and recorded. A Photoionization Detector (PID) and PetroFlag™ Hydrocarbon detection kit were utilized for field screening activities. Each soil boring was logged and examined to document soil lithology, moisture content, color, and indications of potential environmental impacts. Each boring was mapped with a Trimble GPS unit (see Figure 1).

Analytical results and field screen readings indicated the presence of elevated hydrocarbon impacts from soil borings BH 05, BH 06, BH 10, BH 11, and BH 13. Elevated impacts were not observed below 6 feet from any soil boring location. Based on analytical results and field screen readings, there is approximately 200 cubic yards of impacted soil on location. The depths of the impacts are estimated to be between 3 to 7 feet below the ground surface (bgs). Refer to Figure 1 for a diagram of the estimated impacted area. See Table 1 below for analytical and field screen results.

Remediation options for the impacted soil were discussed during a site visit with Whiting, HRL and COGCC personnel on August 11, 2015. Further remediation plans were discussed subsequently by Whiting and HRL during the planning phase. It was decided that the impacted soil will be excavated and amended (blended and aerated) to below COGCC Table 910-1 allowable standards. A trackhoe or a backhoe will be used for excavation activities. The top three (3) feet of soil will be stockpiled as clean root-zone overburden. During the excavation of impacted soil, field screen observations will be collected
