WELL LOCATION CERTIFICATE

BER 44-15

DATE OF FIELD WORK 10/27/2015	DATE OF DRAWING 10/29/2015	PROJECT NO. 1083.080
Augustus Energy Resources, LLC BER 44-15 1S44W		
SE1/4 SE1/4 Section 15, T1S, R44W, 6PM, Yuma County, Colo.

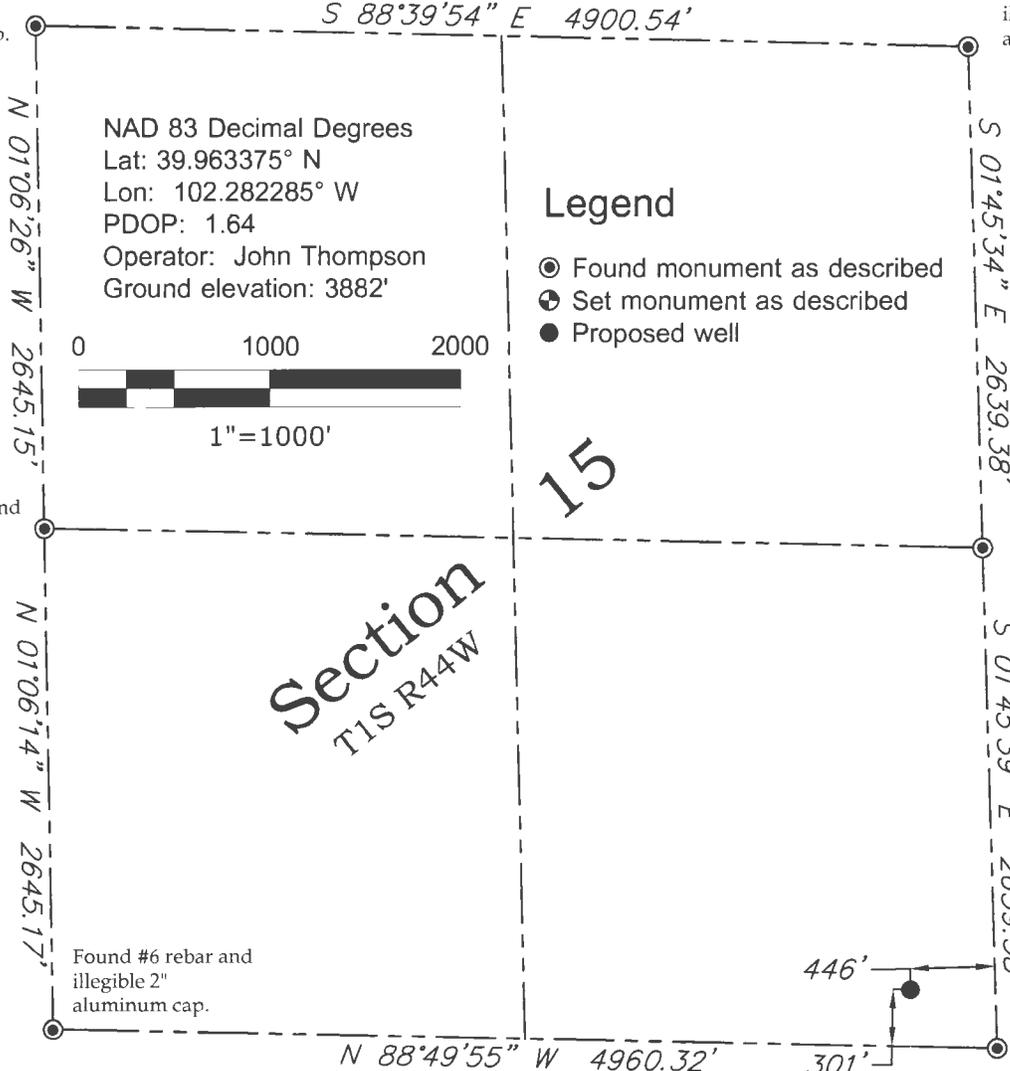
Section 15
 T1S R44W

Found #6 rebar and illegible 2" aluminum cap.

NAD 83 Decimal Degrees
 Lat: 39.963375° N
 Lon: 102.282285° W
 PDOP: 1.64
 Operator: John Thompson
 Ground elevation: 3882'

Found #6 rebar and 2" aluminum cap RLS 1791.

BER 44-15 is to be located at a point 301' from the SOUTH line and 446' from the EAST line, measured at right angles, of the SE Quarter of Section 15, Township 1 South, Range 44 West of the Sixth Principal Meridian, Yuma County, Colorado.

Distances shown hereon are at ground level and are field-measured.

Bearings of this survey are based on the assumption that the west line of the Northwest Quarter of Section 15, Township 1 South, Range 44 West of the 6th Principal Meridian, between monuments described hereon bears N 01°06'26" W as shown hereon.
