# Field Sampling Data Sheet

COGCC Facility ID: Pilkingtion 41-13D & 31-13D with Tank Battery (nearest)  
Site Address: -17601 CR 10, Weld County, NWNE Sec. 13, T-1-N, R-66-W  
Site Contact: n/a  
Phone #: n/a  
Date of Sample: 2/16/2016  
Sample Type (baseline, post-drill, complaint): Complaint #200438711  
Oil & Gas Well API Number: 123-23711 & 123-23174

Complaint #200438711 Aerial Photograph with water well and sampling locations

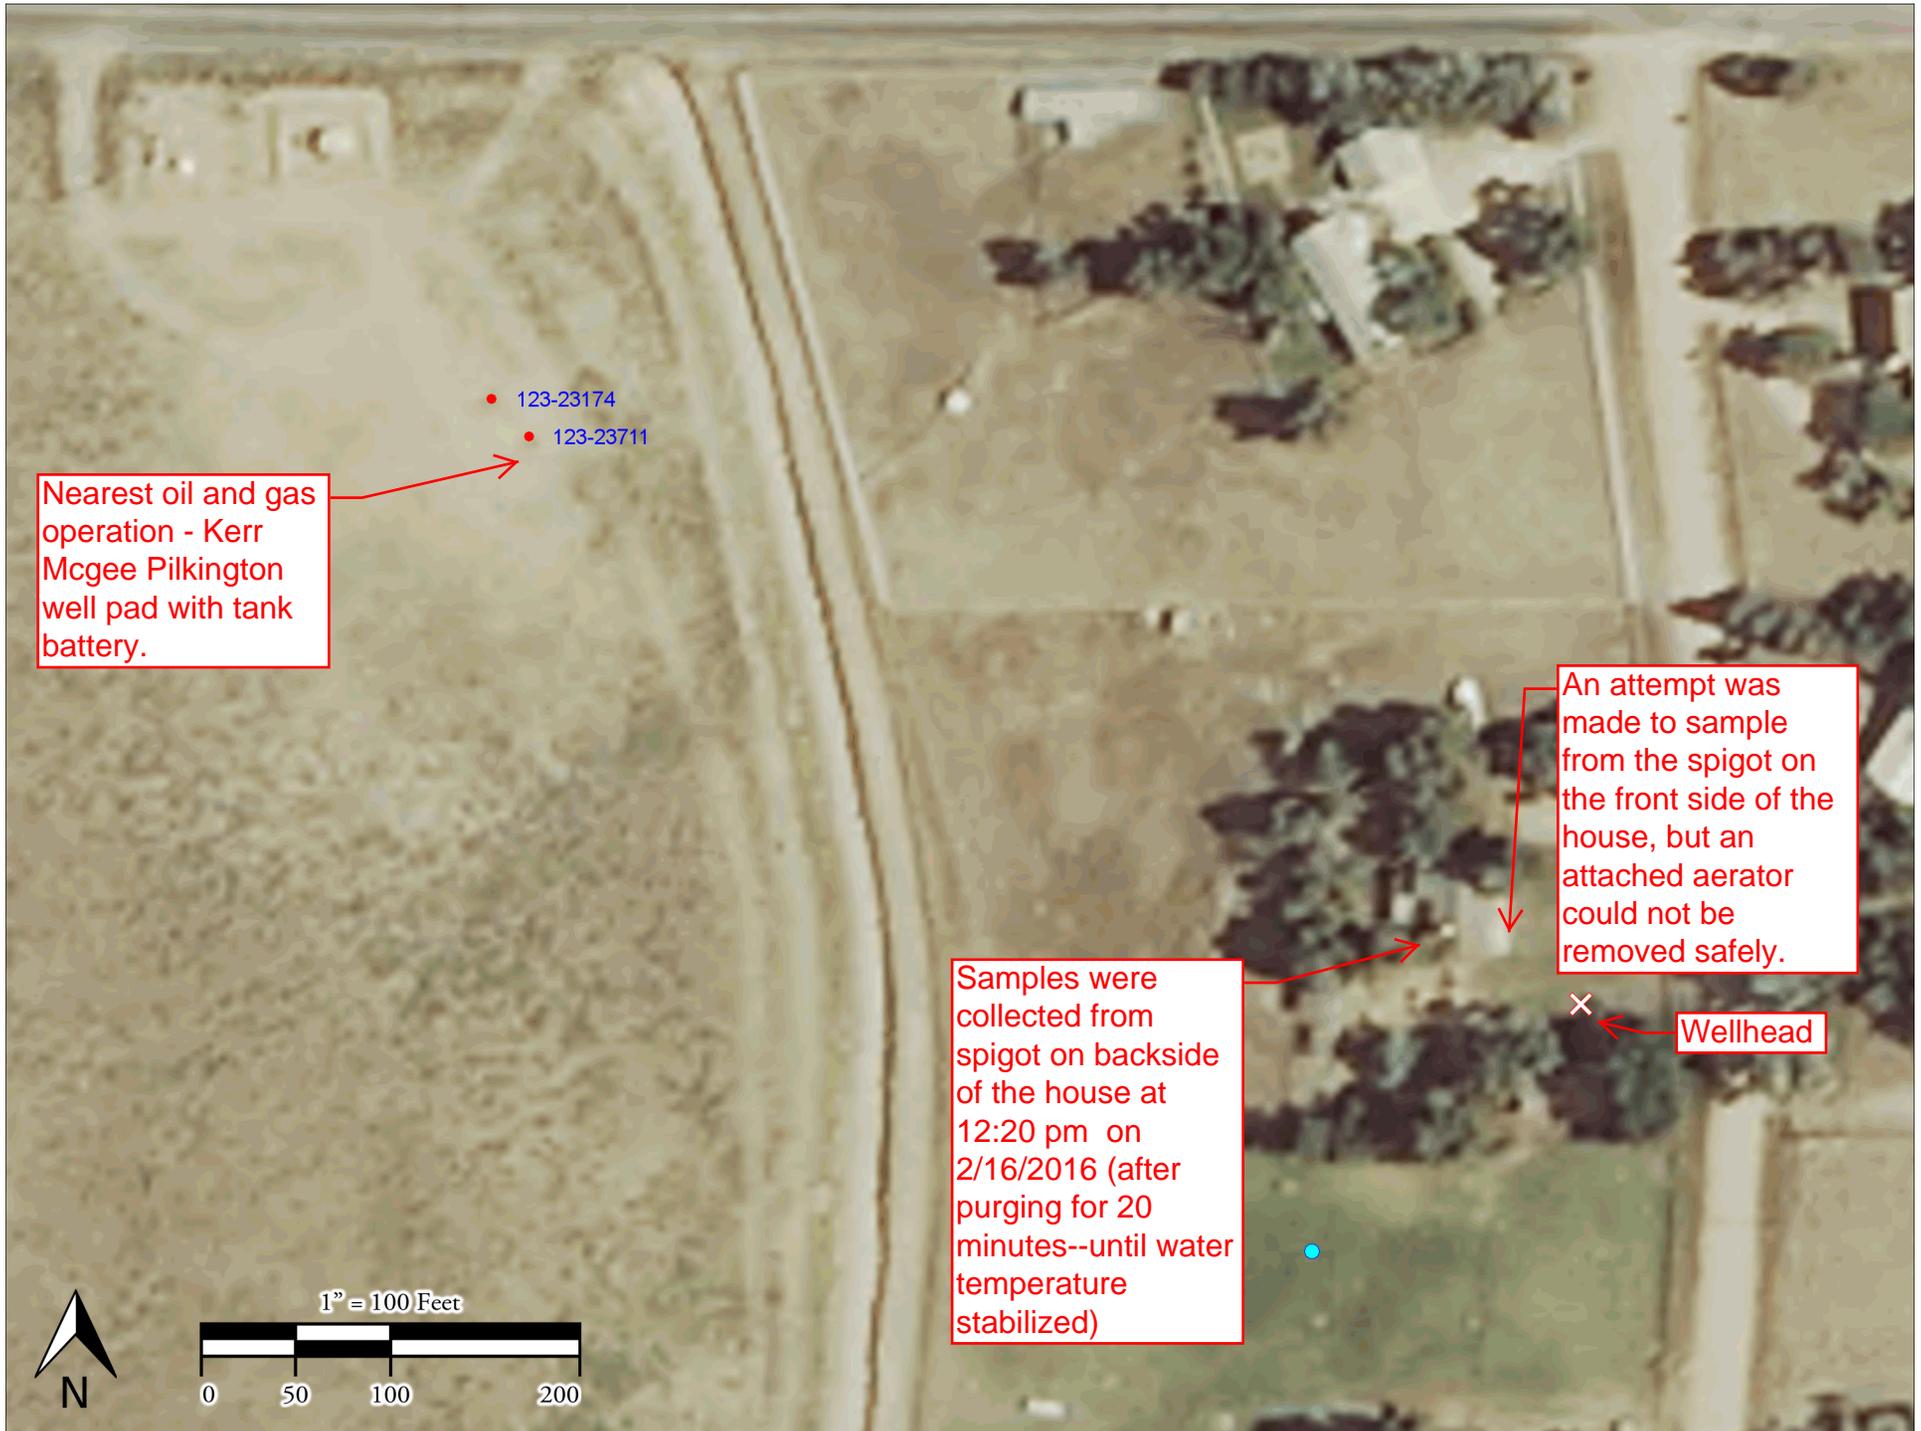
• 123-23174  
• 123-23711

Nearest oil and gas operation - Kerr Mcgee Pilkington well pad with tank battery.

An attempt was made to sample from the spigot on the front side of the house, but an attached aerator could not be removed safely.

Samples were collected from spigot on backside of the house at 12:20 pm on 2/16/2016 (after purging for 20 minutes--until water temperature stabilized)

Wellhead
