**Re: 2015 Annual Groundwater Monitoring Report  
Cottonwood #1 Tank Battery  
NESE Section 13 T6N R66W  
Weld County, Colorado  
Facility #: 322644  
Spill Tracking #: 2315752  
Remediation #: 9319**

DRAWN BY: ESS	<b>Facility Diagram</b> PDC Energy, Inc. – DJ Basin Cottonwood #1 Tank Battery NESE S13 T6N R66W Weld County, CO

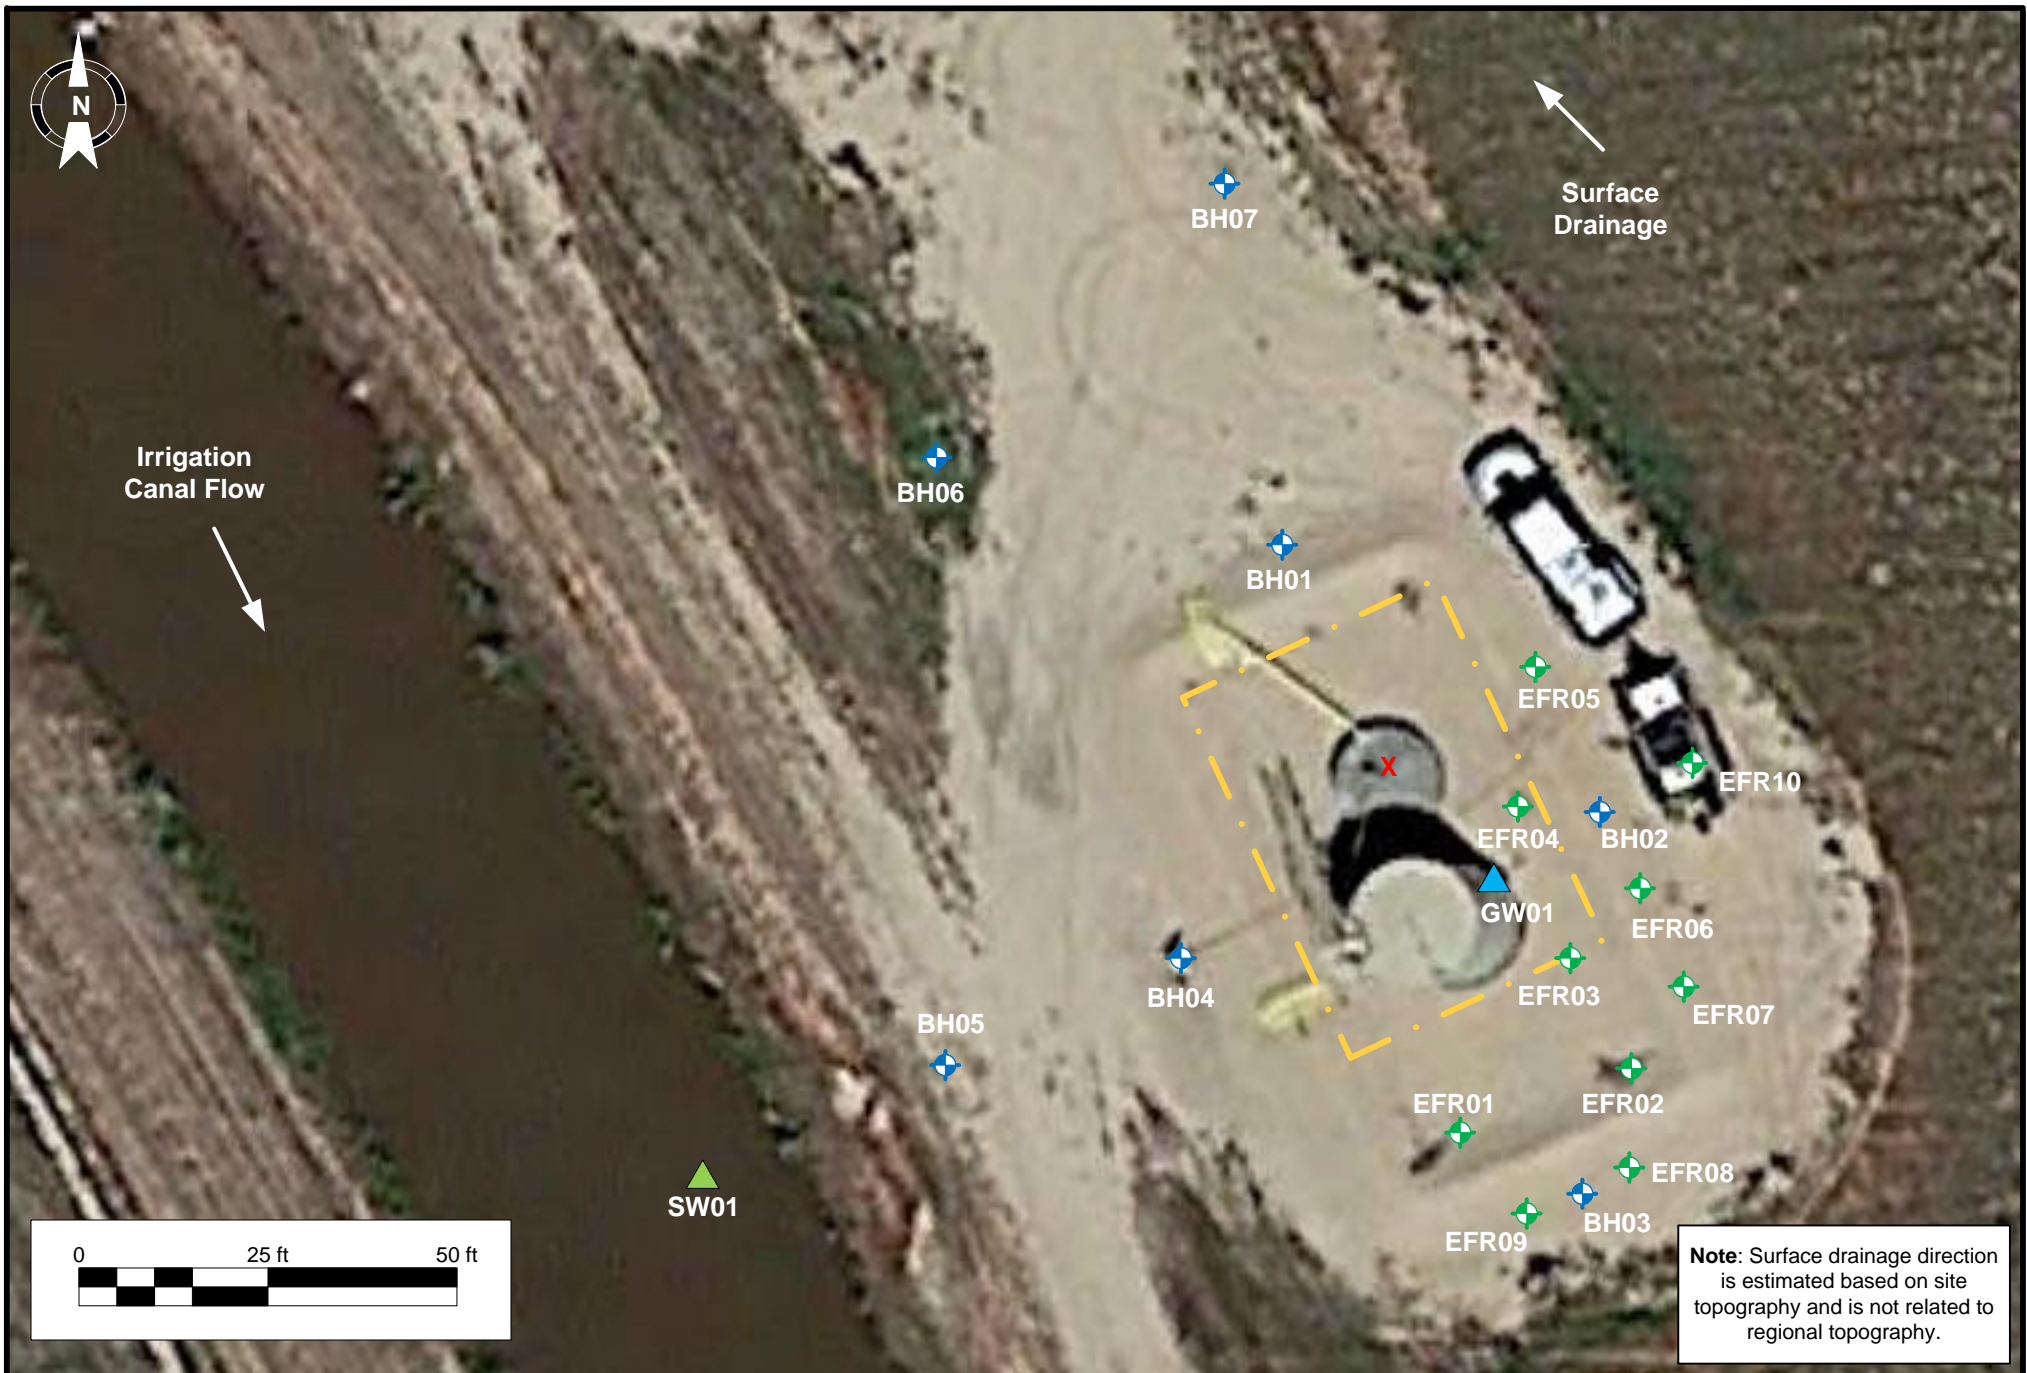
Point of Release	<b>FIGURE 1</b> GROUNDWATER MONITORING SITE MAP
DATE: 2/16/2016

A historic release was discovered at the Site on August 17, 2012, during produced water vault and dump line replacement activities. Following excavation and well installation activities, groundwater monitoring was initiated during the third quarter 2012. The monitoring well network at the Site consists of 7 monitoring and remediation wells (BH01 - BH07), as shown in Figure 1. Historic groundwater monitoring results are presented in Table 1. Groundwater monitoring results for 2015 are summarized below.

Tasman initiated enhanced fluid recovery (EFR) and air sparge (AS) events at the site during the fourth quarter 2012. EFR/AS will remain the selected remediation strategy for this site through the first quarter 2016. Following the completion of remediation activities, four additional quarters of compliance groundwater monitoring will be conducted to confirm that BTEX concentrations remain below applicable COGCC Table 910-1 groundwater standards.
