Final Reclamation Inspection

Operator: Adkins Oil

Location ID: 393754

Morgan County, CO

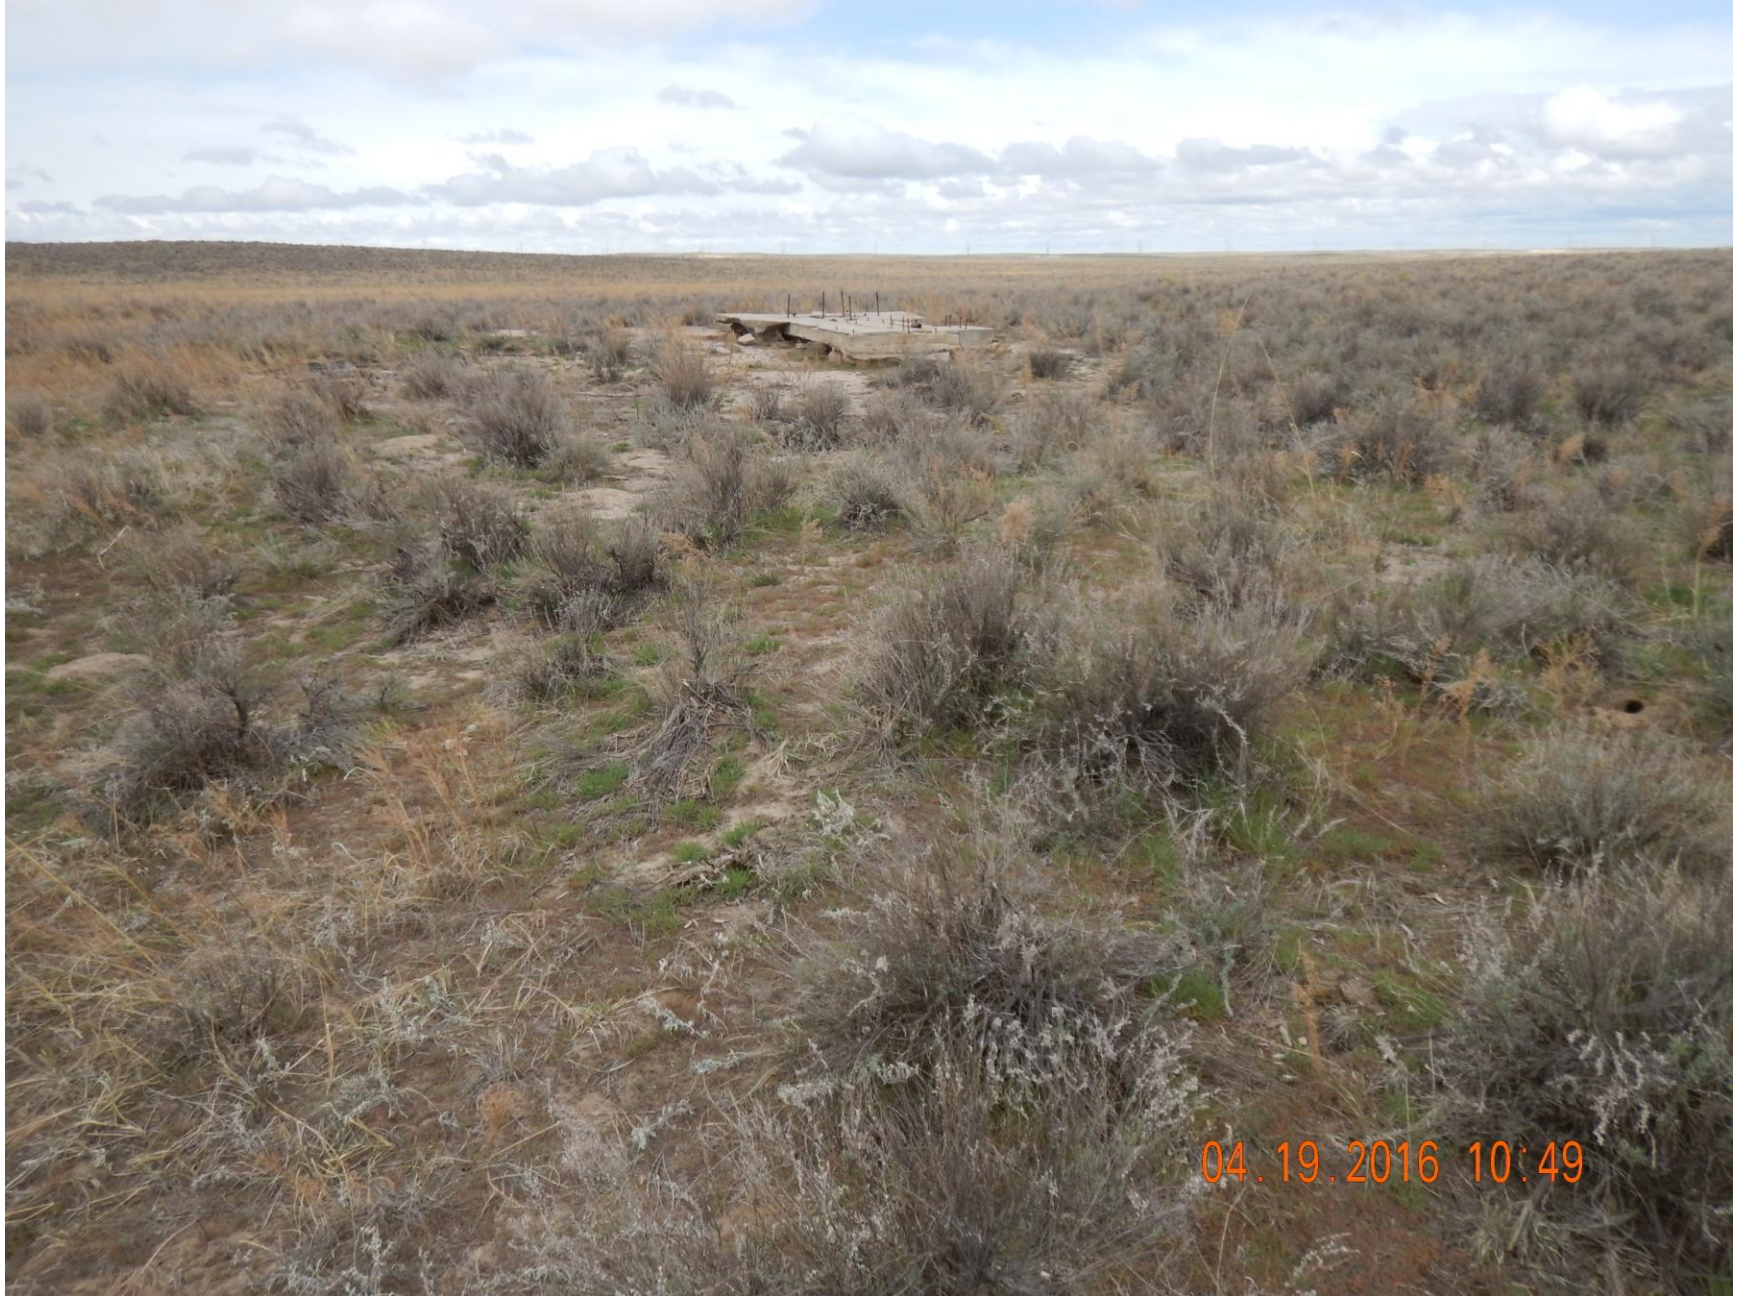
Figure 1: Photo taken from the east end of the location, facing west. Photo shows cement pump-pad identified in Doc. # 673502676

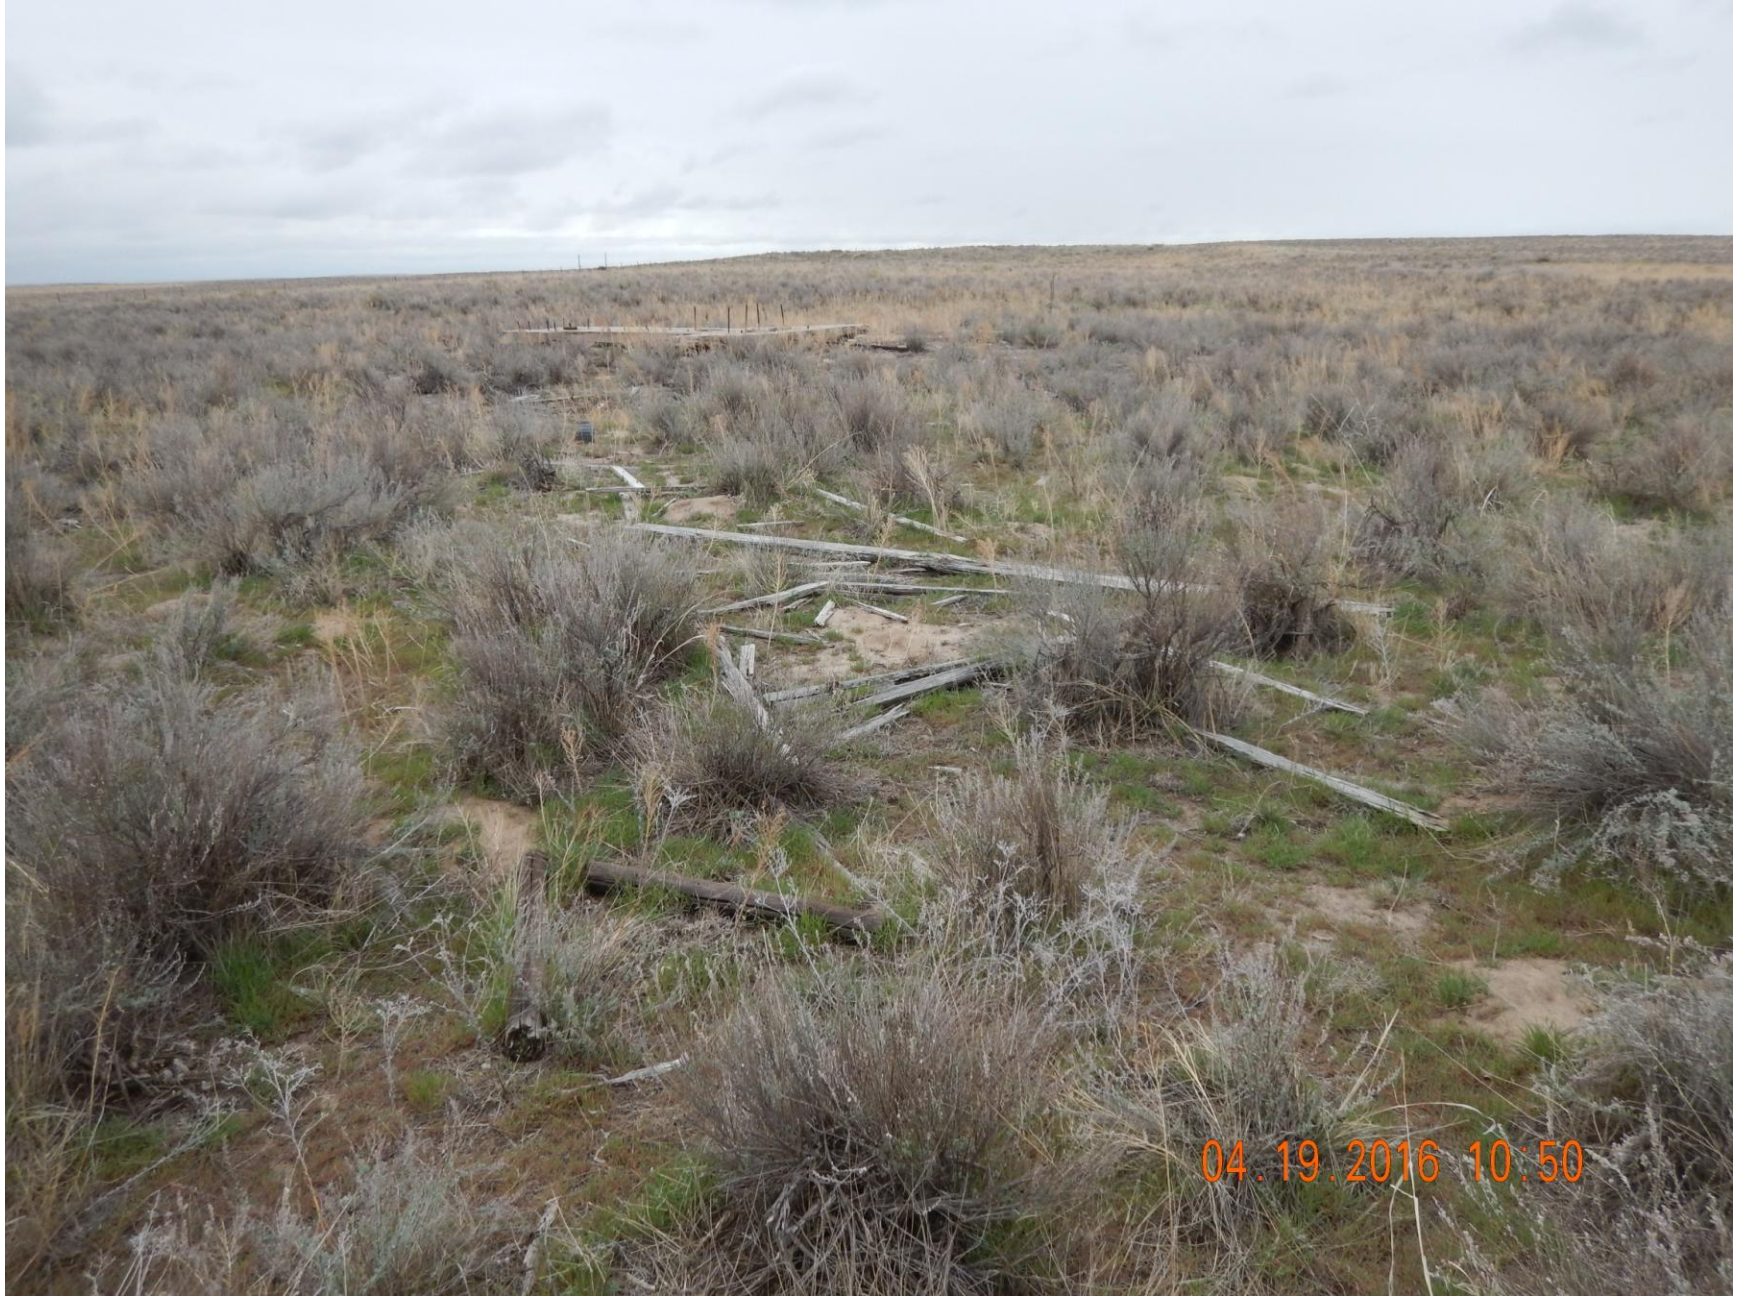
Figure 1: Photo taken from the north end of the location, facing south. Photo shows cement pump-pad and trash debris identified in Doc. # 673502676.

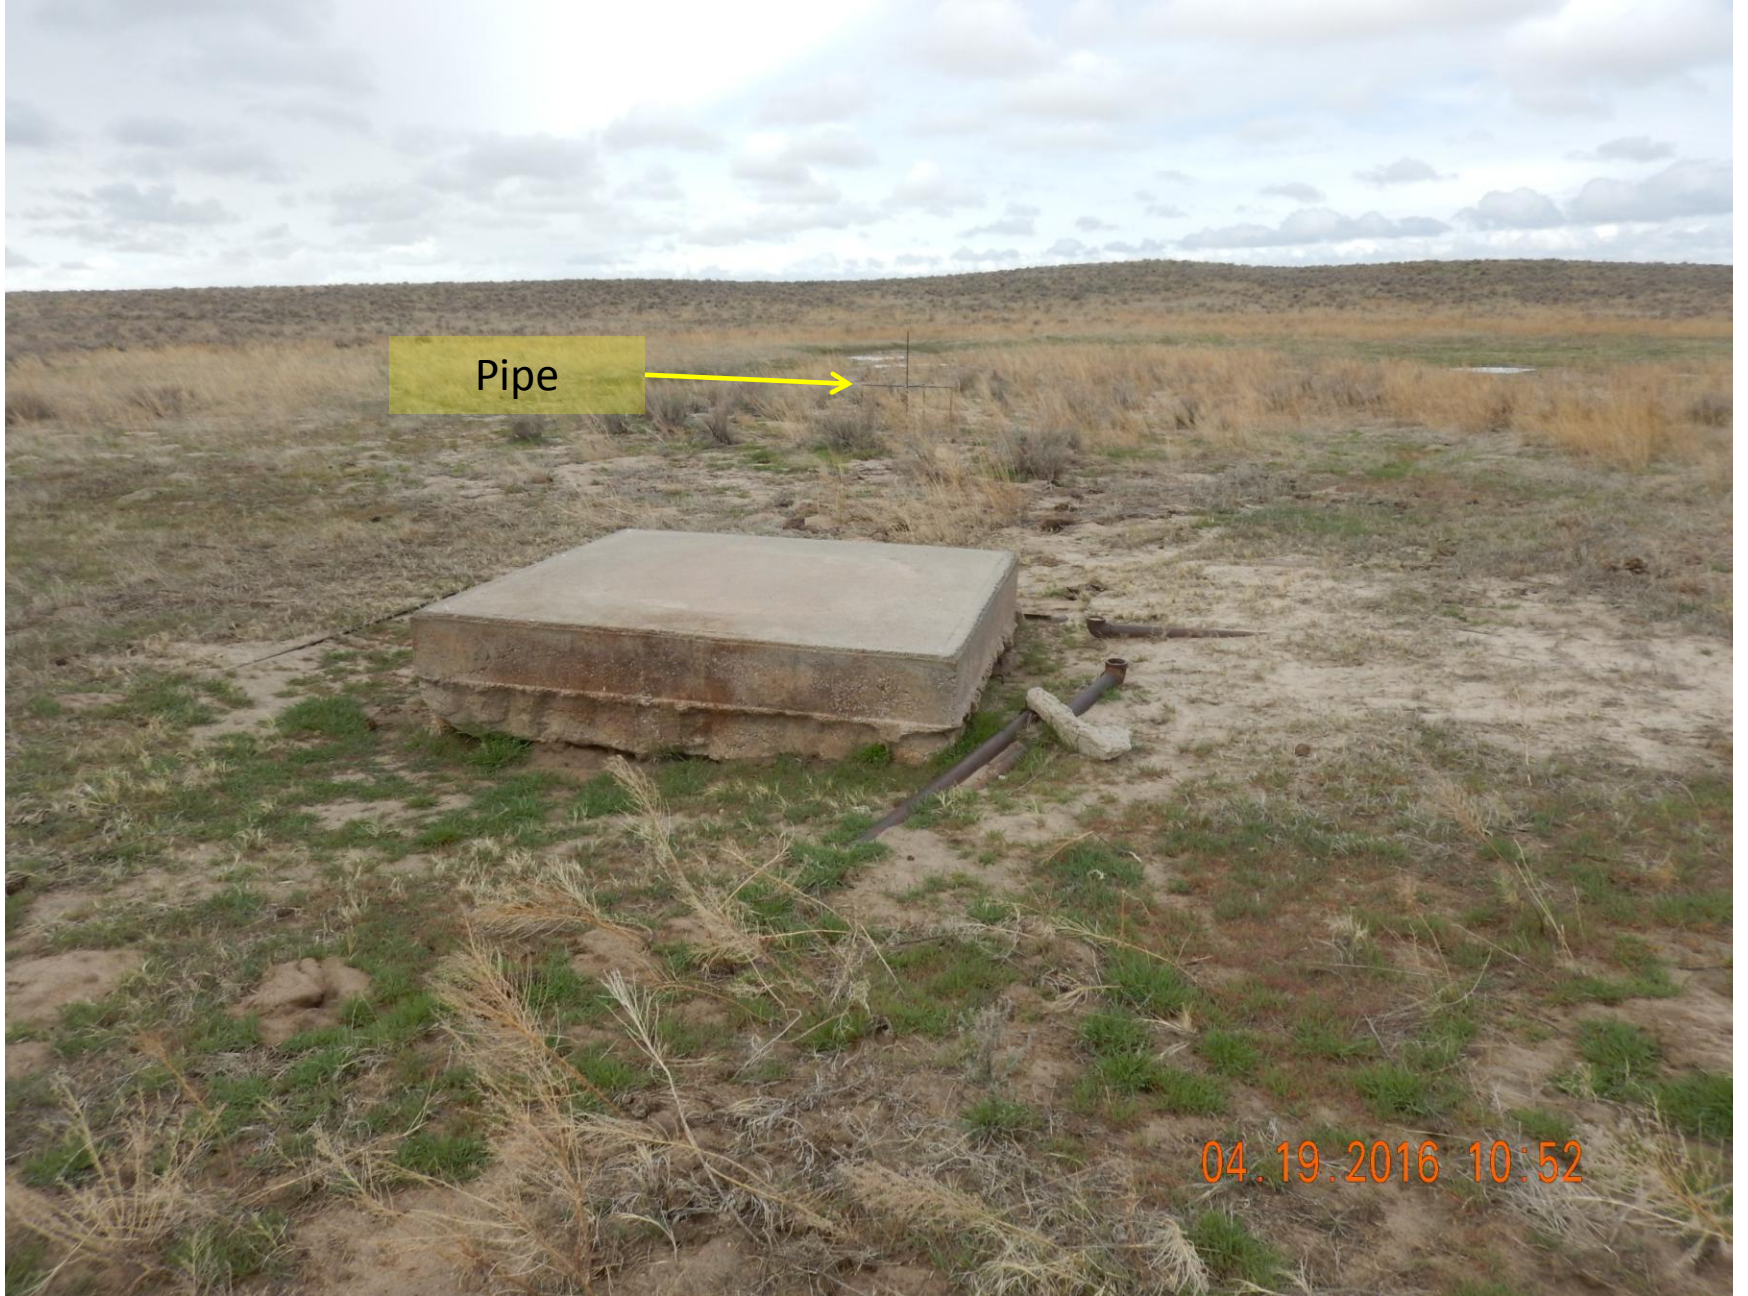
Figure 3: Photo taken west of the cement pump-pad, facing west. Photo shows additional cement pad (approx 8'x8'x2') and pipe equipment remaining in the ground.

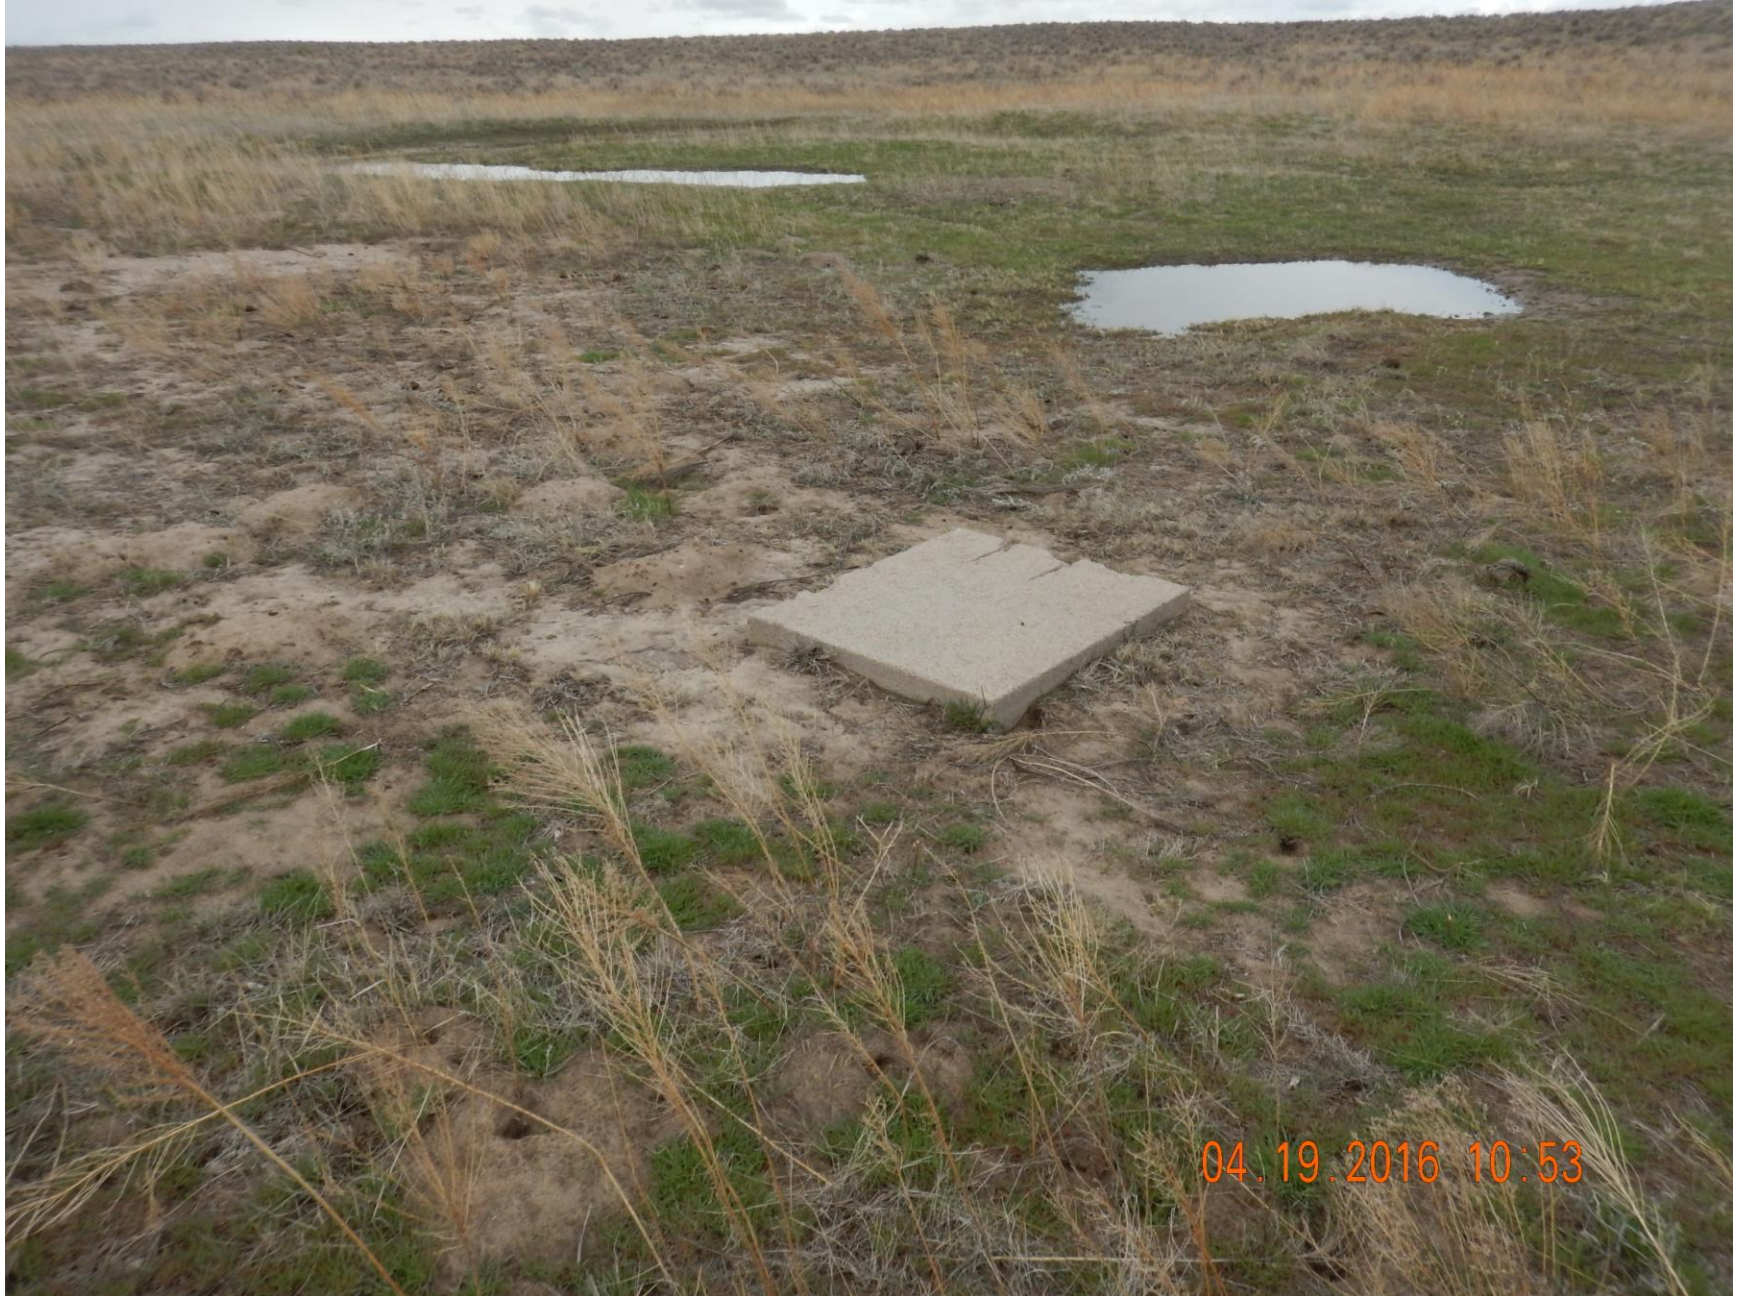
Figure 1: Photo taken west of the cement pump-pad, facing west. Photo shows additional cement pad (approx 3'x3'x6") remaining.

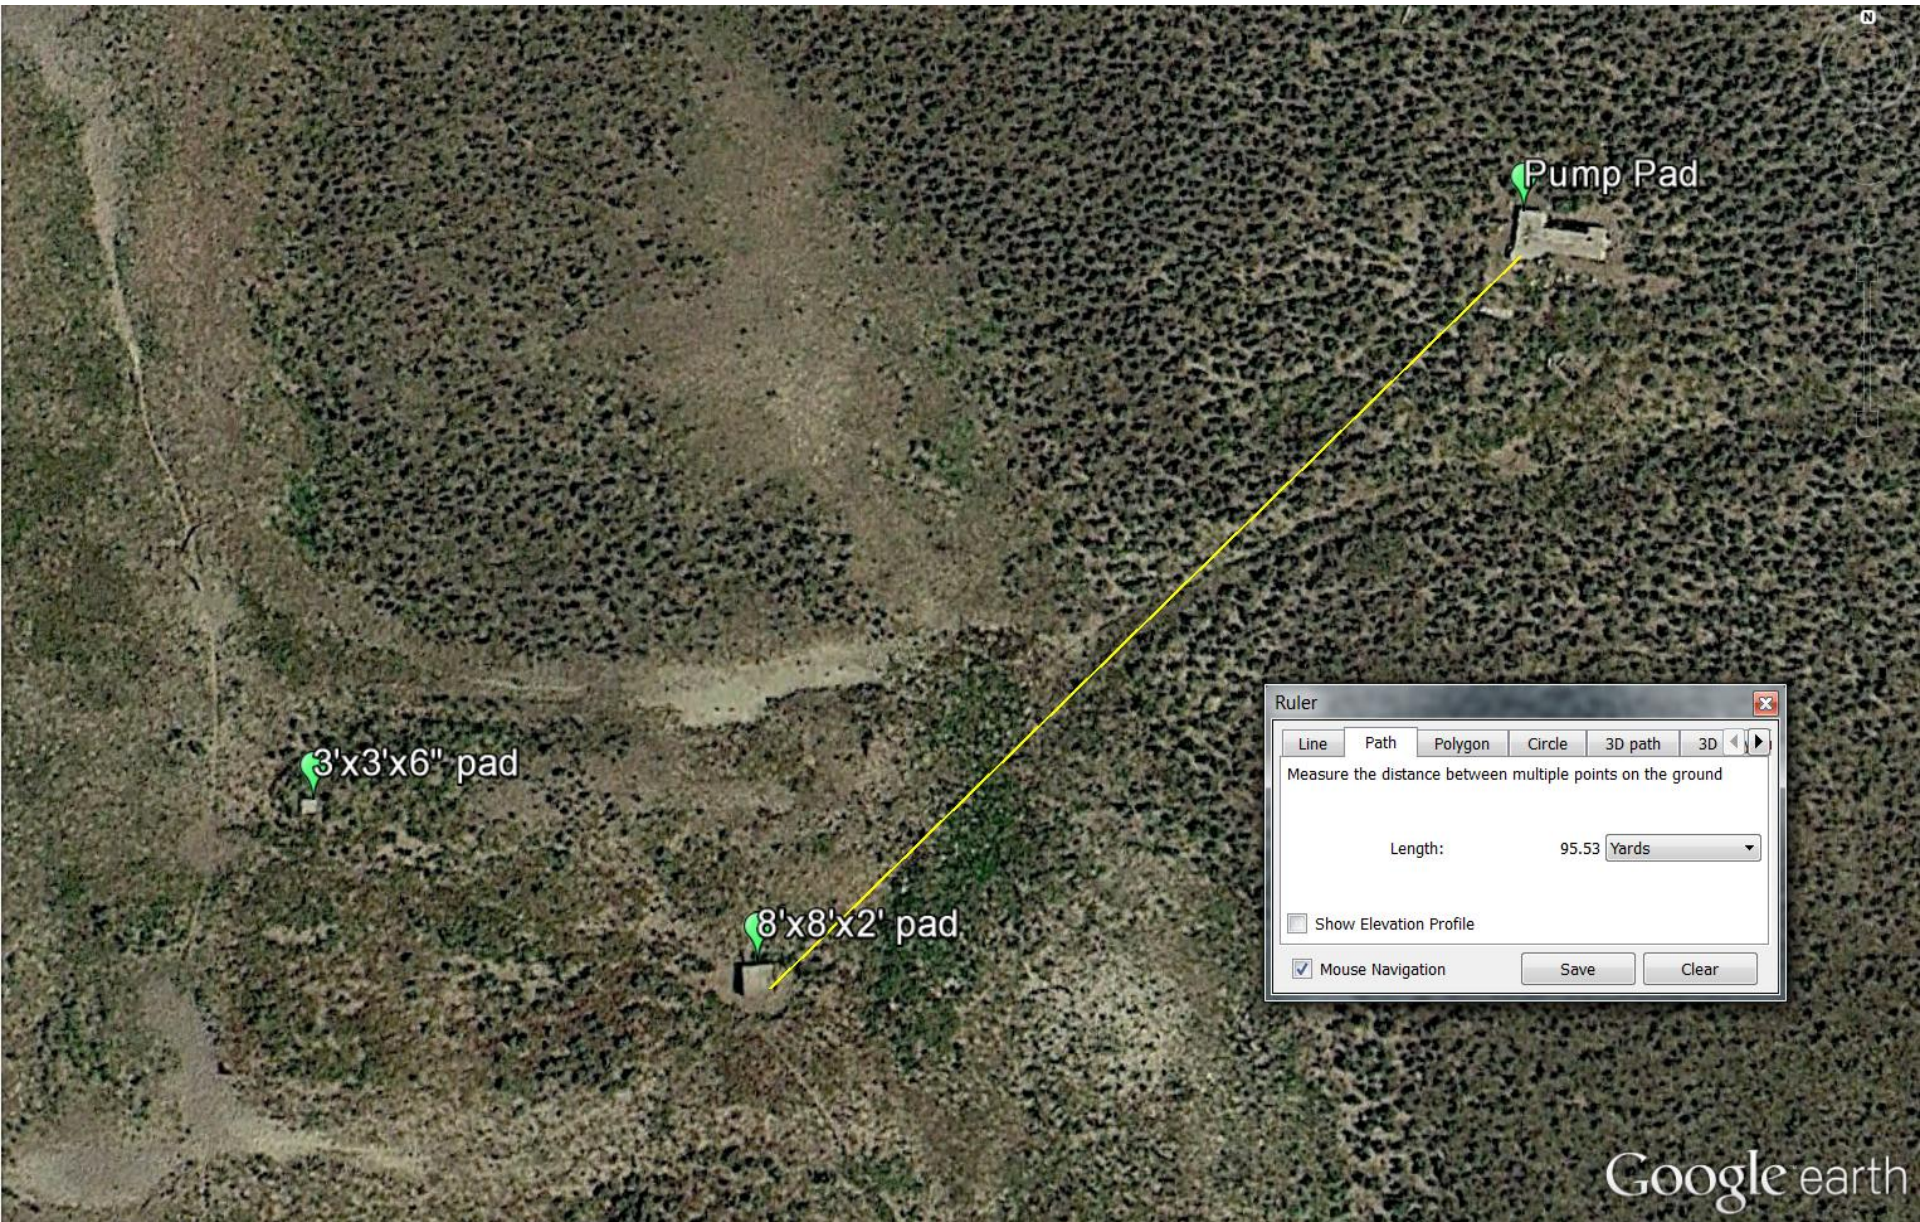
Figure 5: Aerial imagery providing reference to cement pad locations compared to pump-pad.
