SITE INVESTIGATION AND REMEDIATION WORKPLAN

Facility Name: Fuqua 18-15 Well Pad

**RE: Fuqua 18-15 Pad Separator Release Additional Site Investigation
and Remediation Work Plan - Project #012-0225**

Laramie Energy II
Fuqua 18-15 Additional Site Investigation
May 15, 2012

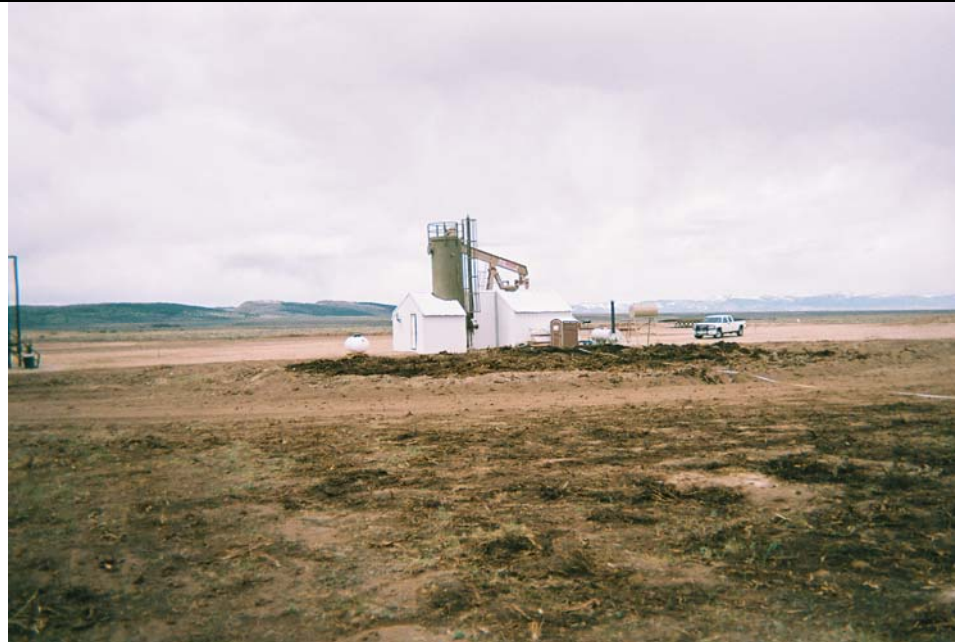
Subject: A top valve seal on the vertical separator failed resulting in the January 29, 2012 condensate release. Impacted vegetation and soils were scraped up using a loader and placed within secondary containment to the east of the separator. Stained soils and vegetation are shown in the foreground.

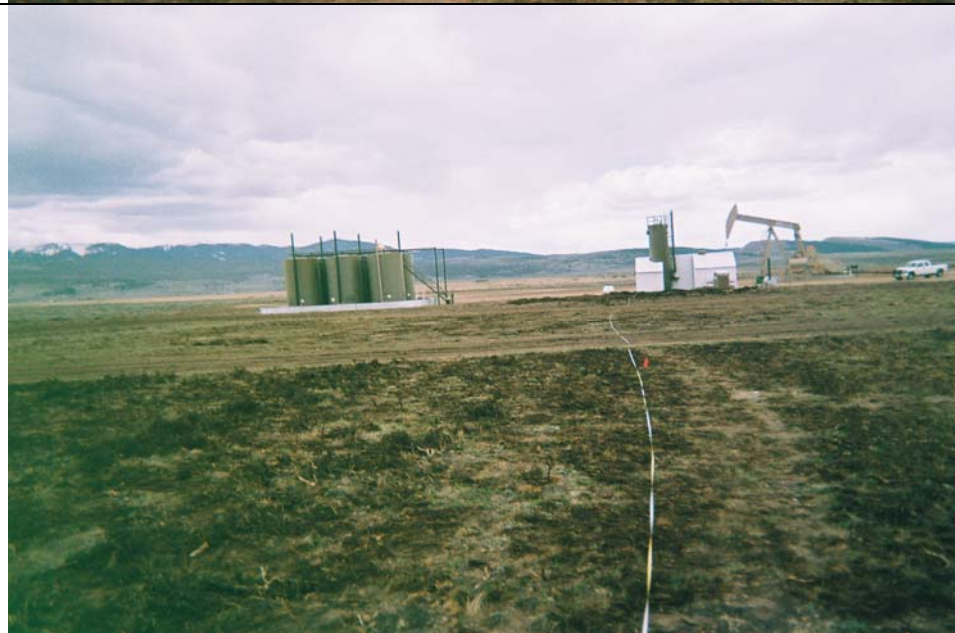
Subject: Photograph shows the approximate centerline of the release at a distance of approximately 250 feet from the vertical separator. Stained soil and vegetation are shown in the foreground. The orange pinflag marks the location of SS9.

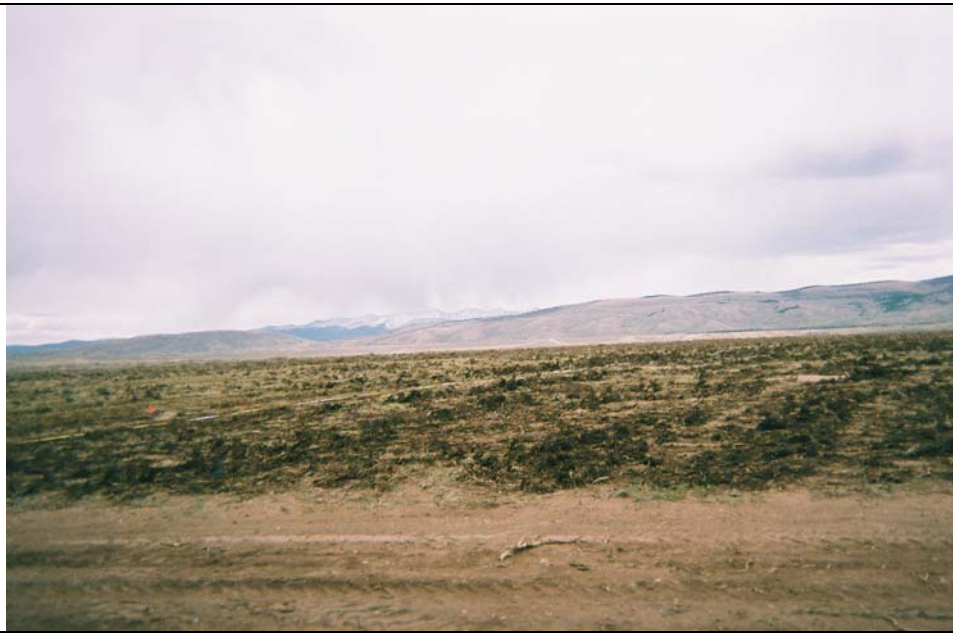
Subject: Photograph taken from the access road showing the impacted area of surface soils and vegetation. The impact area fanned out from the vertical separator to the east of the well pad and was between 160 feet and 200 feet wide. Measurements of the impact area were taken using the Trimble GPS unit based on visual extent of staining. The primary impact area extended out approximately 450 feet from the separator.

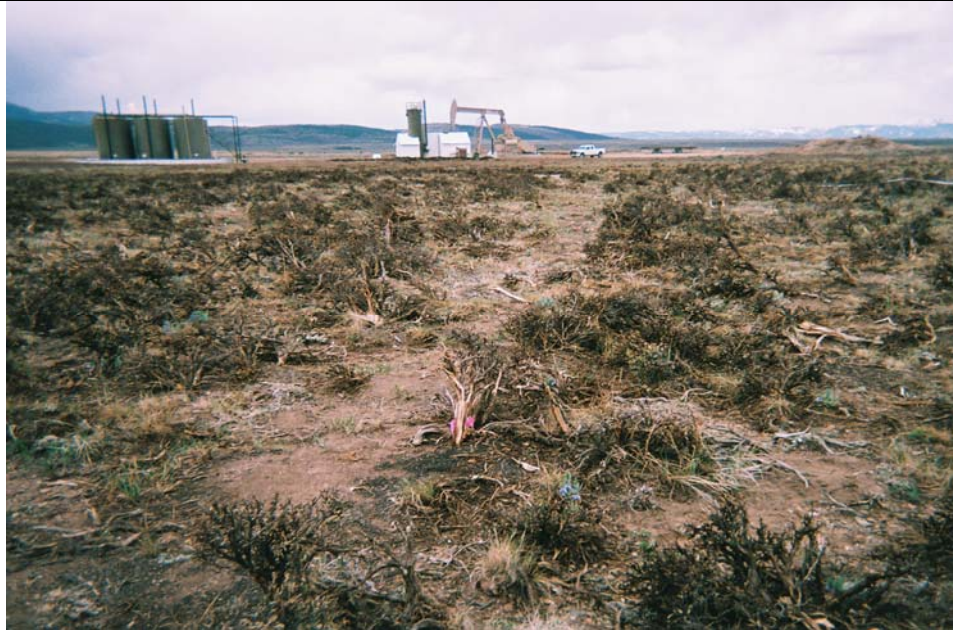
Subject: Soil sample location SS5 was located approximately 300 feet east of the separator and 25 feet south of the centerline. The approximate sample location was marked with flagging tape. New vegetation appeared to be coming up within the impacted area.

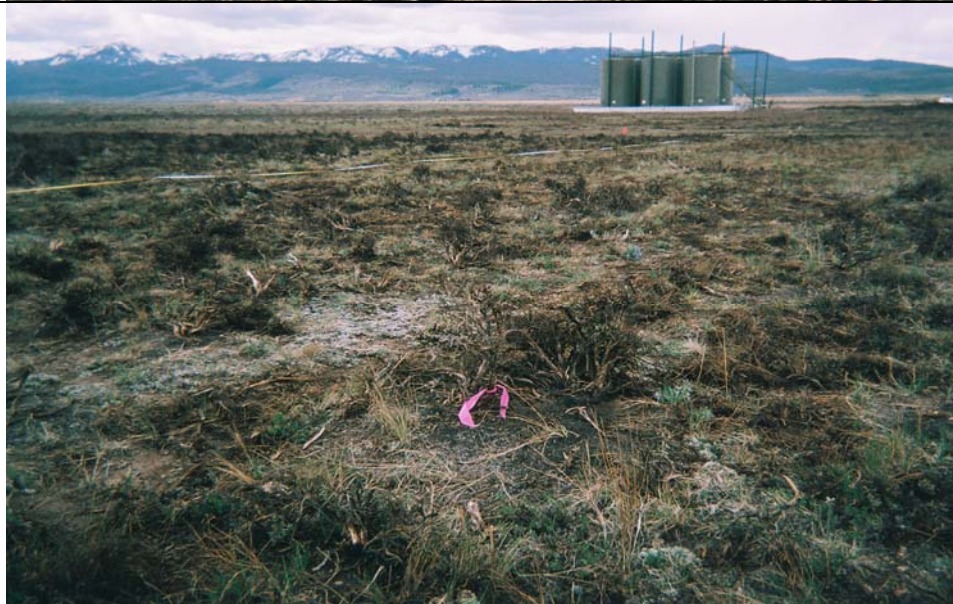
Subject: Soil sample location SS6 was located approximately 300 feet east of the separator and 25 feet north of the centerline of the release. Approximate sample locations were marked with flagging tape and recorded with the Trimble GPS.

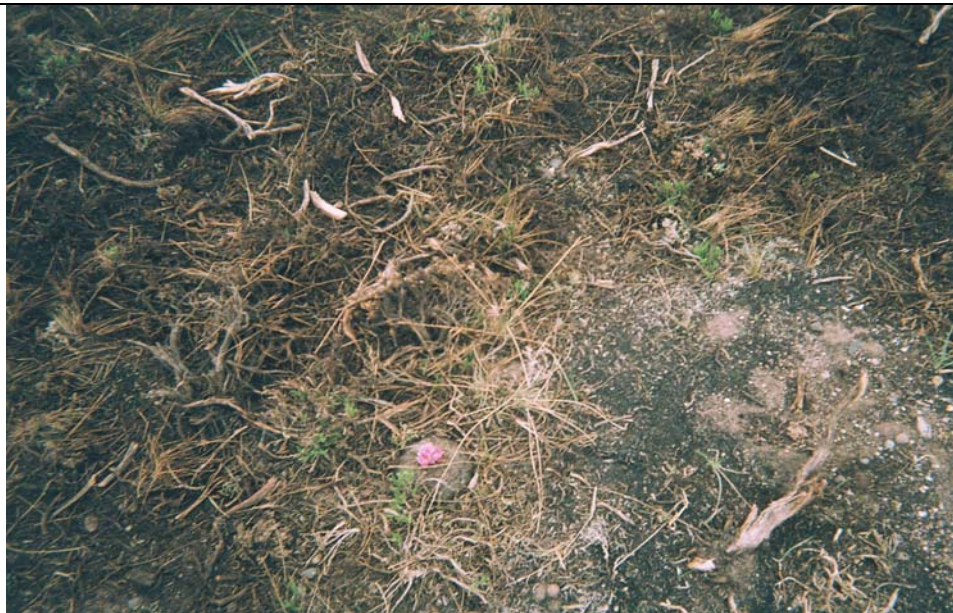
Subject: Barrel cacti were observed in bloom and other plants were observed coming up within the stained and impacted vegetation area.

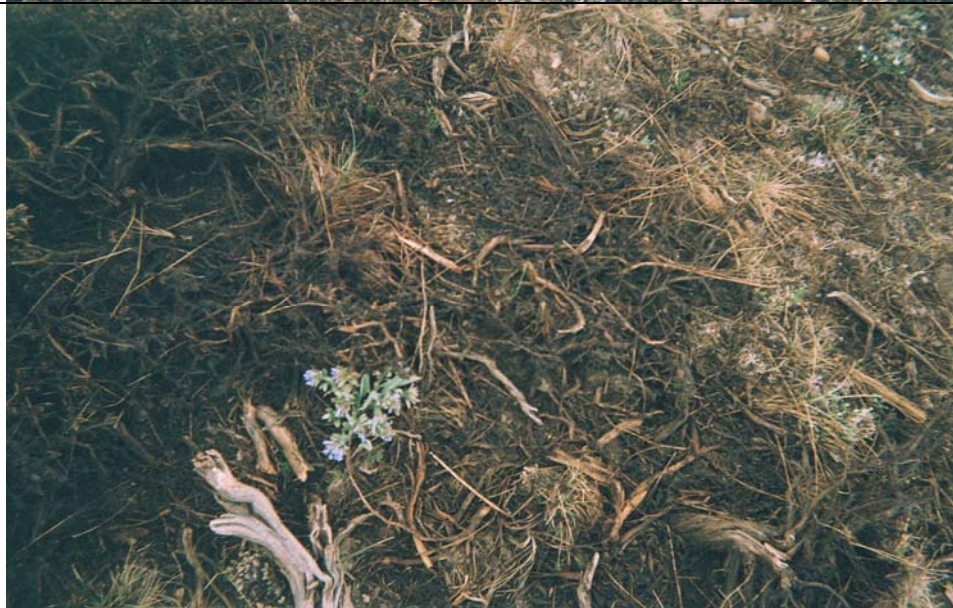
Subject: Flowering plants and grasses were observed coming up within the impact area. Photograph shows soil and vegetation staining.

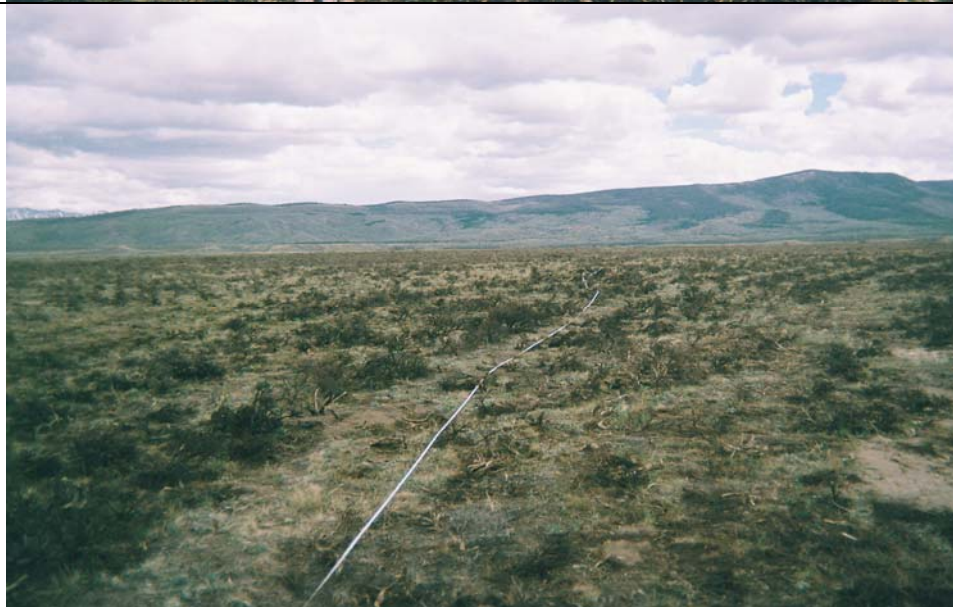
Subject: Photograph shows the approximate centerline of the release looking to the east of the Fuqua 18-15 well pad. The extent of primary impact and the soil sample locations were measured using fiberglass tape measures. The photograph was taken near the locations of SS7 (right – south ~25 feet) and SS8 (left – north ~15 feet) from the release centerline.

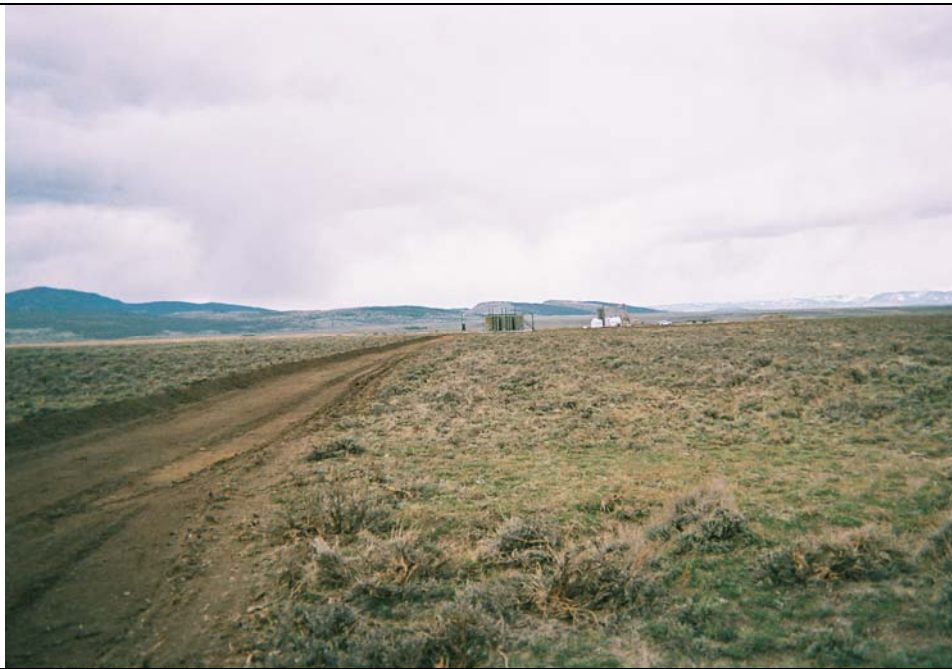
Subject: Photograph shows the Fuqua 18-15 well pad from the southeast corner of the fire break. The soils and vegetation were not observed to be impacted out this far; however, there were “fingers” and spots of staining that extended from the primary impact area that are included within the extent of the fire break.

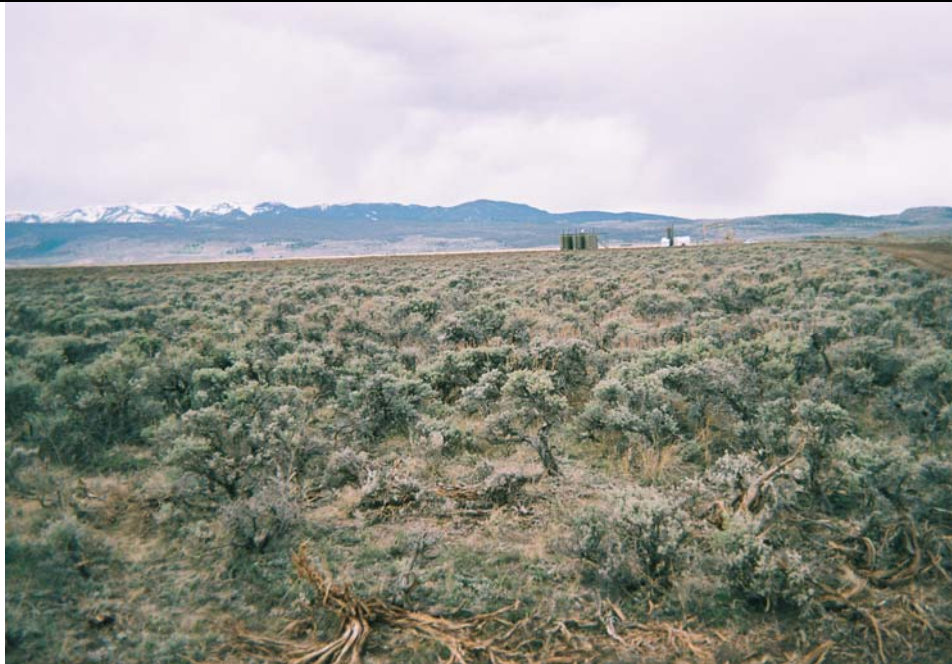
Subject: Photograph shows the area contained within the fire break from the northwest corner. The sagebrush, grasses, and soils in this area were not impacted.

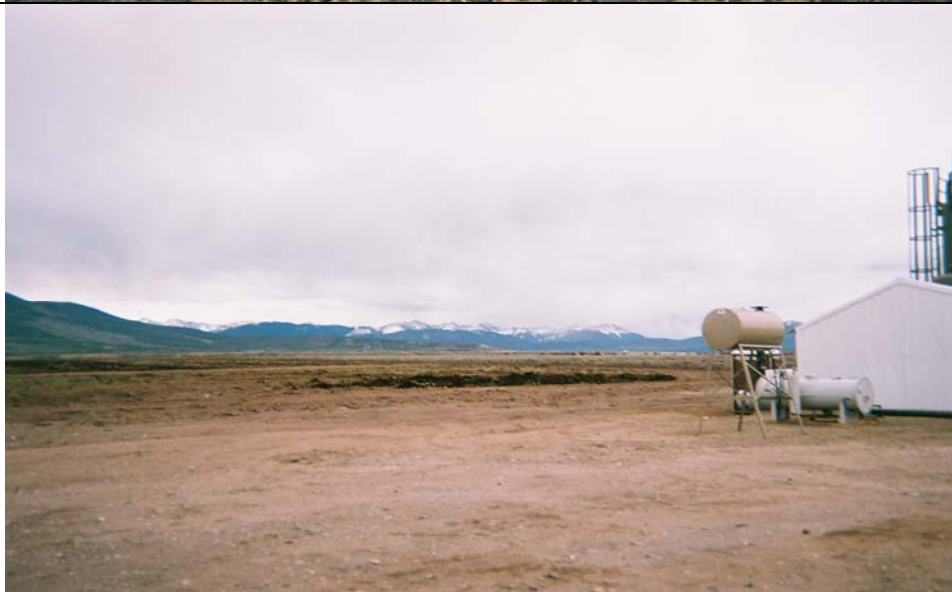
Subject: Photograph shows the stockpiled vegetation and stained soils and the vertical separator (right). Soil sample SS10 was collected from the stockpiled vegetation and soils located within an earthen containment berm.

The impacted vegetation in the stockpile will be broken up into smaller pieces by mechanical means, either using heavy equipment with track to spread out and drive over the pile or through use of chains. The impacted stock pile will be treated with the surfactant solution to break up the hydrocarbons. Once other areas have met the Table 910-1 standard of 500 mg/kg for both DRO and ORO the fire break will be reclaimed using the shredded stockpiled vegetation as mulch. The resulting mulch will need to meet Table 910-1 standards before being used to restore the fire break. The fire break area will be covered with soil and will be re-seeded with a suitable dry land pasture grass seed mix as recommended by the local USDA Natural Resources Conservation Service office and approval of the Fuqua Ranch.
