iCem[®] Service

SYNERGY RESOURCES CORPORATION

SRC Vista 43-2N-A

Surface

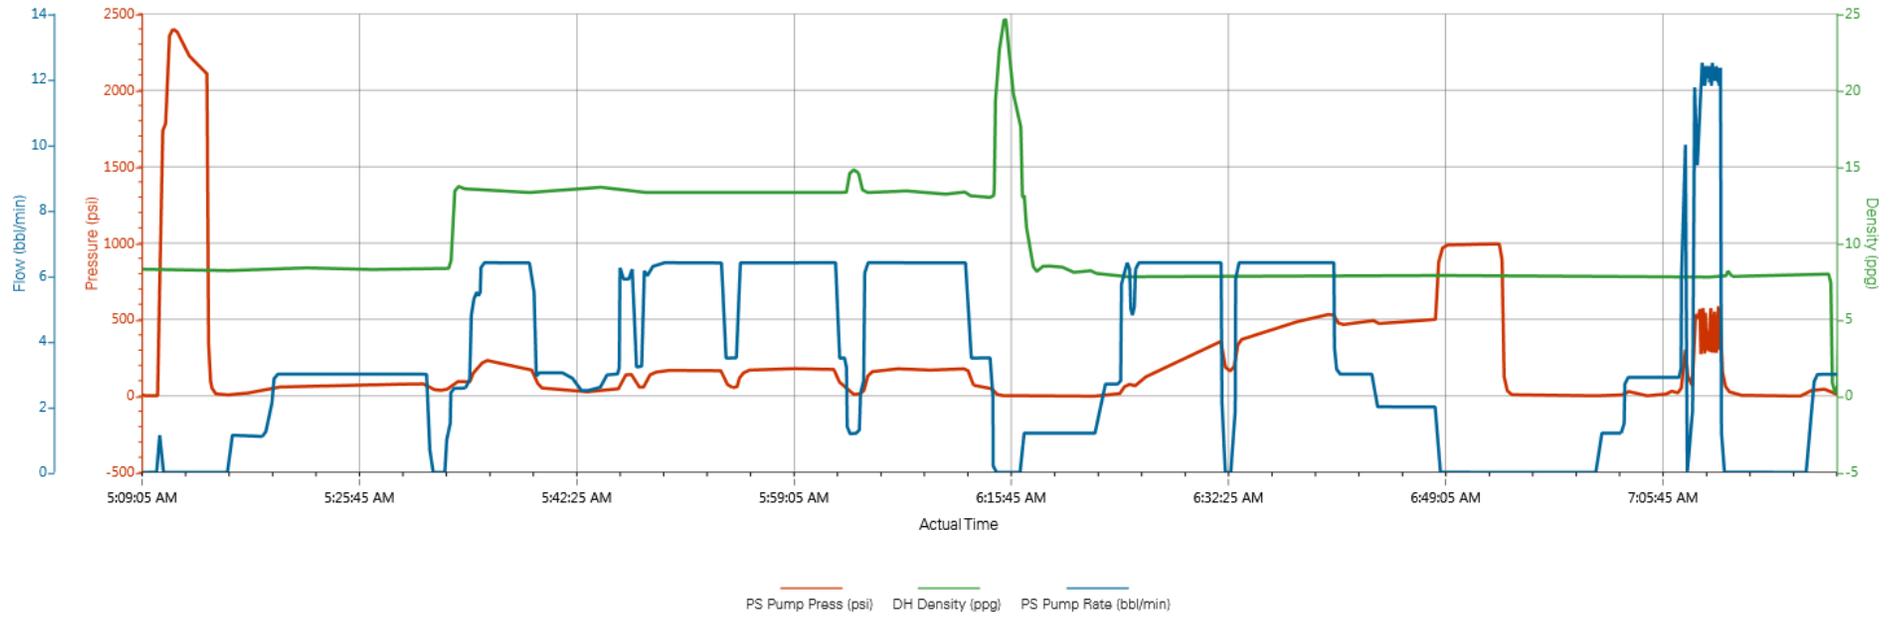
3.1 Case 1-Custom Results.png

Synergy - SRC Vista 43-2N-A - 9 5/8" Surface Casing
