Hiawatha Field Area General Information

Lion Government 22-26 & 31-26D

Lion Government Well #22-26 of Whiting O & G
COD053178, SENW Sec. 26, T12N, R101W
03/25/08

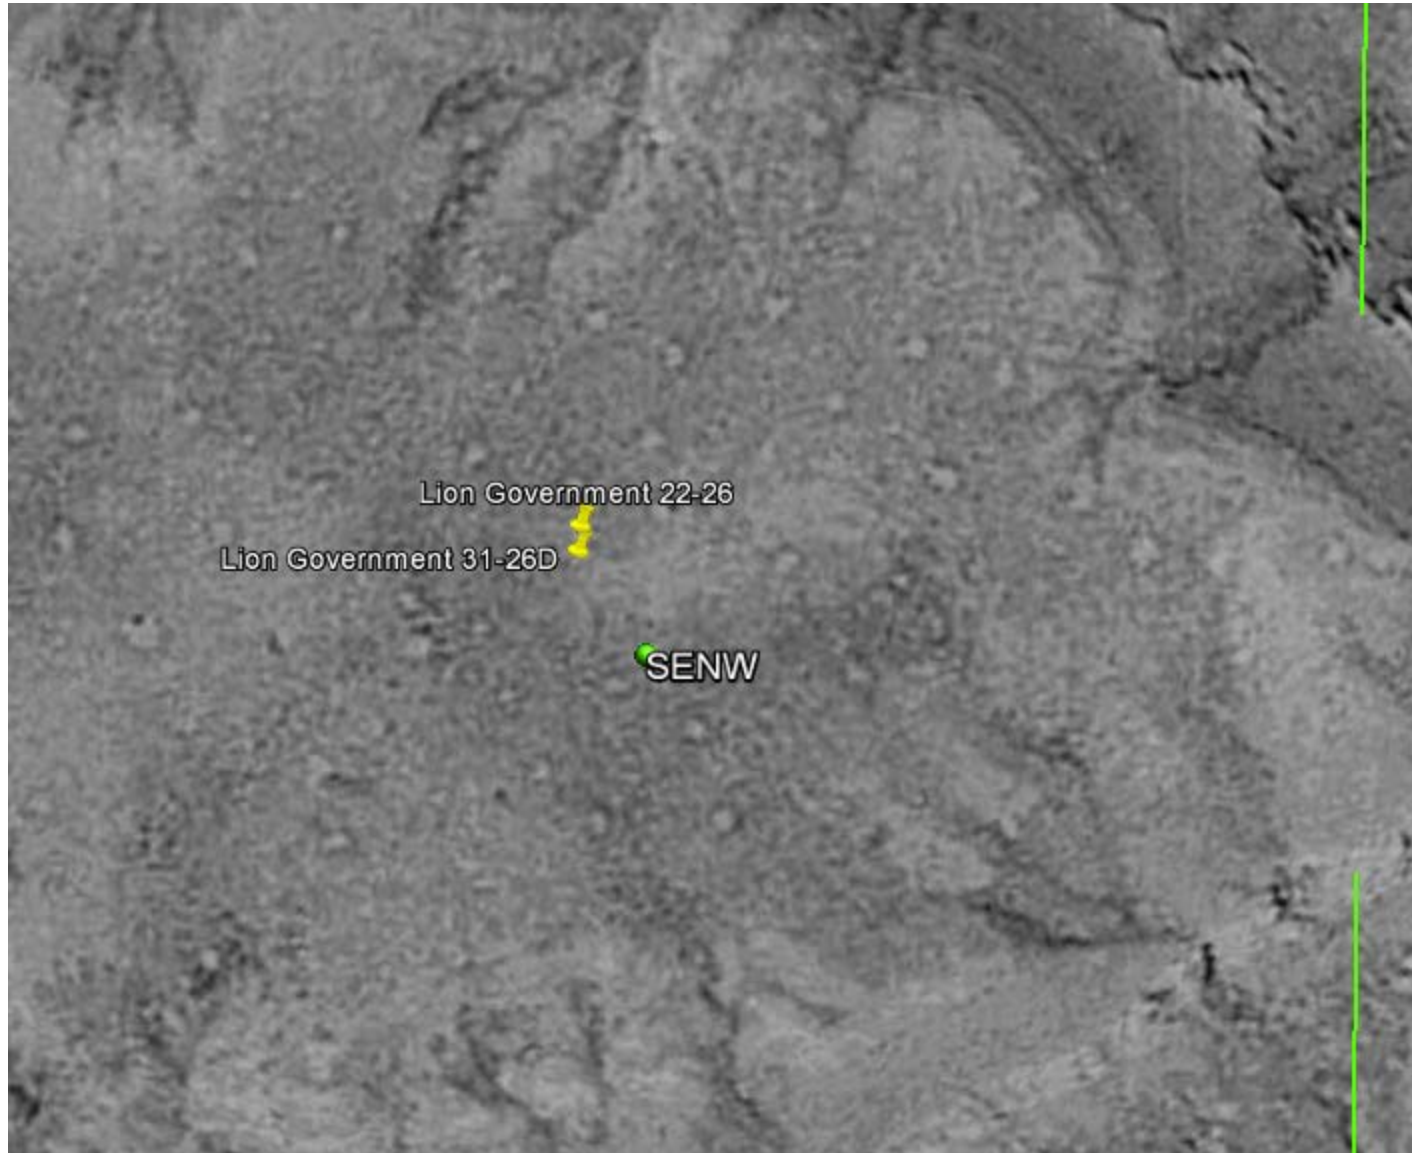
Future Lion Government 22-26 and 31-26D Site – 9-2006

- Google imagery from 9-2006 (actually probably very early October 06) after both wells were drilled shows only one reserve pit on the site. It looks like they used a single reserve pit, probably the 22-26 pit, Pit Permit No. 274513, to hold the cuttings from both wells. Therefore Pit Permit No. 283441 and Pit Permit No. 274513 represent a single constructed pit that served two wells Lion Government 22-26, API 05-081-07210 and Lion Government 31-26D, API 05-081-07266.

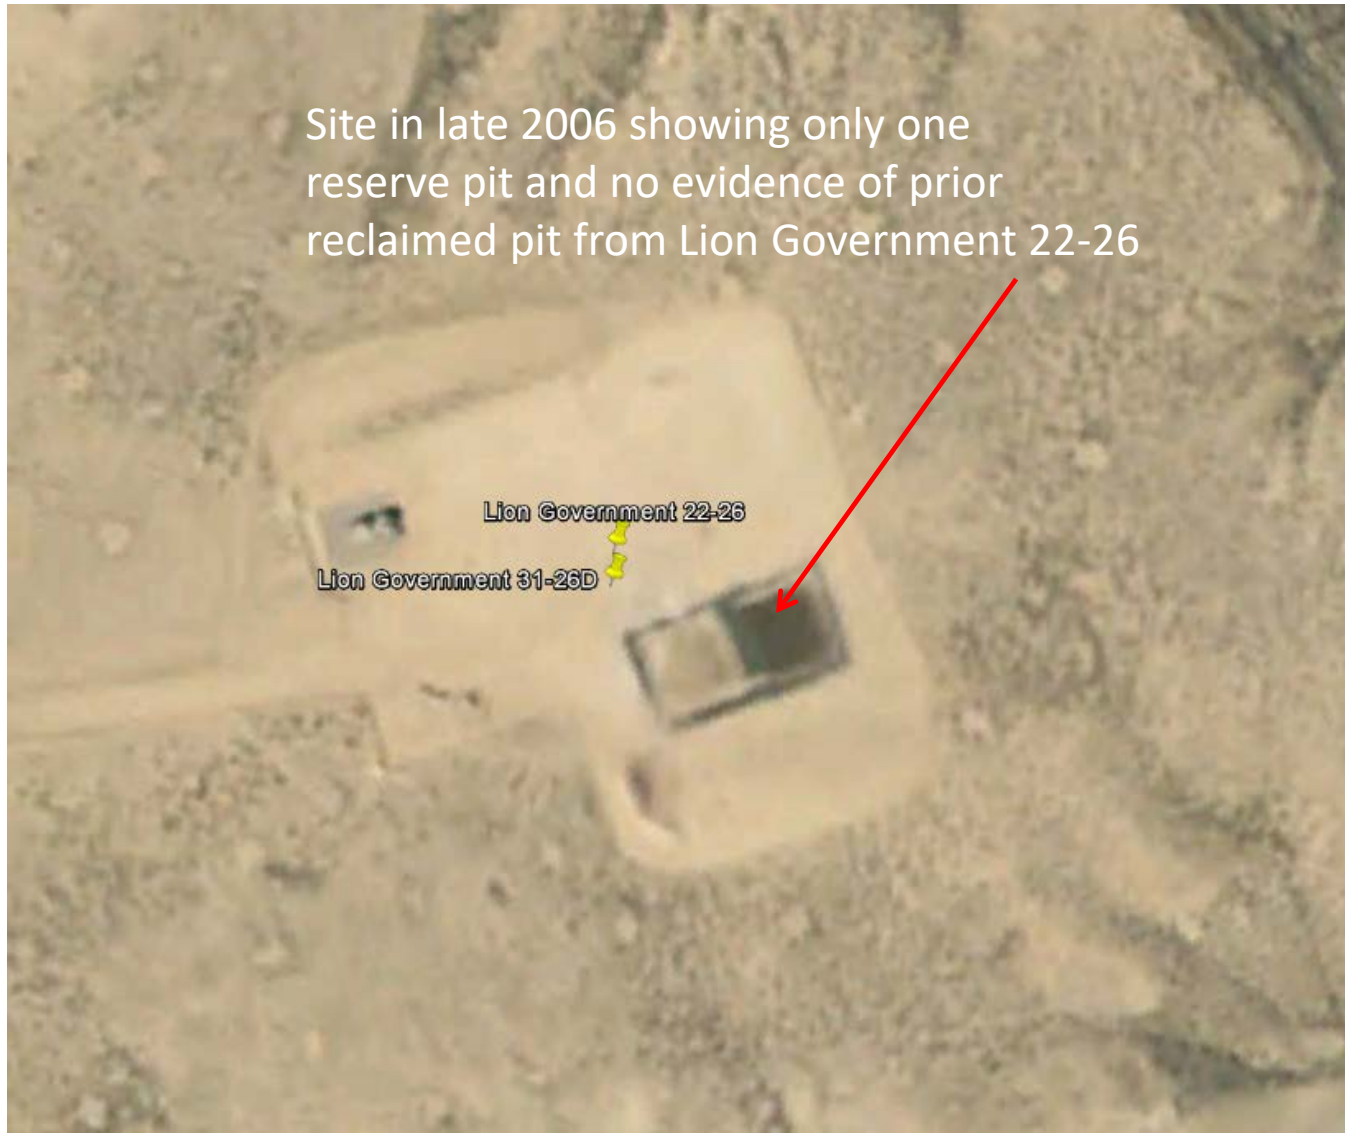
Lion Government 22-26 & 31-26D – Labeled 9-2006

Probably early October 06 – No Rig In Evidence

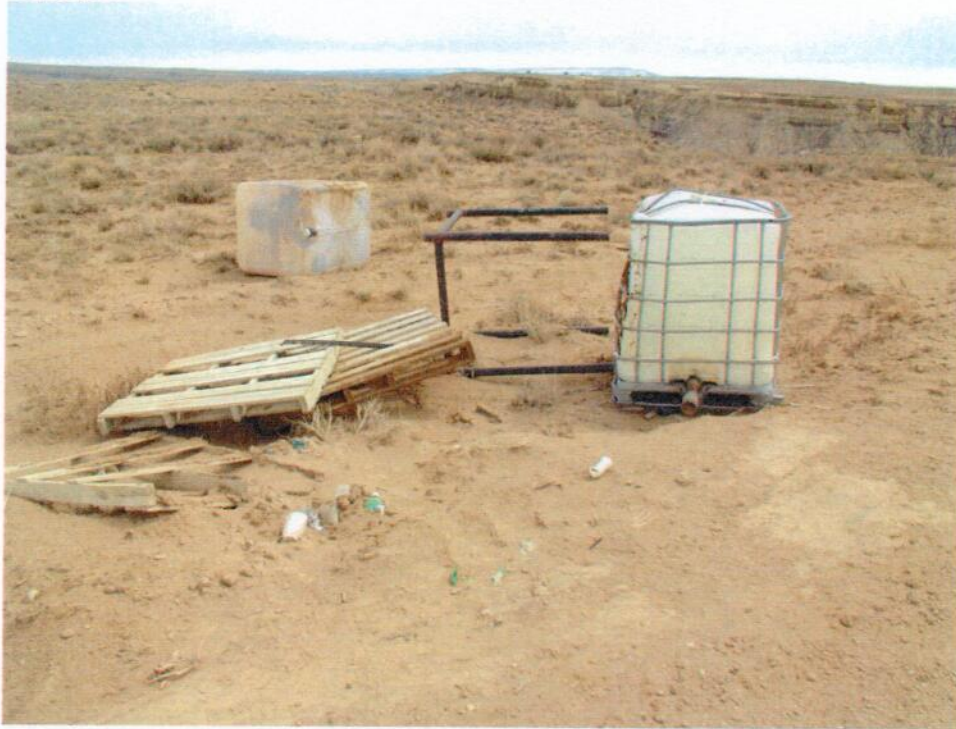
Some tanks and trash were left on the site after interim reclamation. Also, soil sample bags were left near tank berm. Called and left message w/ Mike Staab of Whiting requesting the site be cleaned up.

Trash needs to be removed.

PET called Mike Staab 4/4/08. He reconfirmed cleanup will be done by field pumpers Keith/Paukey by 4/7/08

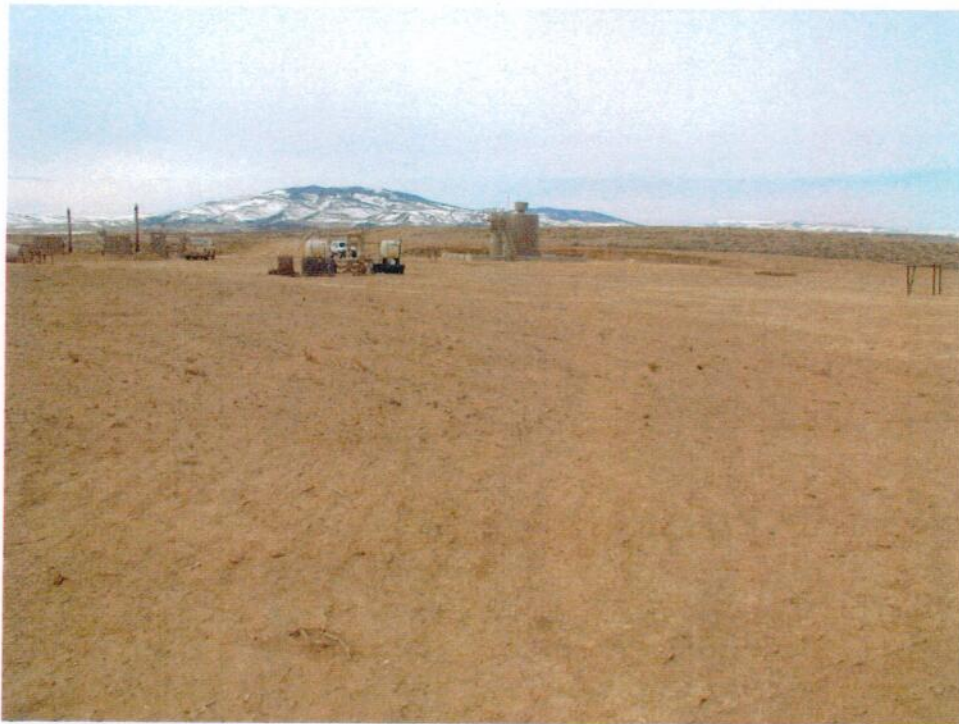
Recontouring looks good.

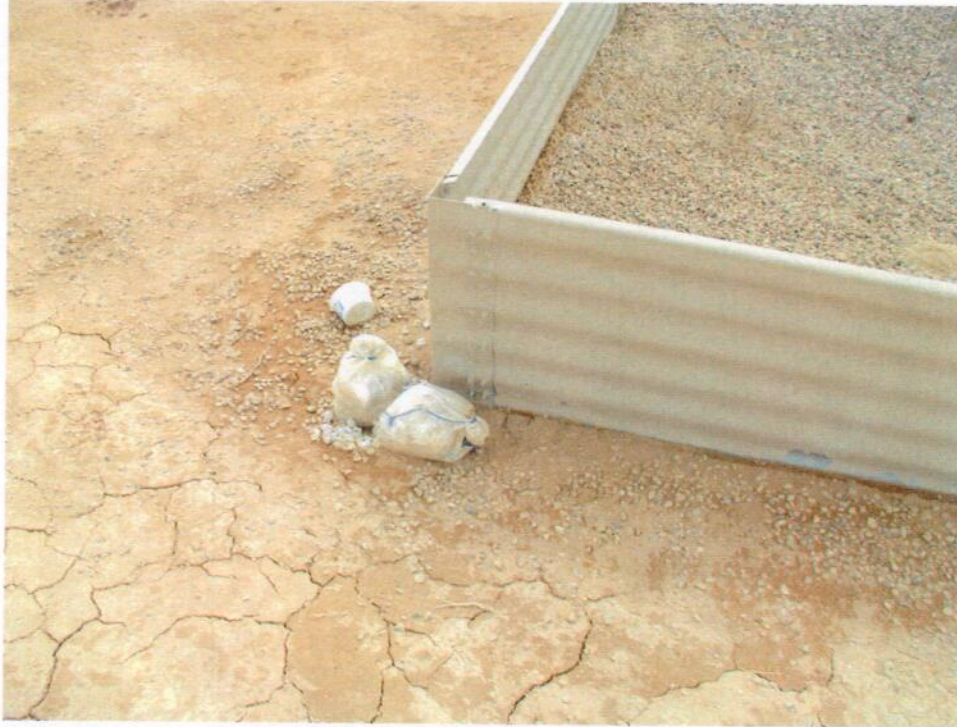
Lion Government Well #22-26 of Whiting O & G
COD053178, SENW Sec. 26, T12N, R101W
03/25/08

Soil sample bags were left near containment berm.

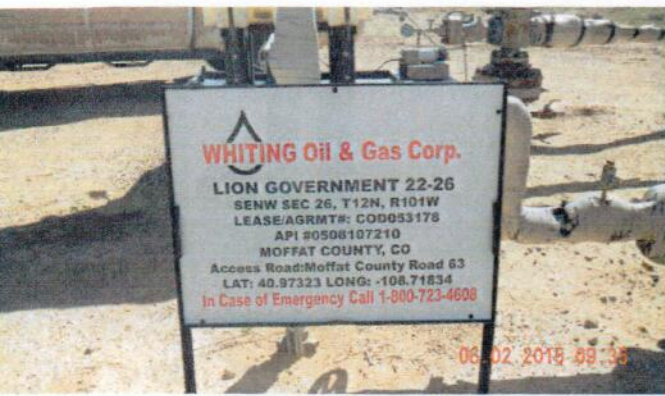
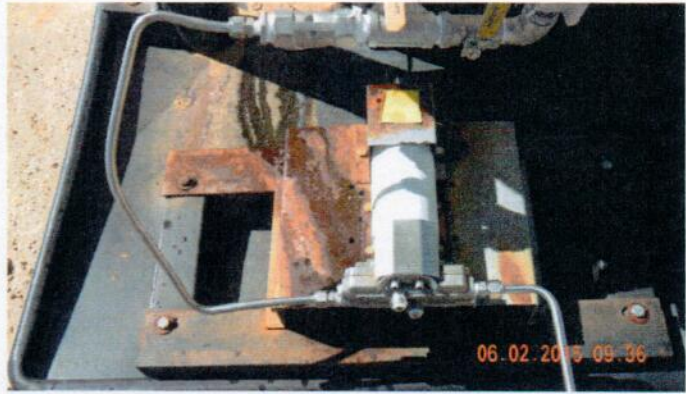
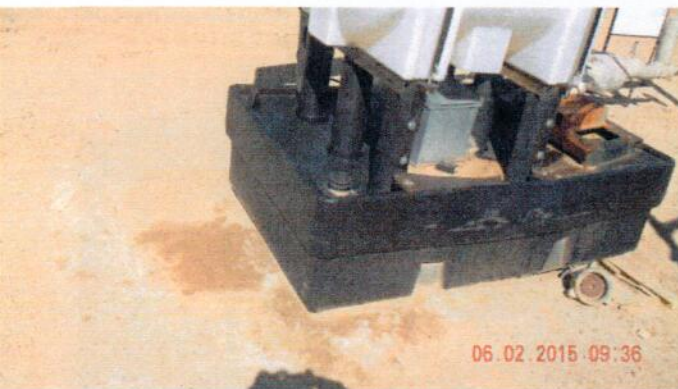
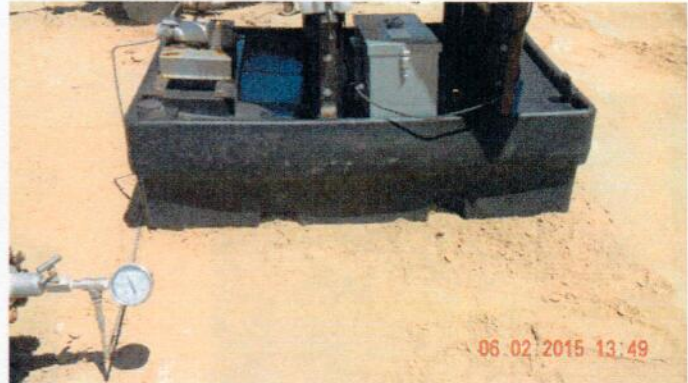
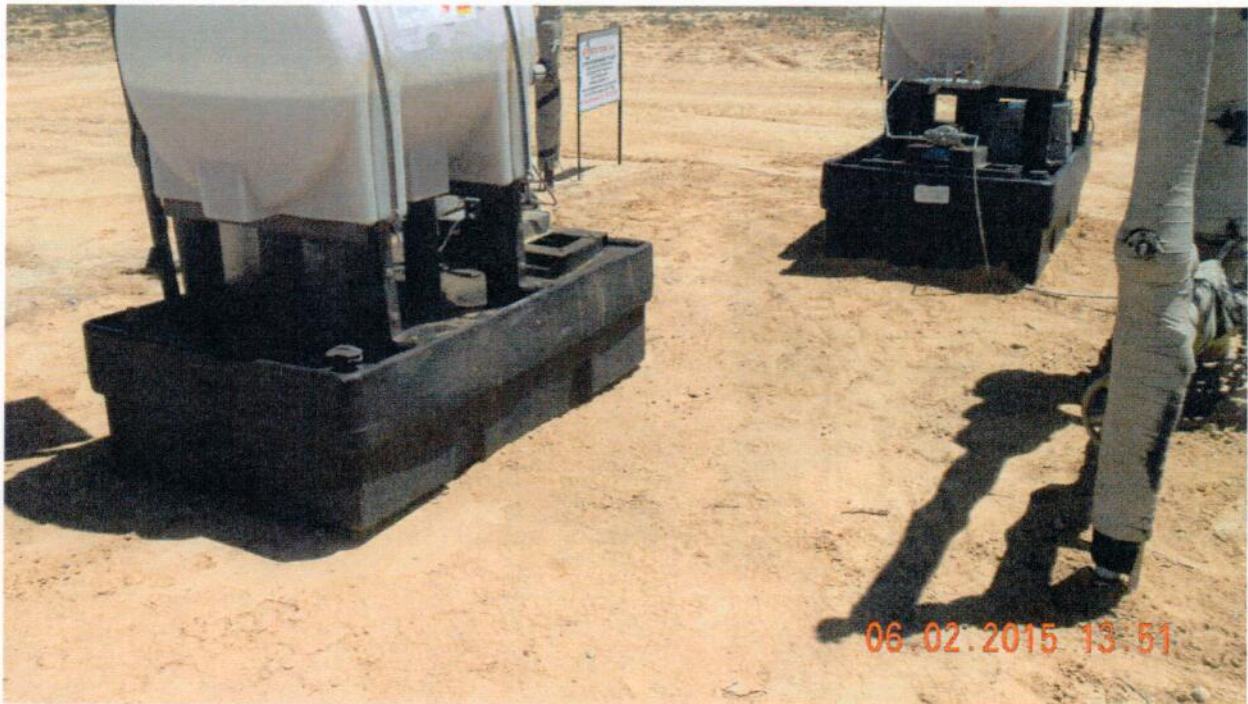
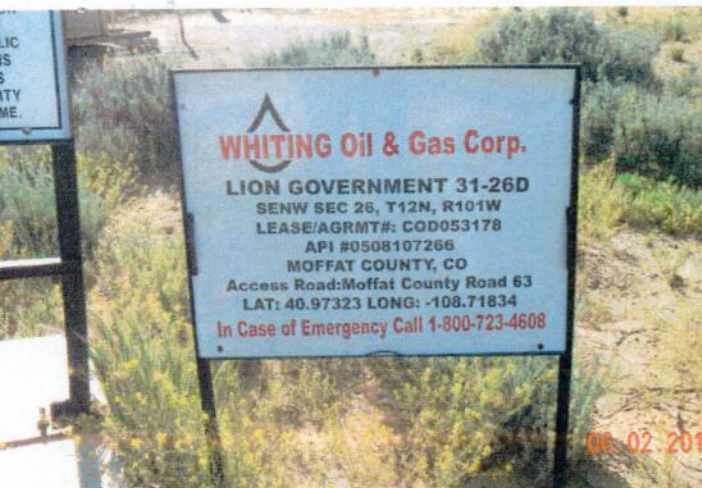
Photo documentation from Whiting that inspection concerns were fixed.

Received photo documentation from Whiting that inspection concerns were fixed - chem tanks have been replaced, and netting tightened down.
