Final Reclamation & Stormwater Inspection

12/13/2016

Operator: Oilfield Salvage & Service #65550

Location ID: 311709

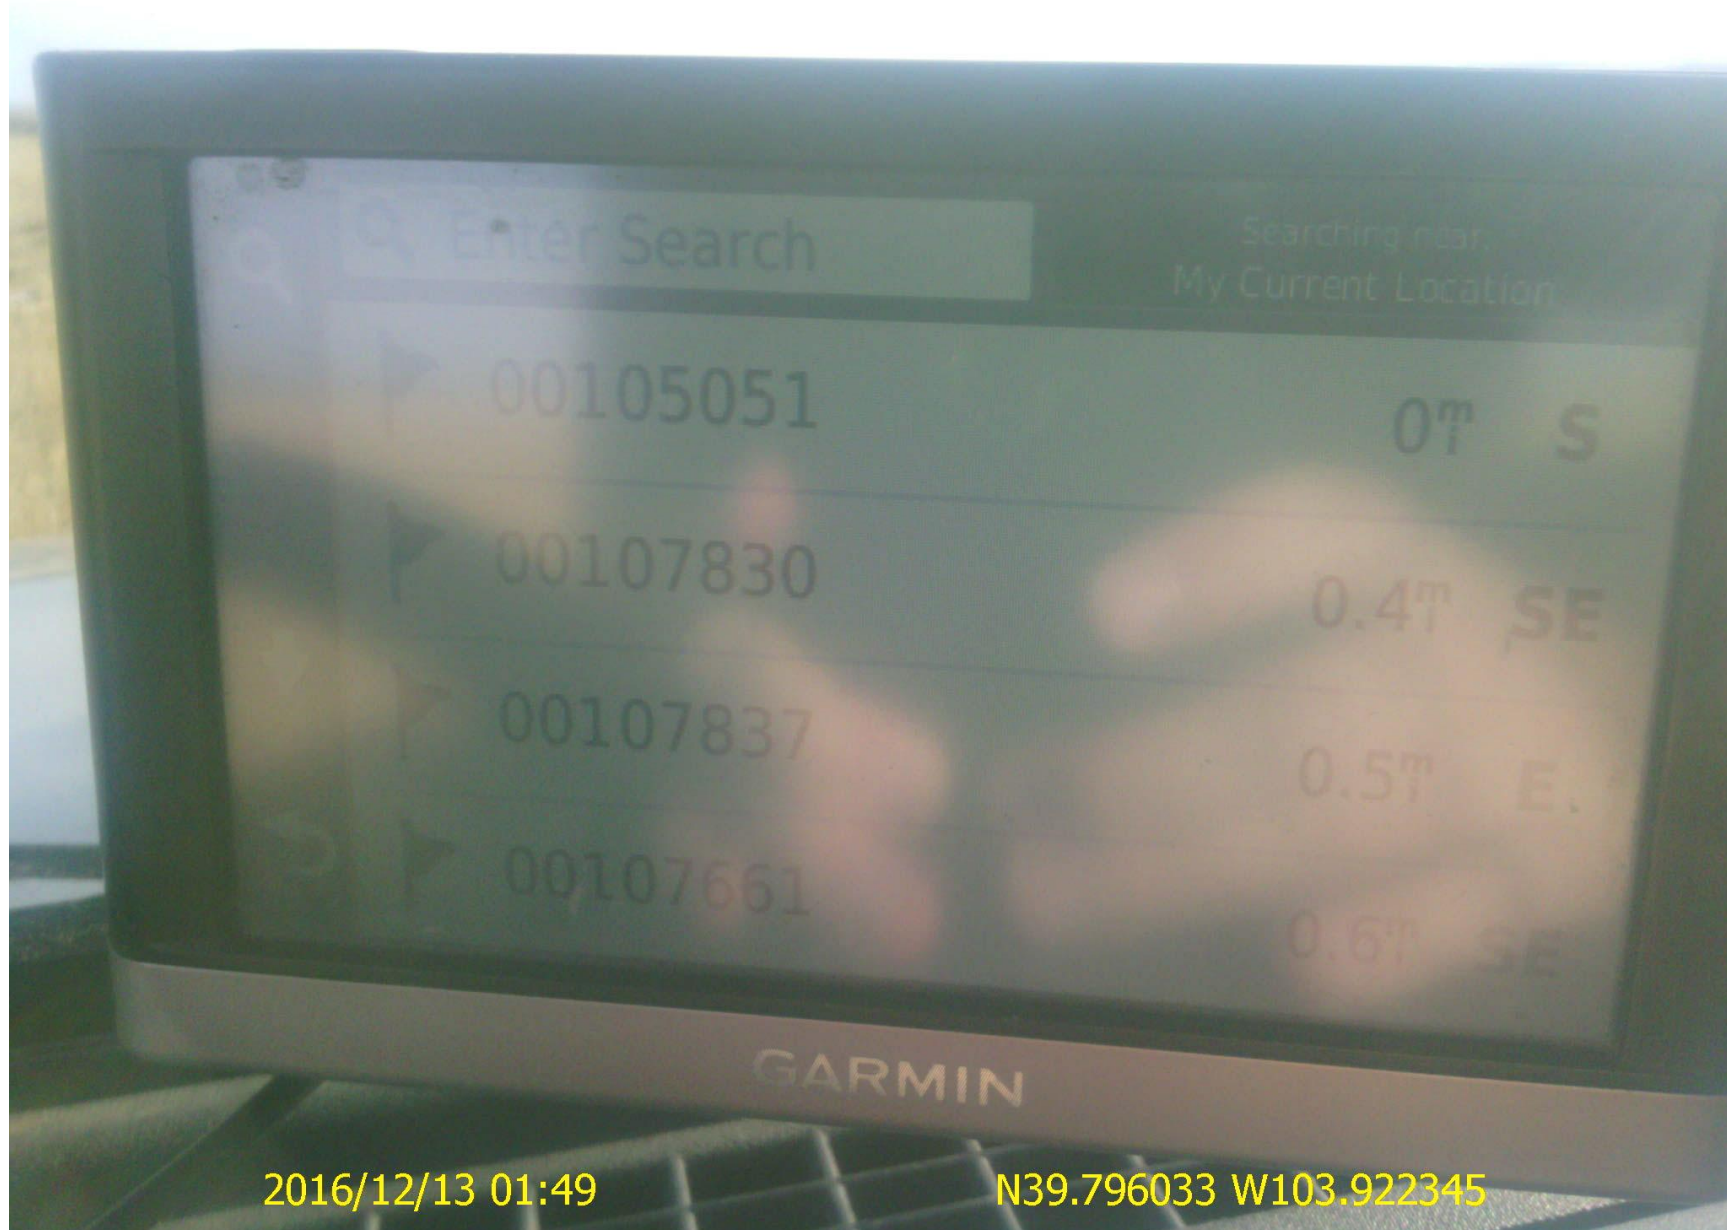
Figure 1: Photo of GPS confirming location. See photos from inspection Doc. #682501125 for additional information and details

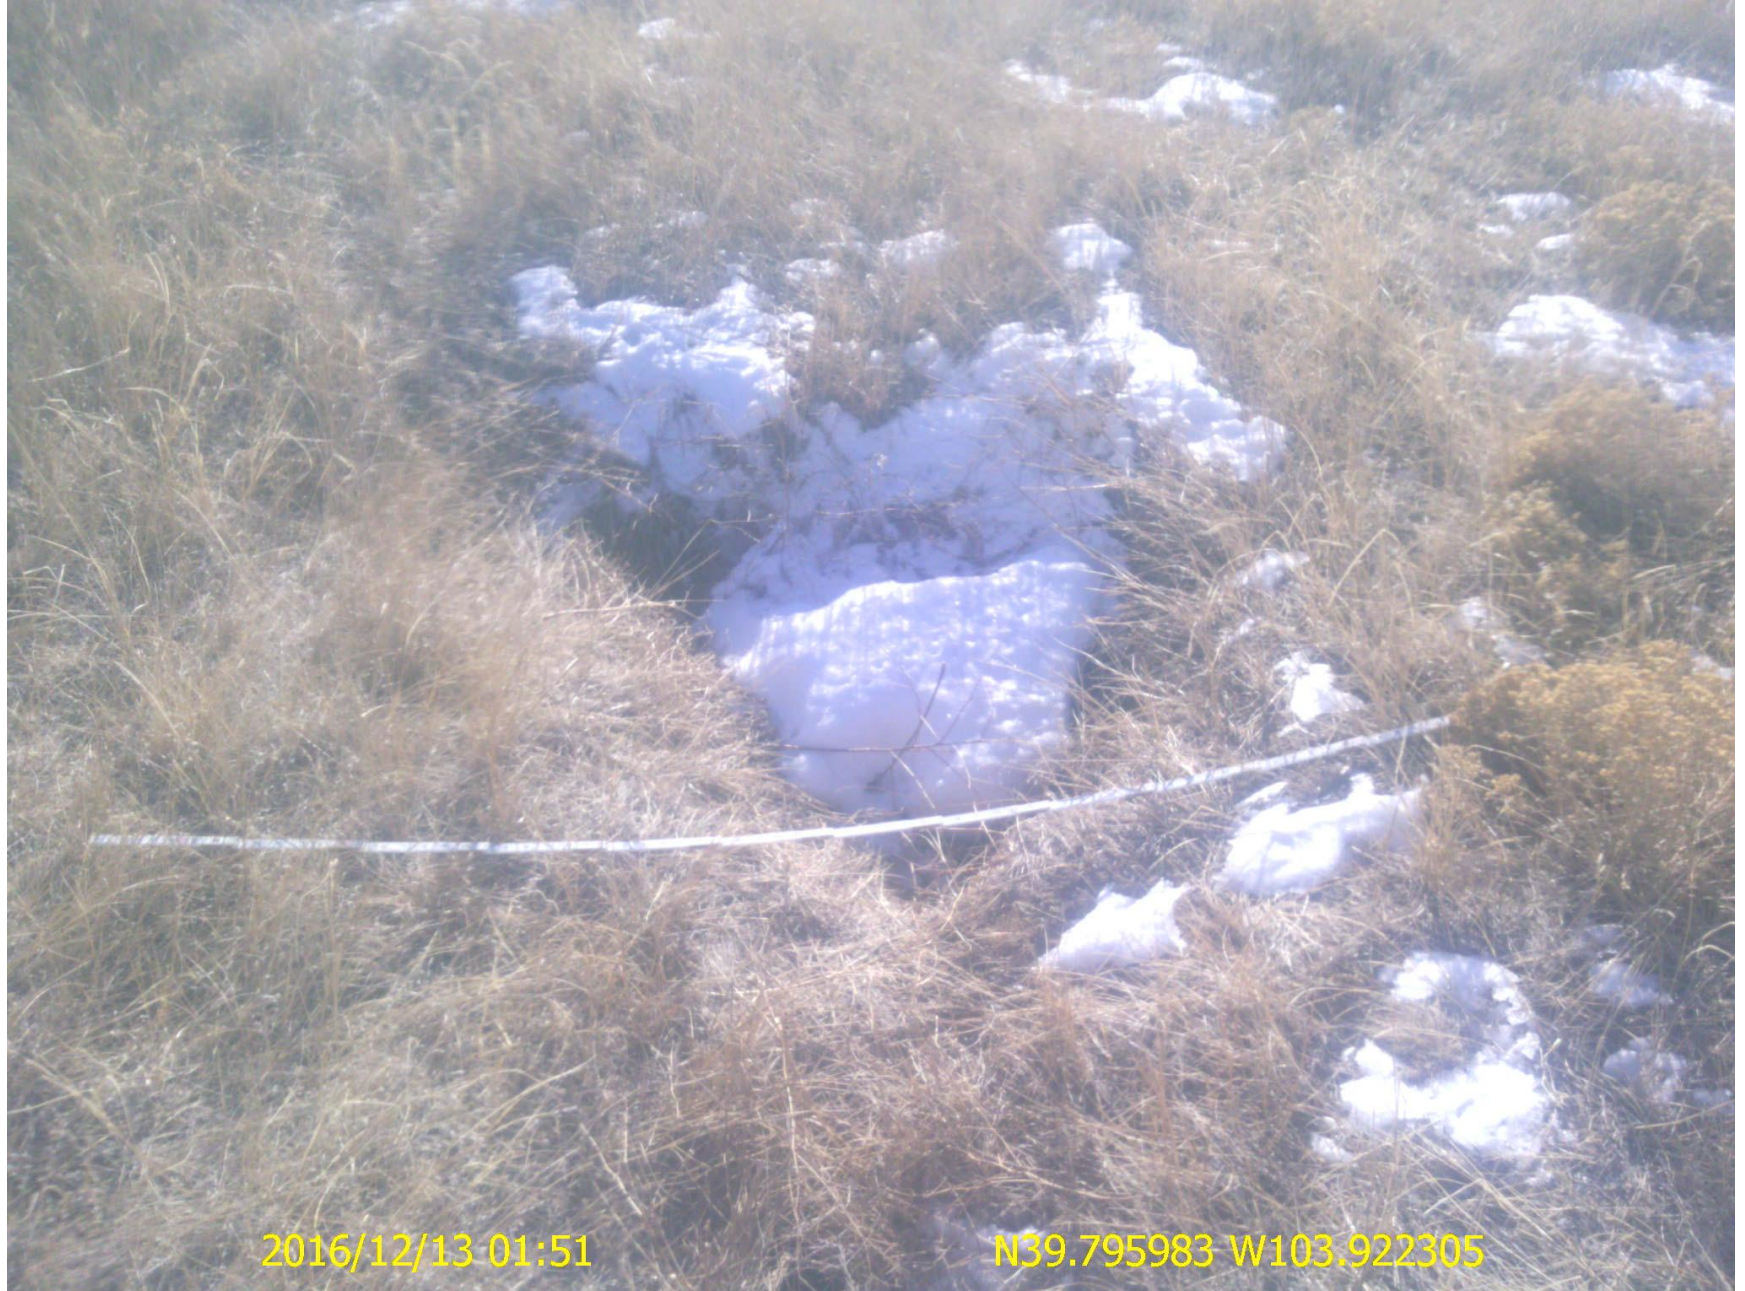
Figure 2: Photo of hole found on location. 6' measuring stick for reference. Hole is approximately 2 feet deep. See photos from inspection Doc. #682501125 for additional information and details

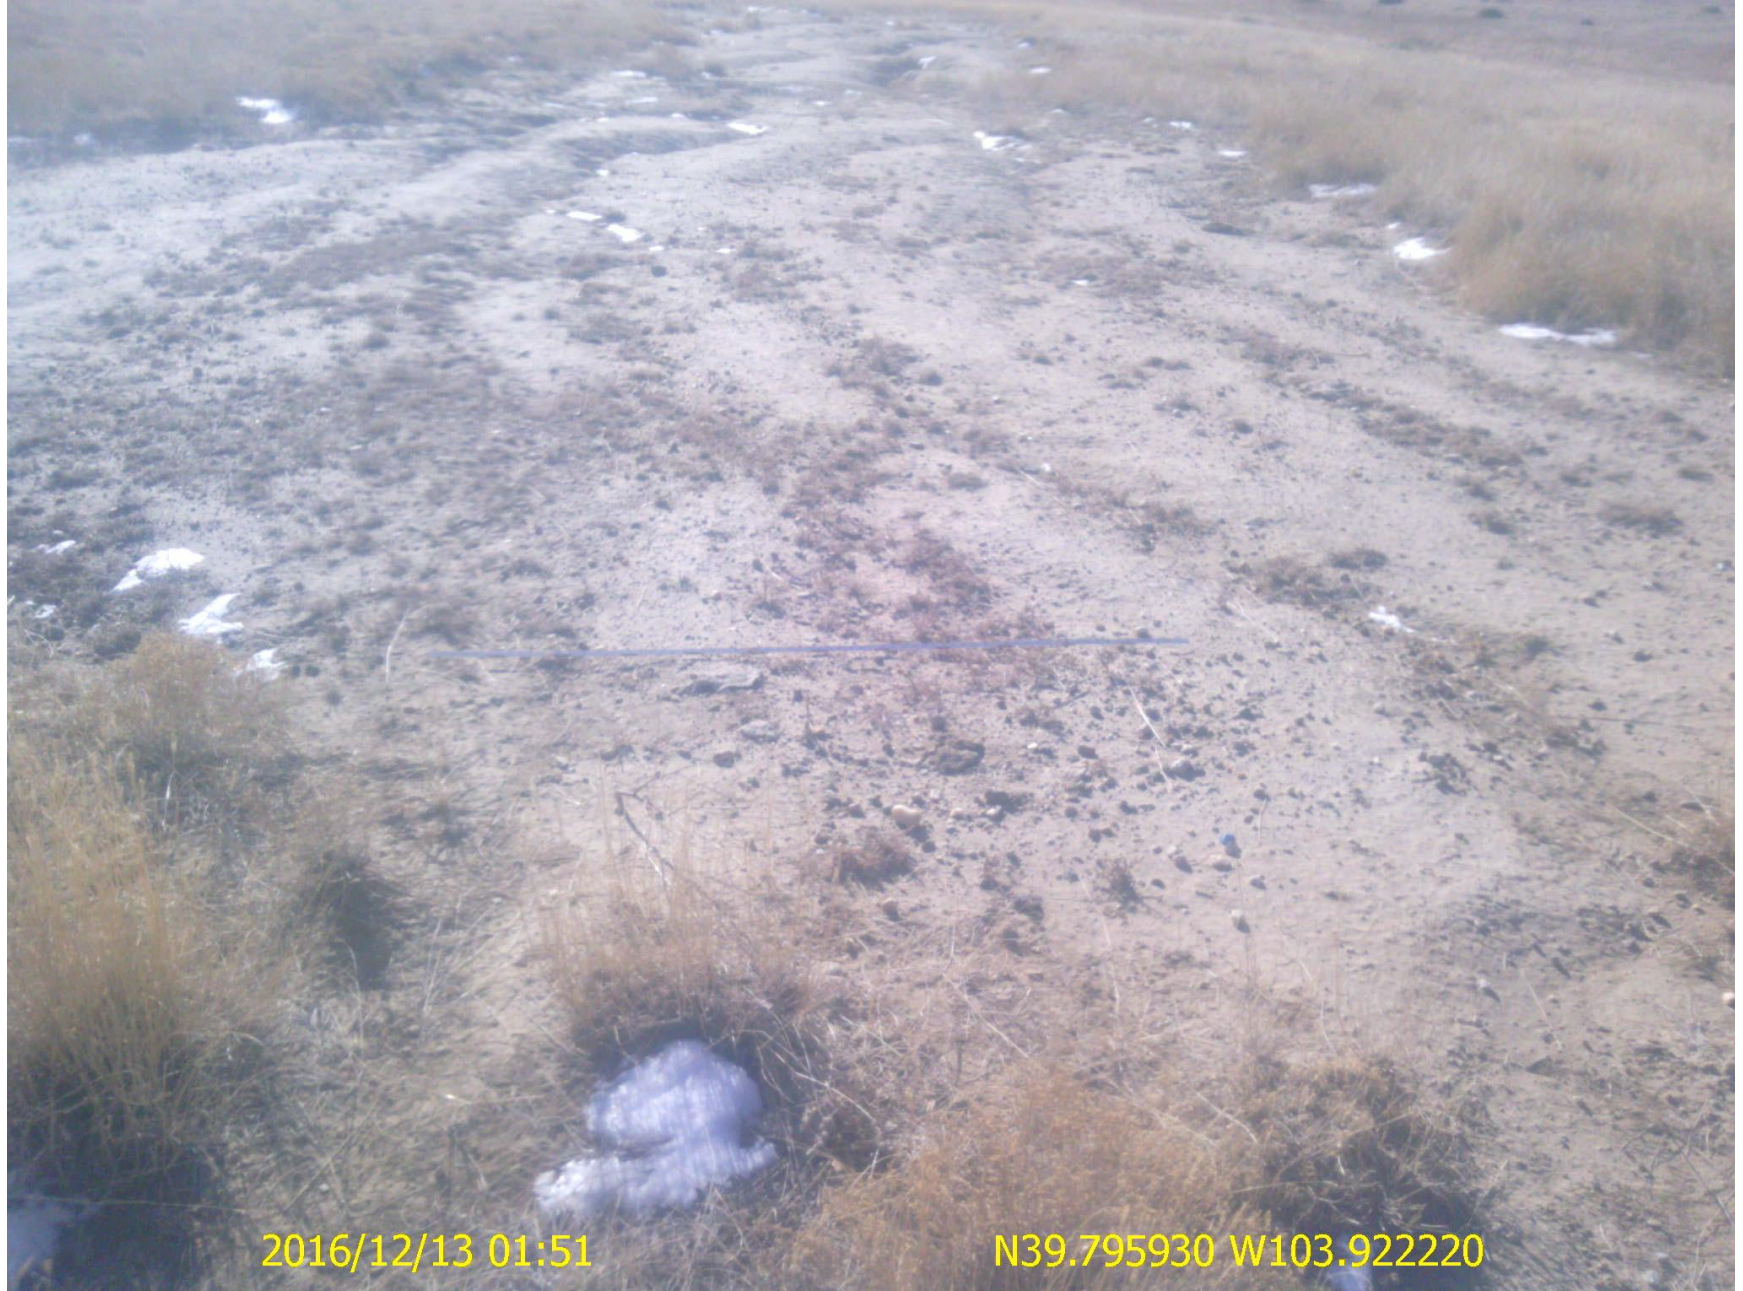
Figure 3: Photo taken from the south end of the location, facing south. Photo shows large un-vegetated area experiencing erosion. Photo shows stormwater and sediment control BMPs have not been installed. See photos from inspection Doc. #682501125 for additional information and details
