Reclamation and Stormwater Inspection

01/18/2017

Operator: Bonanza Creek #8960

Location ID: 427785

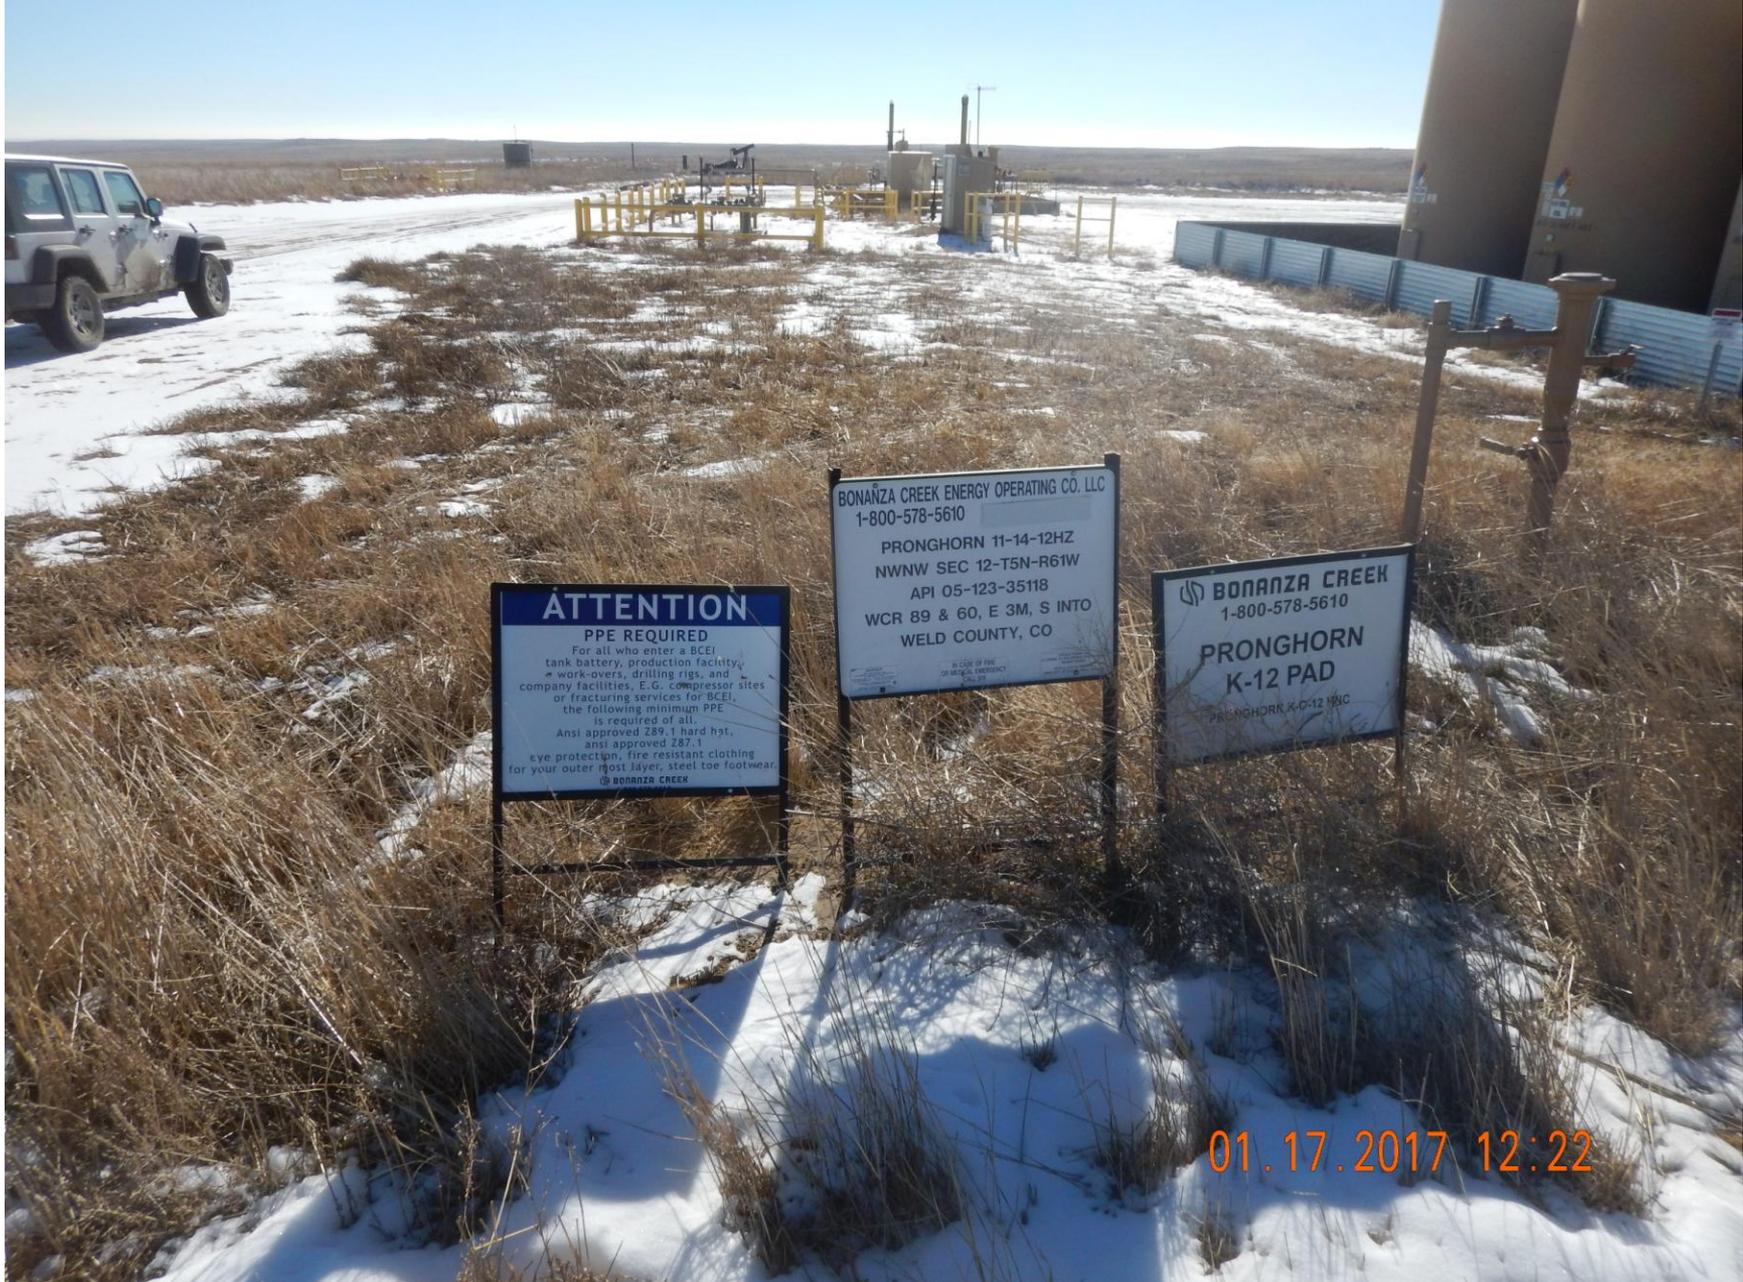
Figure 1: Photo taken from the northeast corner of the location. Photo shows signs at location entrance.

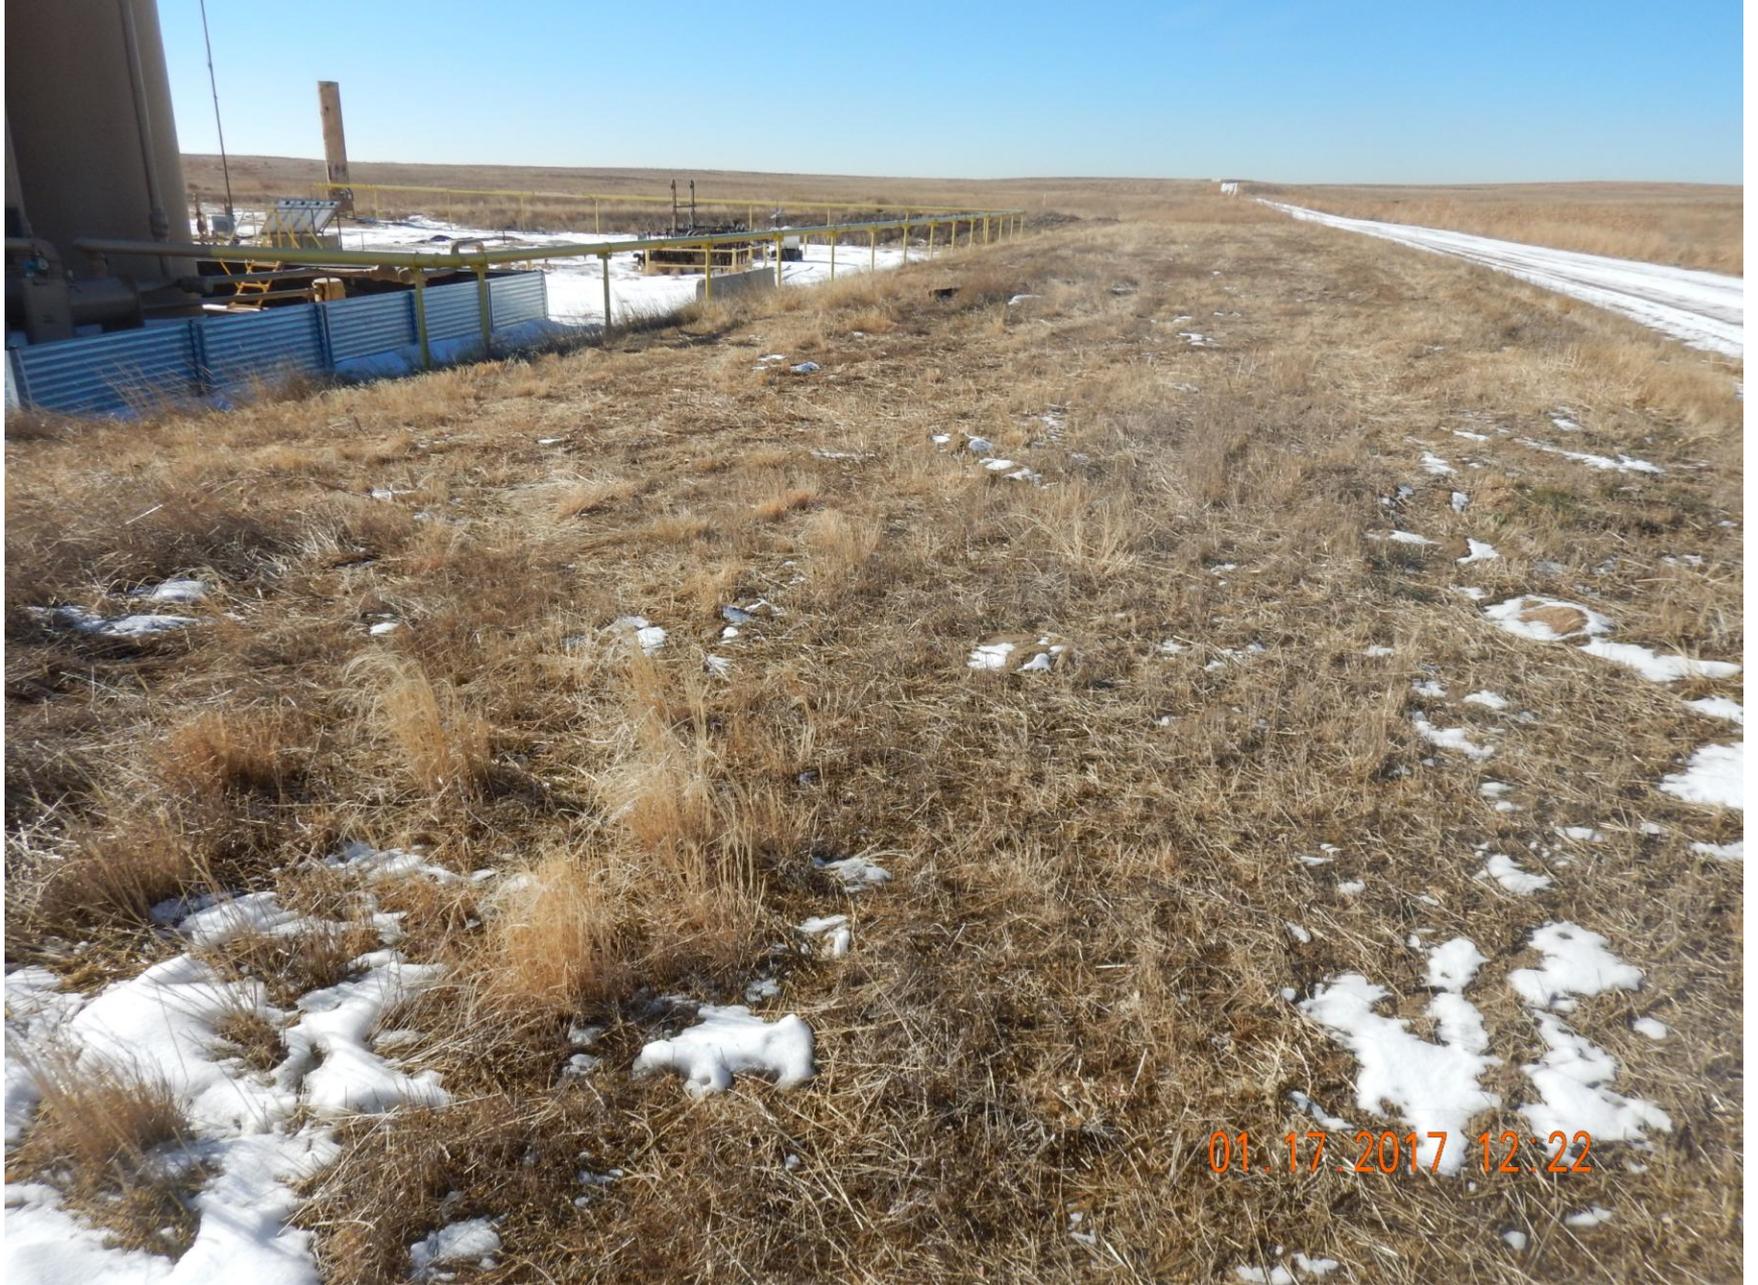
Figure 2: Photo taken from the northeast end of the location, facing west. Photo shows vegetation over the interim area.

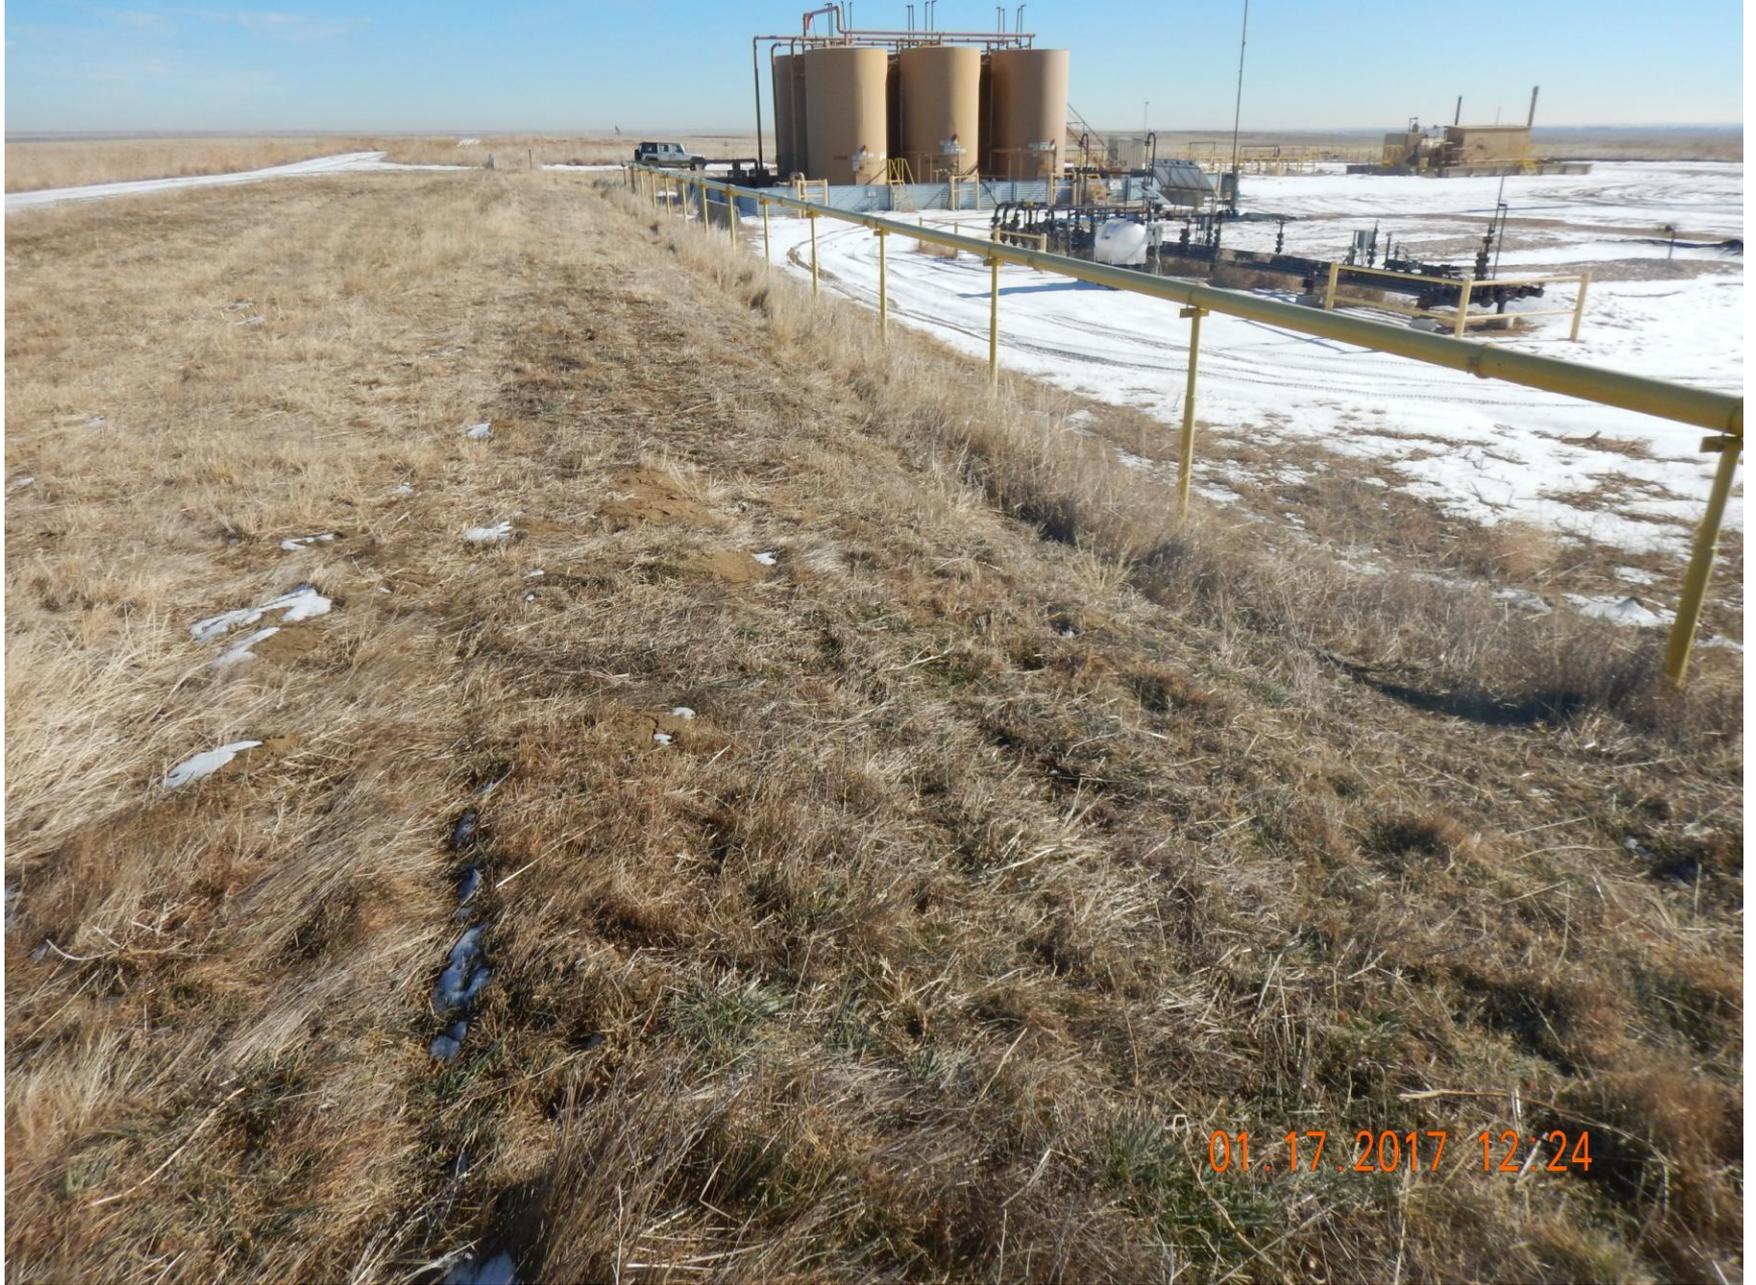
Figure 3: Photo taken from the northwest end of the location, facing east. Photo shows vegetation over the interim area.

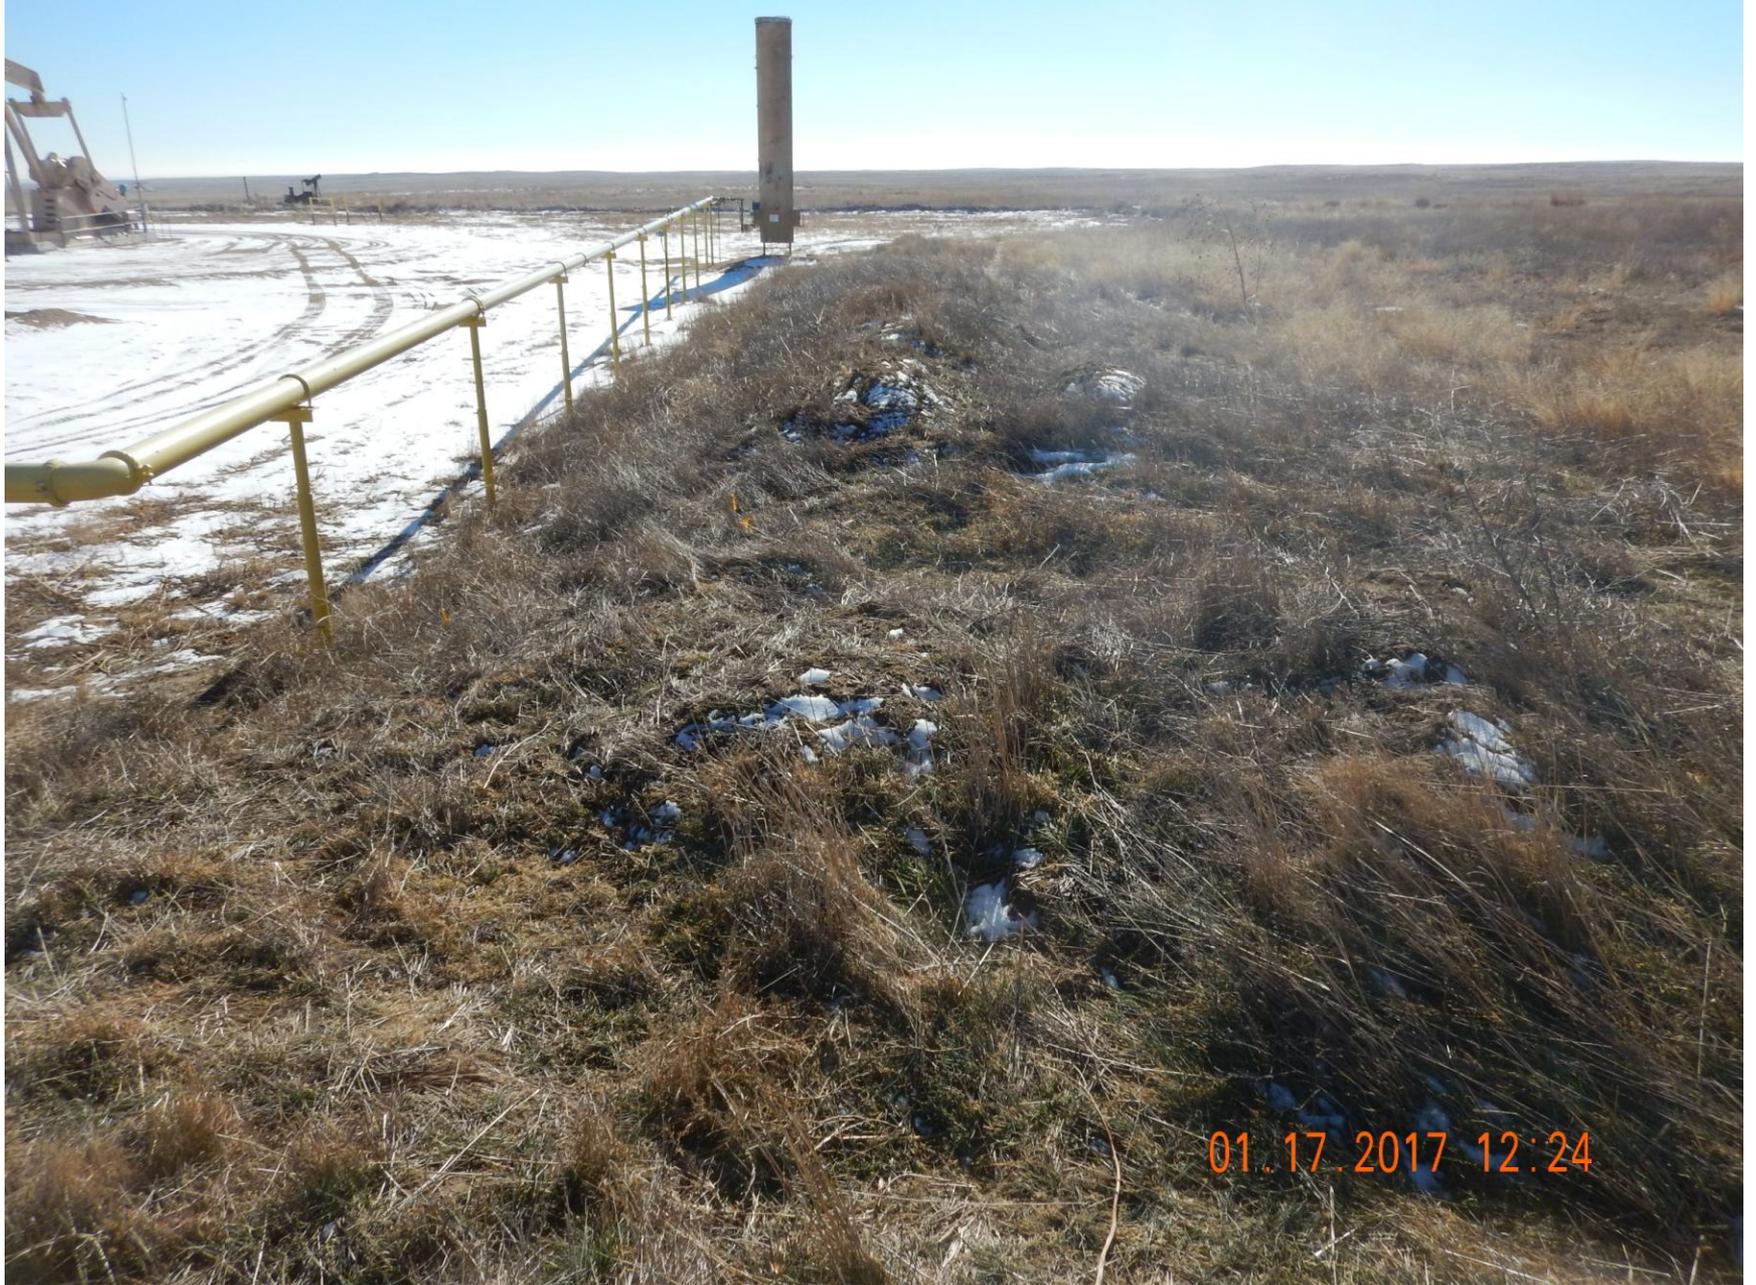
Figure 4: Photo taken from the northwest end of the location, facing south. Photo shows vegetation over the interim area. Note vegetation seen in photo is predominantly cheat grass, or annual triticum species (does not contribute to the %80 desirable cover).

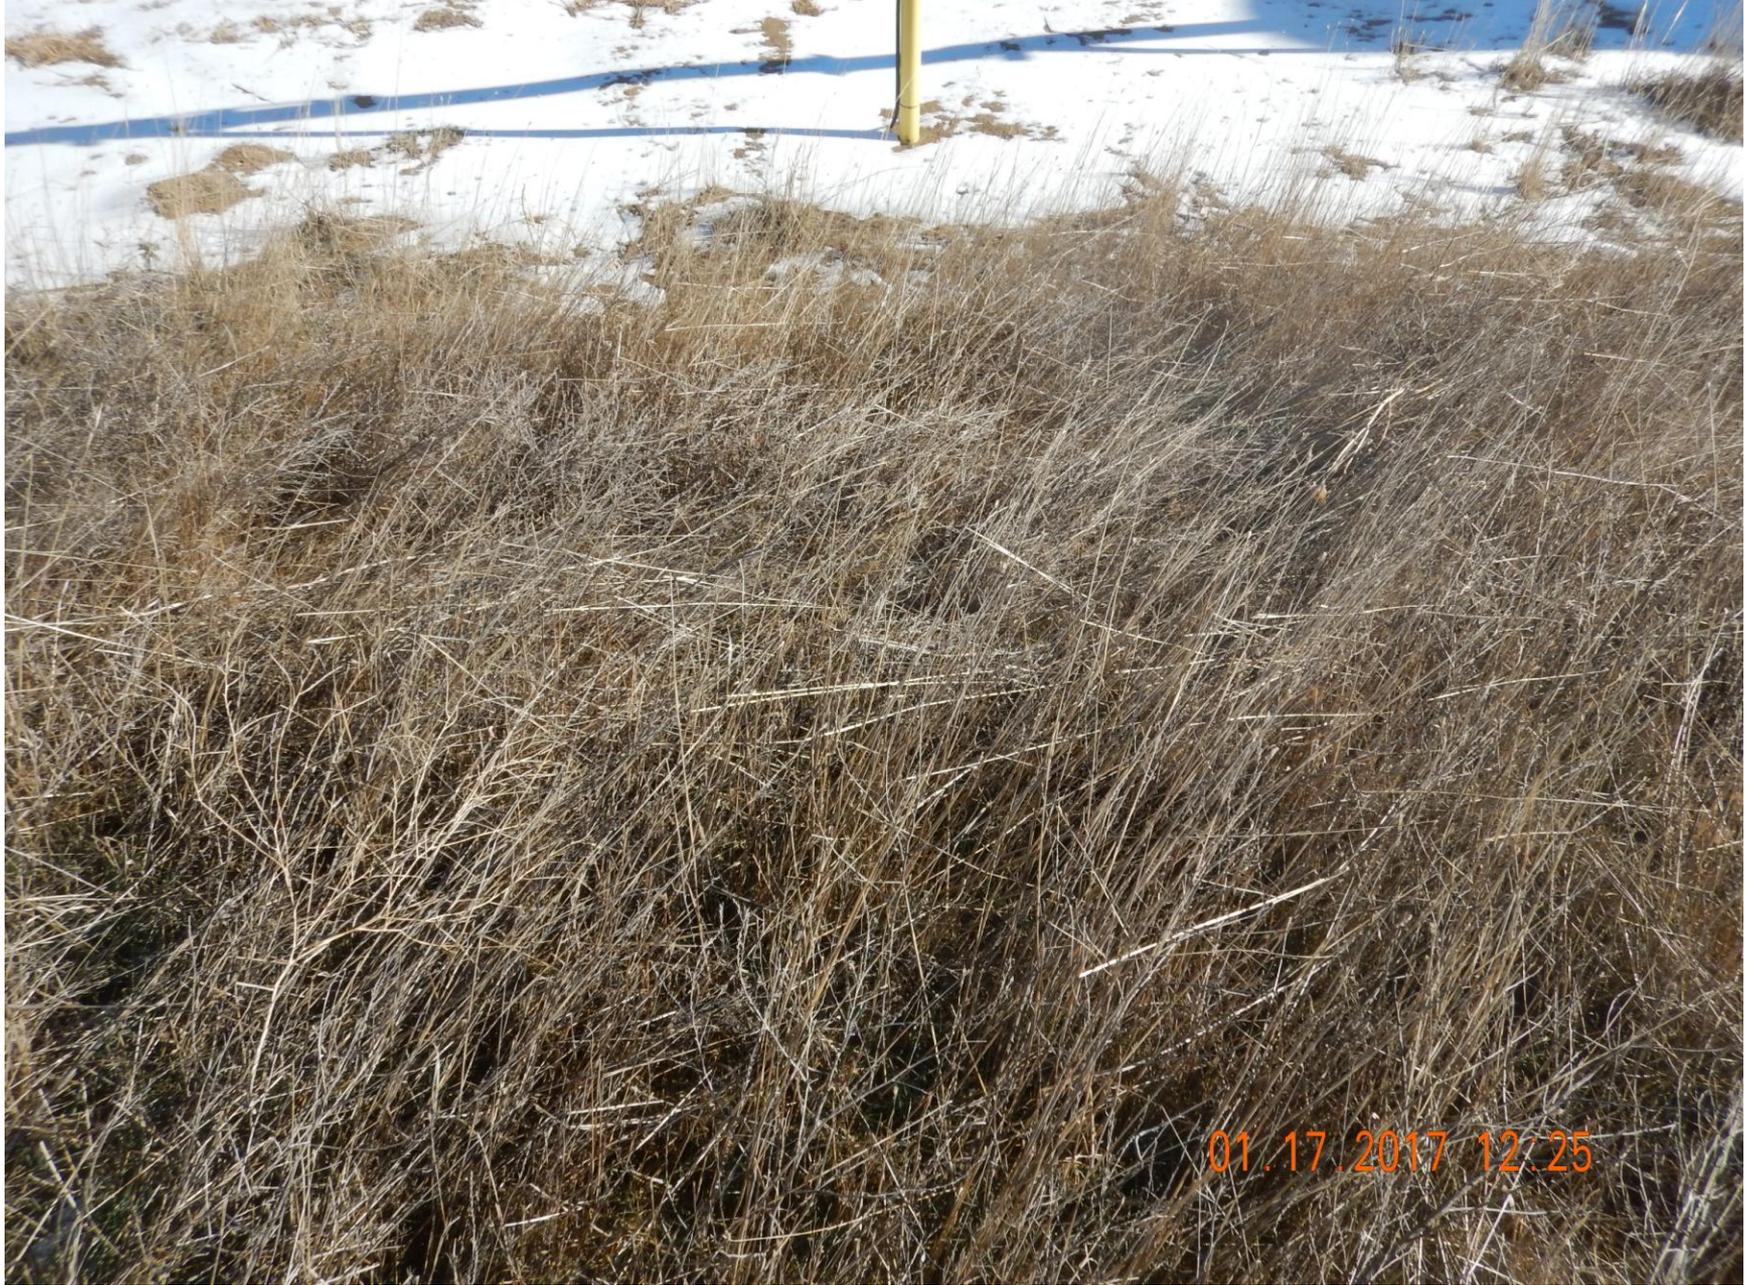
Figure 5: Photo taken from the berm on the west end of the location. Vegetation seen in photo is predominantly an annual triticum species (does not contribute to the %80 desirable cover).

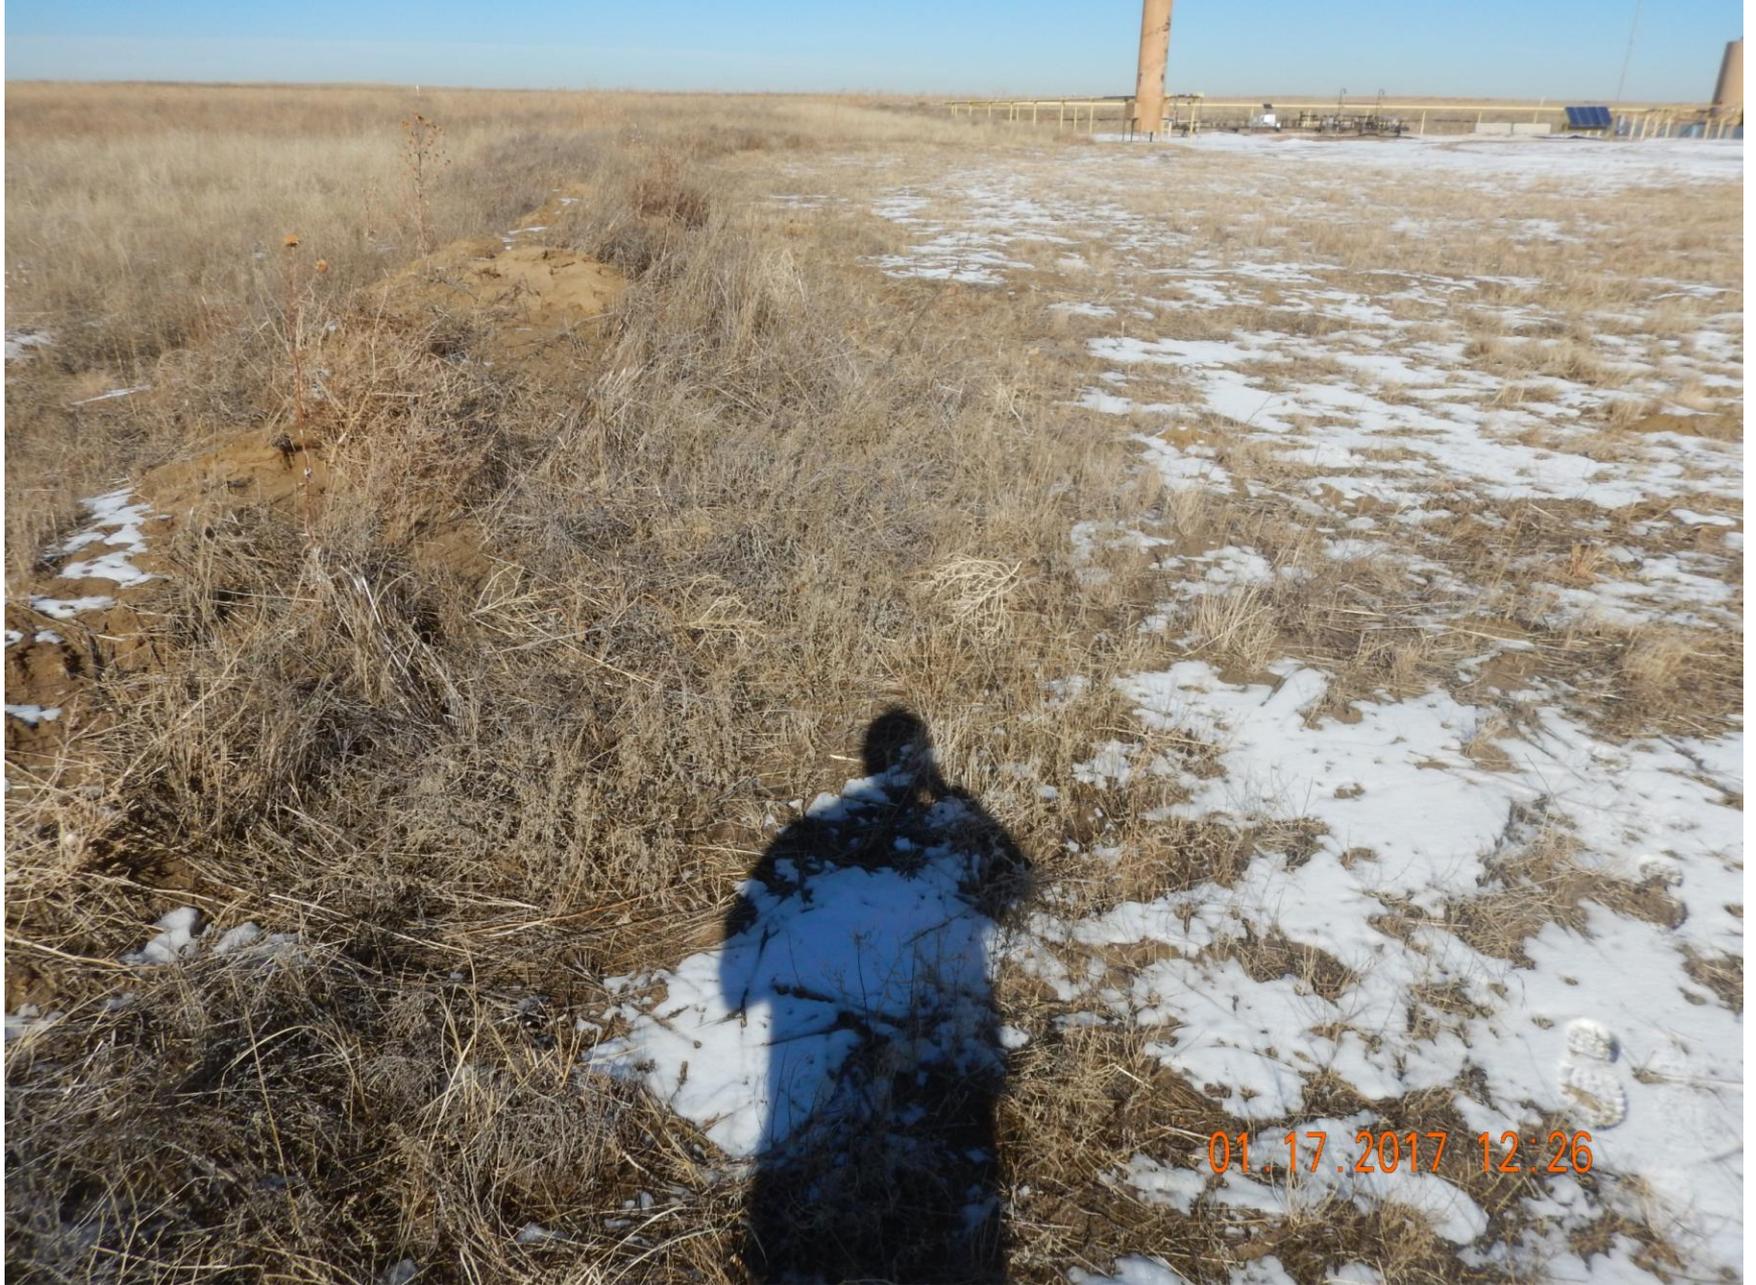
Figure 6: Photo taken from the southwest end of the location, facing north. Photo shows vegetation over the interim area. Vegetation over interim area predominantly undesirable weedy species such as russian thistle.

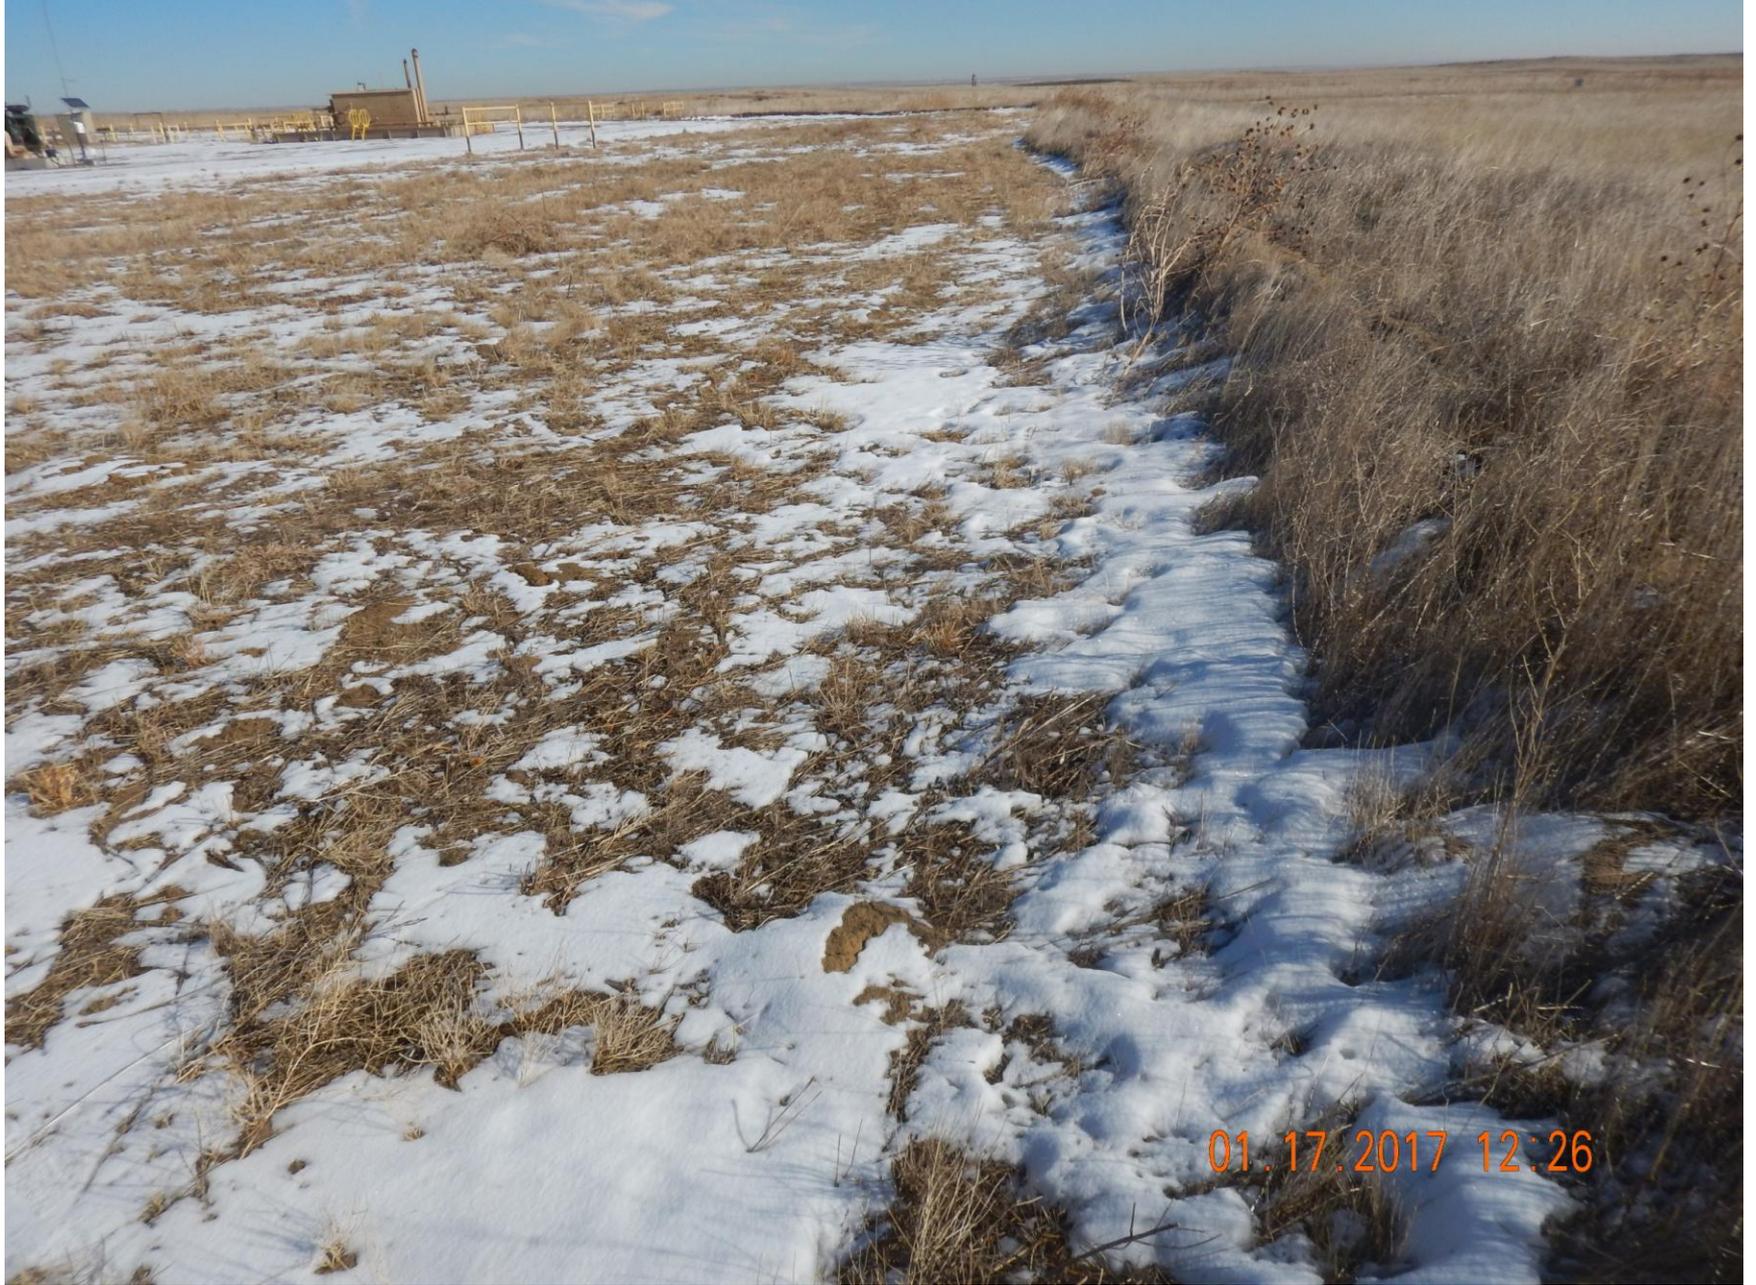
Figure 7: Photo taken from the southwest end of the location, facing east. Photo shows vegetation over the interim area. Vegetation over interim area predominantly undesirable weedy species such as russian thistle.

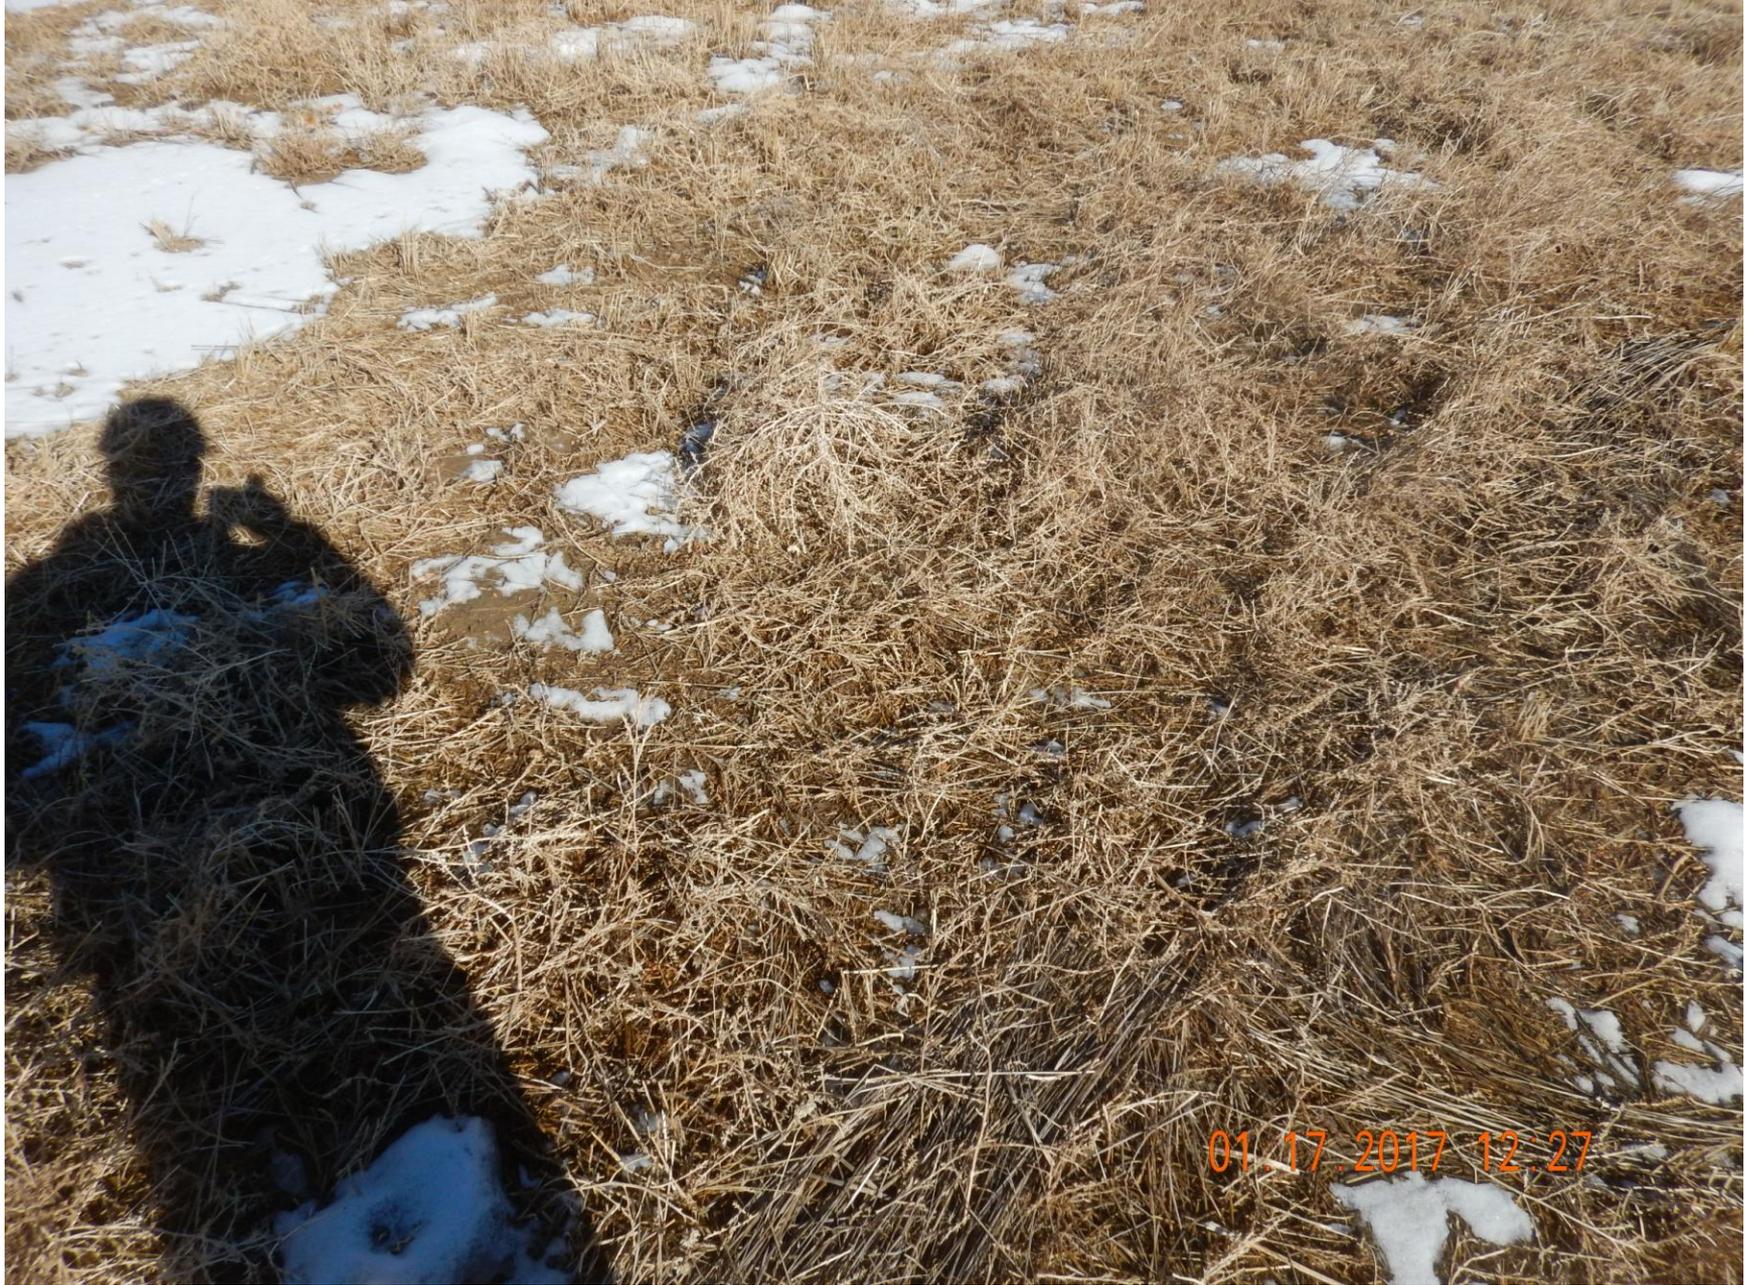
Figure 8: Photo taken from the south end of the location. Photo shows vegetation over the interim area. Vegetation over interim area predominantly undesirable weedy species such as russian thistle. Very little desirable perennial vegetative growth evident.

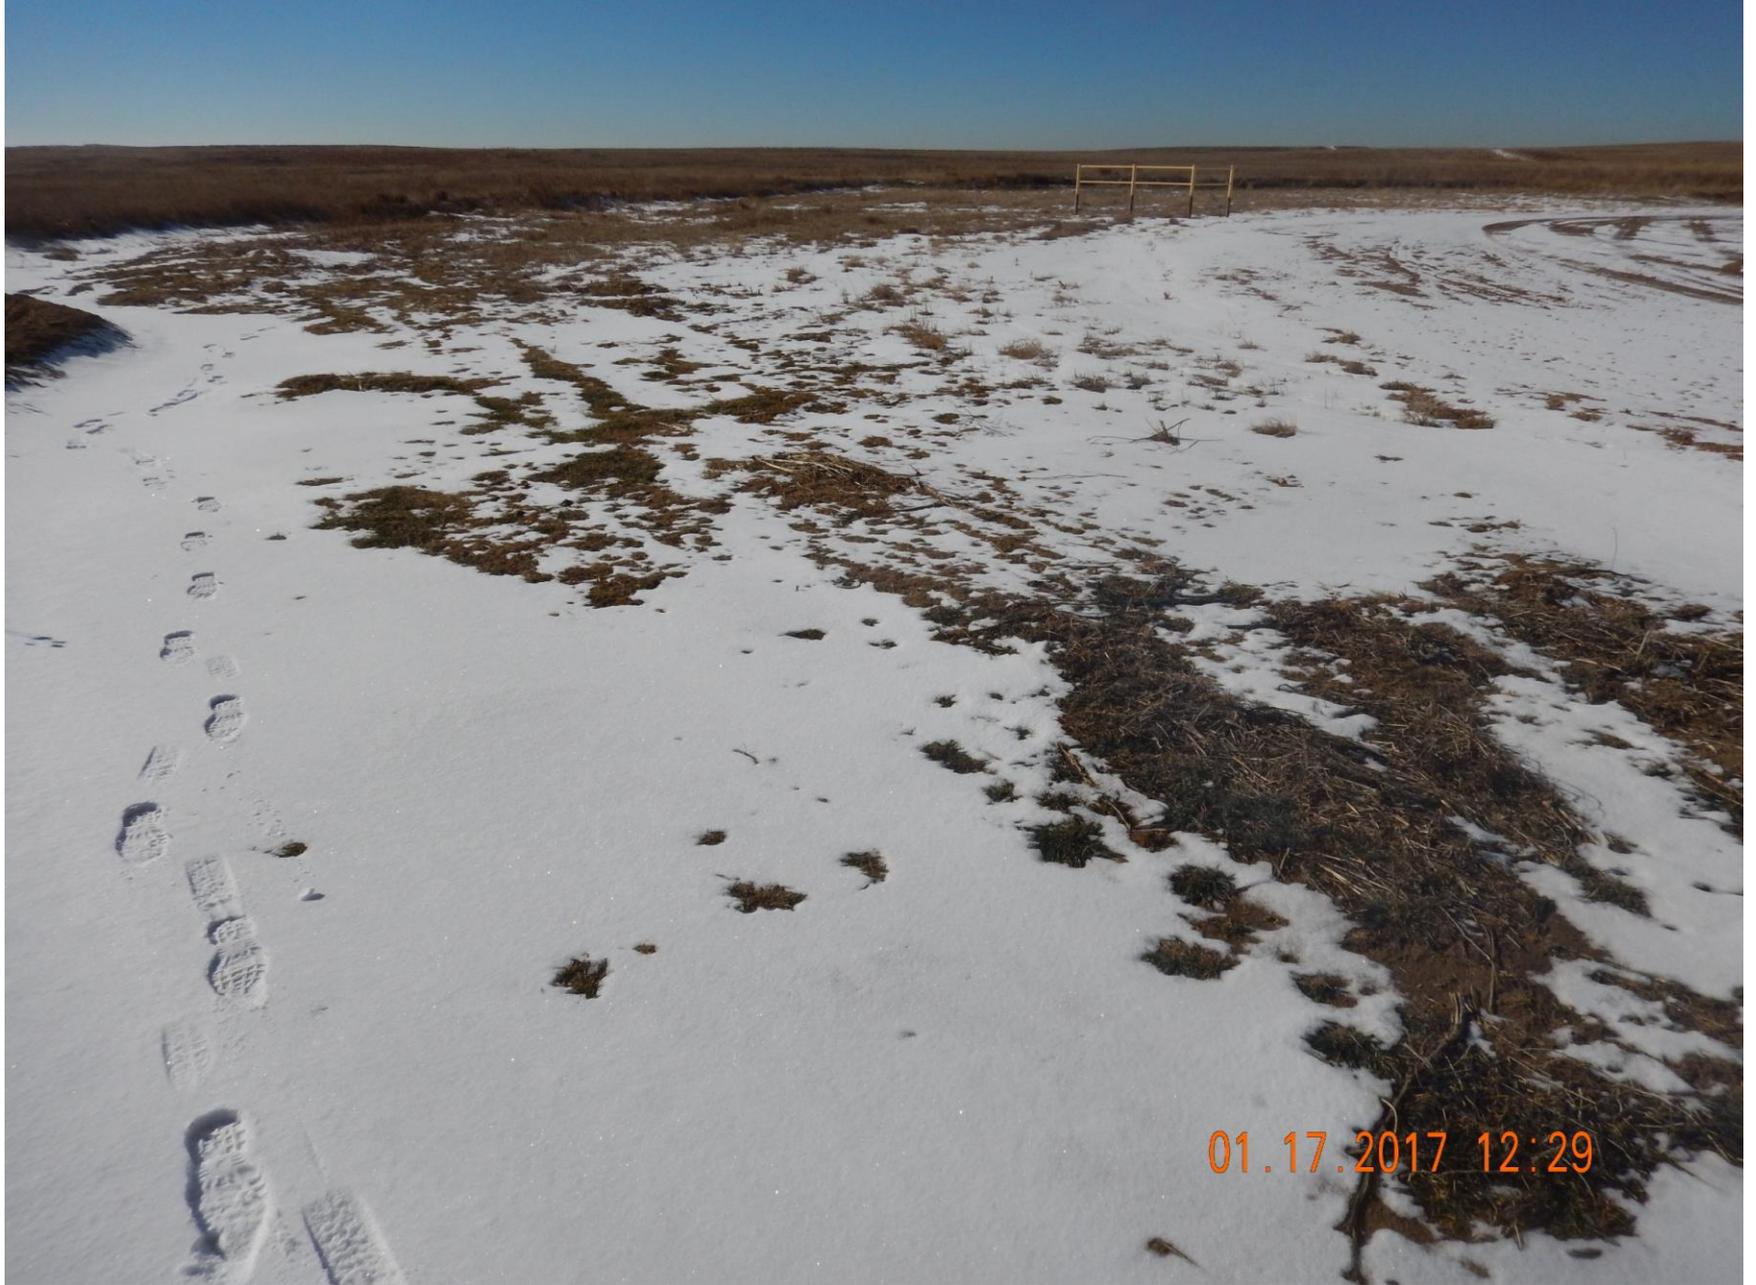
Figure 9: Photo taken from the southeast end of the location, facing west. Photo shows vegetation over the interim area. Vegetation over interim area predominantly undesirable weedy species such as russian thistle.
