# Inspection Photos

Operator: Klabzuba O&G #10148

Location ID: 393701

Inspection Doc. Number: 682501780

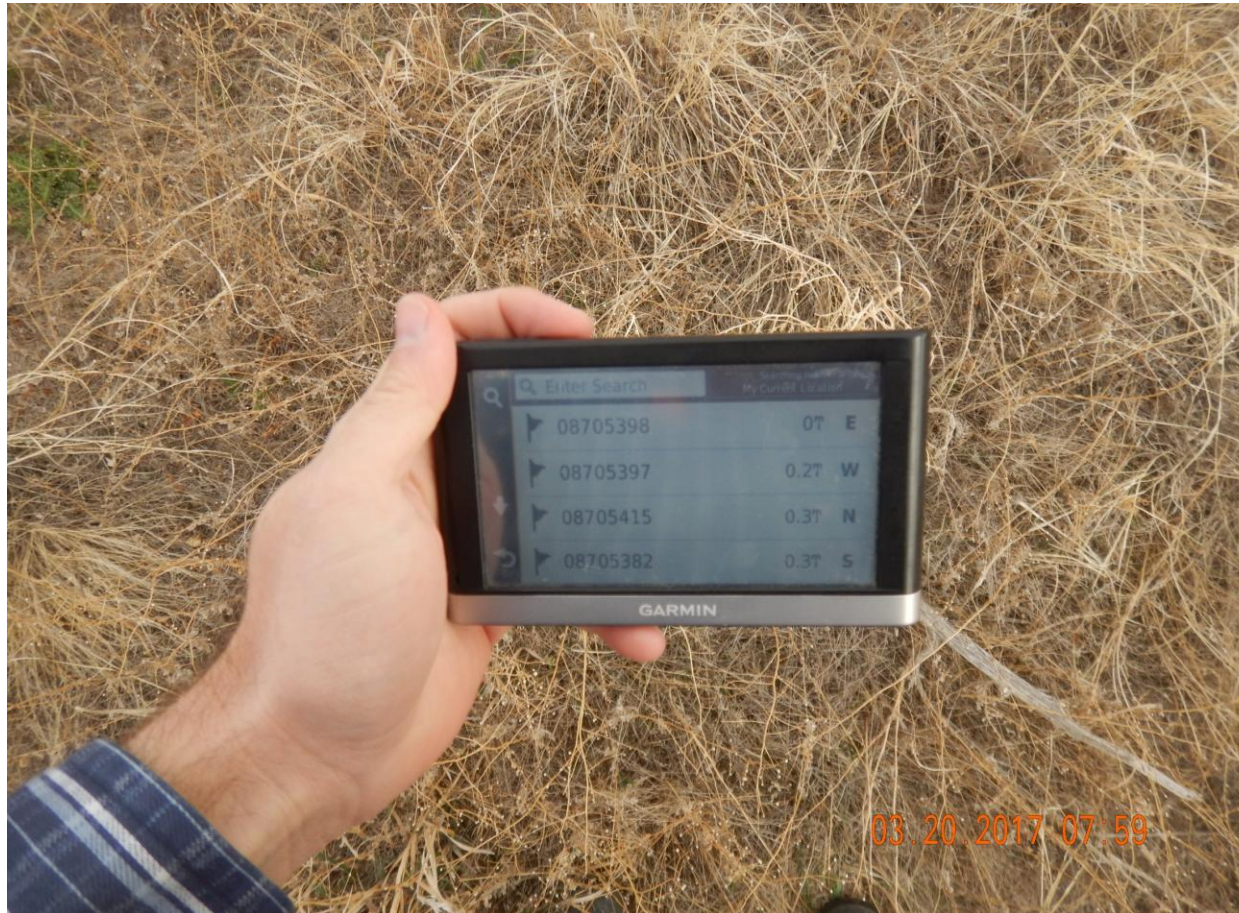
**Photo 1:** Photo of GPS verifying location.

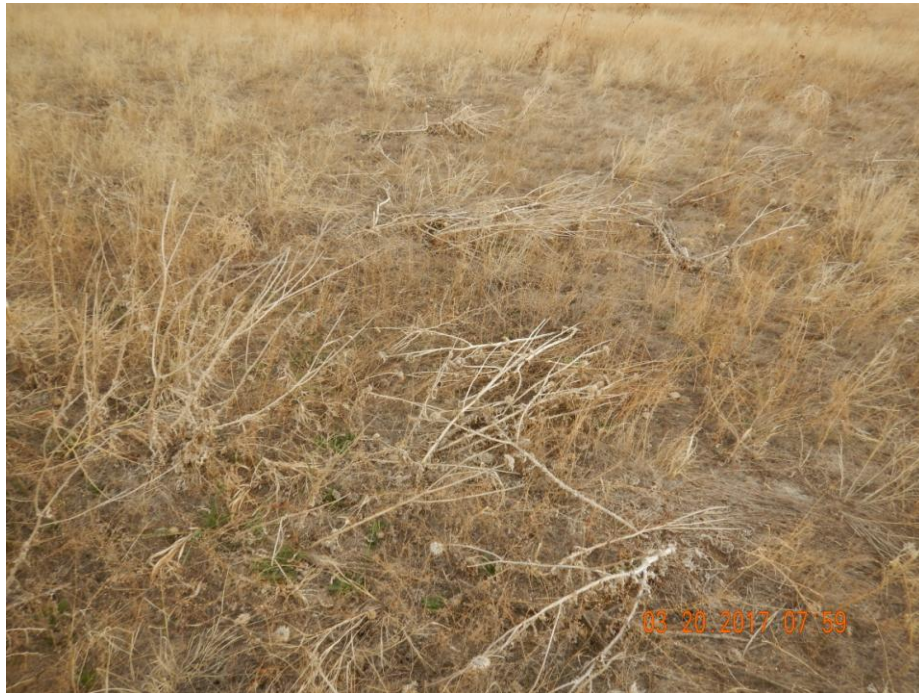
**Photo 2:** Photo taken from the location. Photo shows remnant Musk thistle stalks from 2016 growing season. Musk thistle is a Colorado State listed Noxious Weed and needs to be managed. Photo also shows vegetation in the disturbance area predominantly undesirable weedy cheat grass.

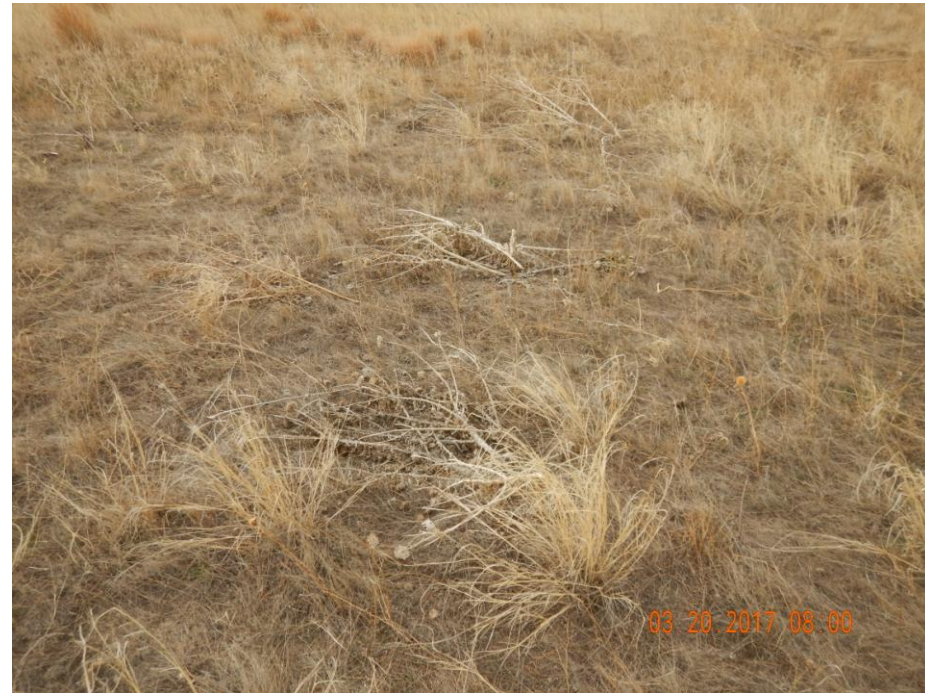
**Photo 3:** Photo taken from the location. Photo shows remnant Musk thistle stalks from 2016 growing season. Musk thistle is a Colorado State listed Noxious Weed and needs to be managed. Photo also shows vegetation in the disturbance area predominantly undesirable weedy cheat grass.

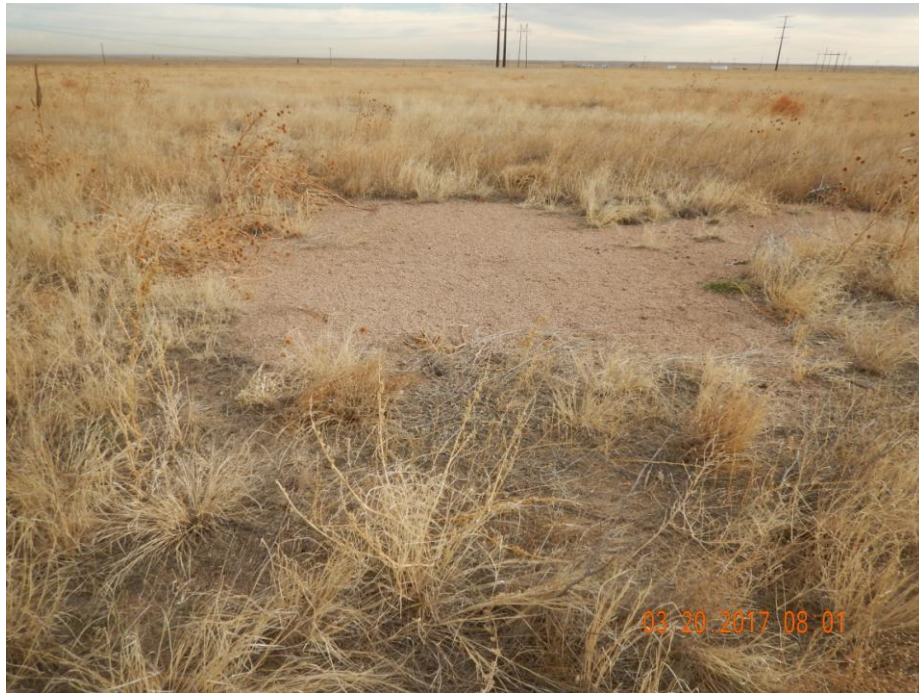
**Photo 4:** Photo taken from the location, facing north. Photo shows large areas that remain unvegetated and graveled.

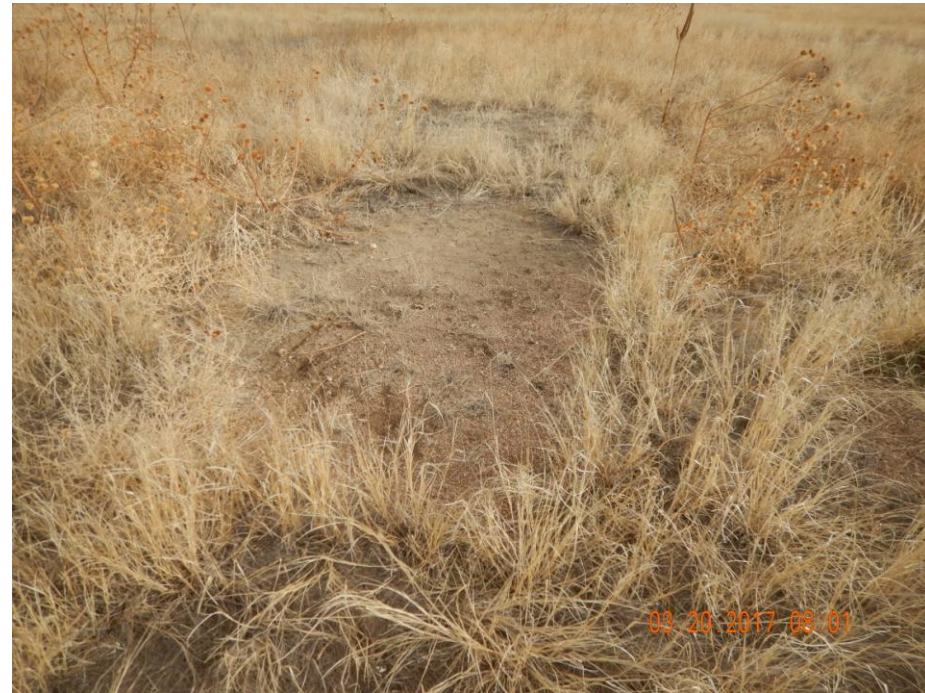
**Photo 5:** Photo taken from the location, facing north. Photo shows large areas that remain unvegetated and graveled.

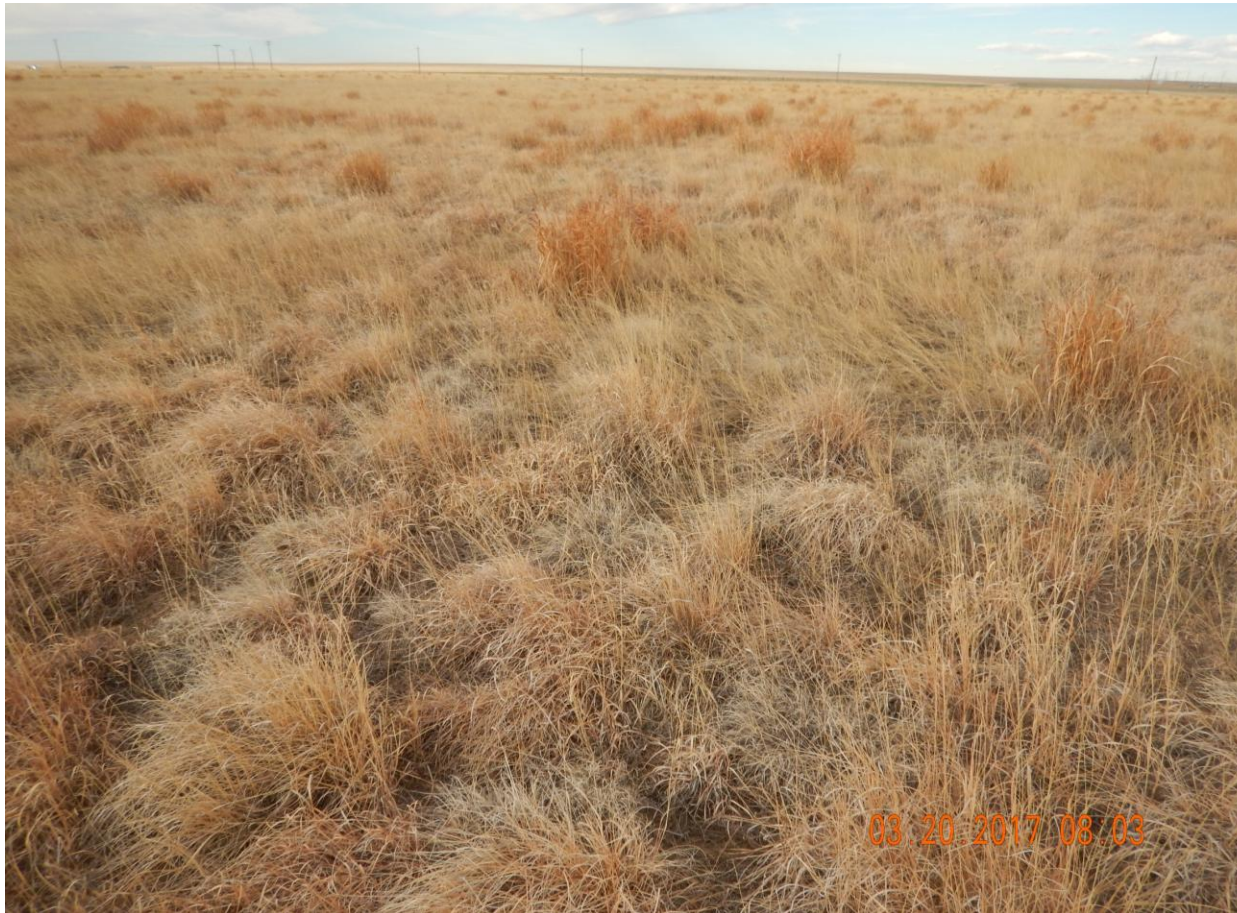
**Photo 6:** Photo of vegetation in the reference area. Vegetation seen here predominantly a mix of sideoats grama, western wheat, switch grass and little bluestem.
