# Flowline Inspection

May 22, 2017

Operator: OLDS OIL CORPORATION- #65888

API: 05-069-05014

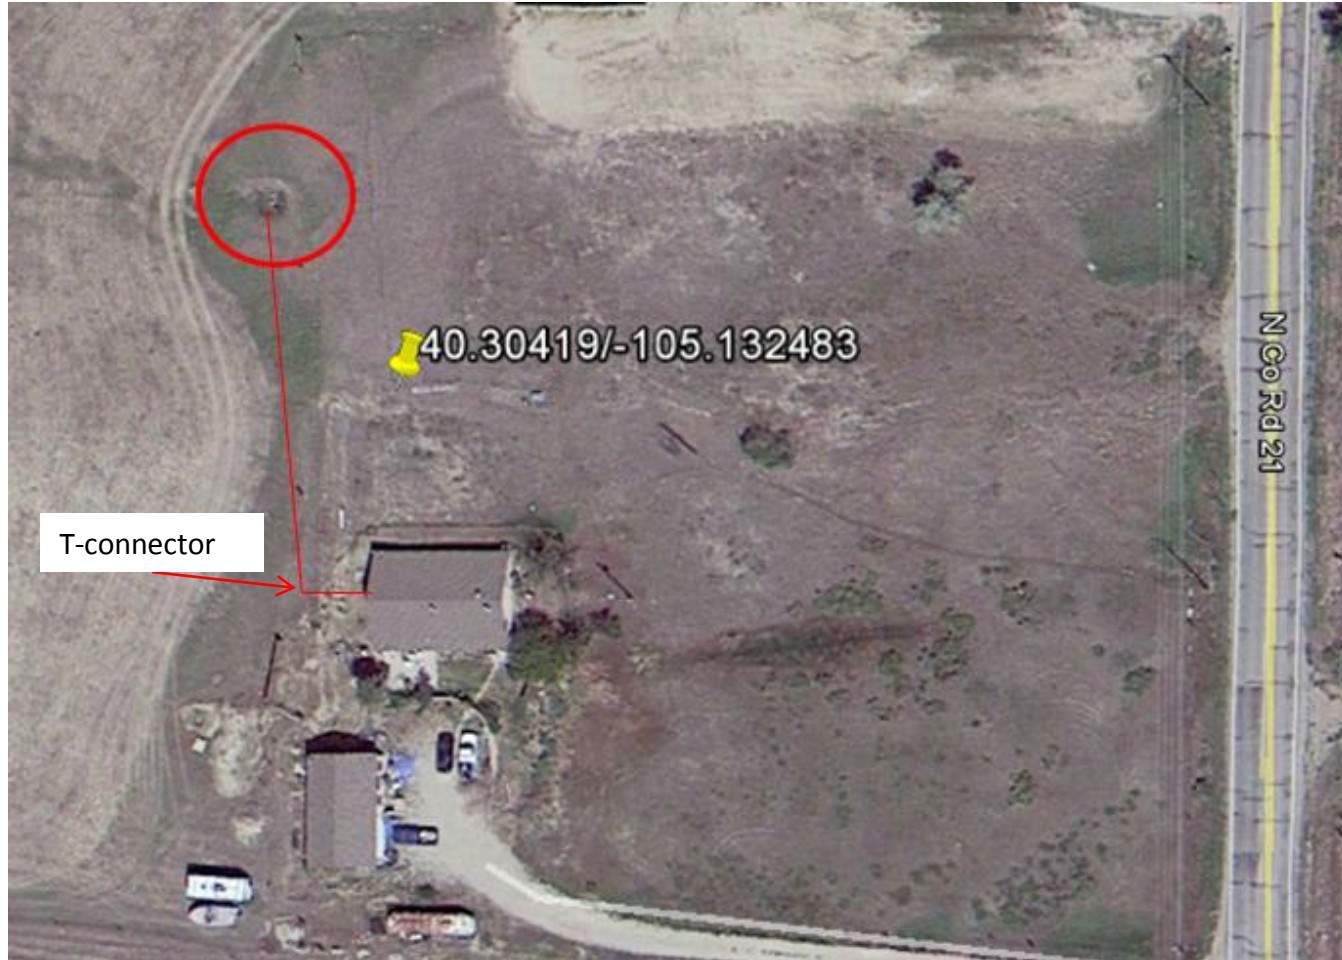
Google Earth aerial imagery from 8/8/2012 illustrating the depressed area (red circle) that was identified as the well from a previous inspection. A partially buried flowline appears to travel south from the depressed area, then has a T-connector west of the house that then connects into the house. The flowline appears to continue south from the T-connector west of the house.

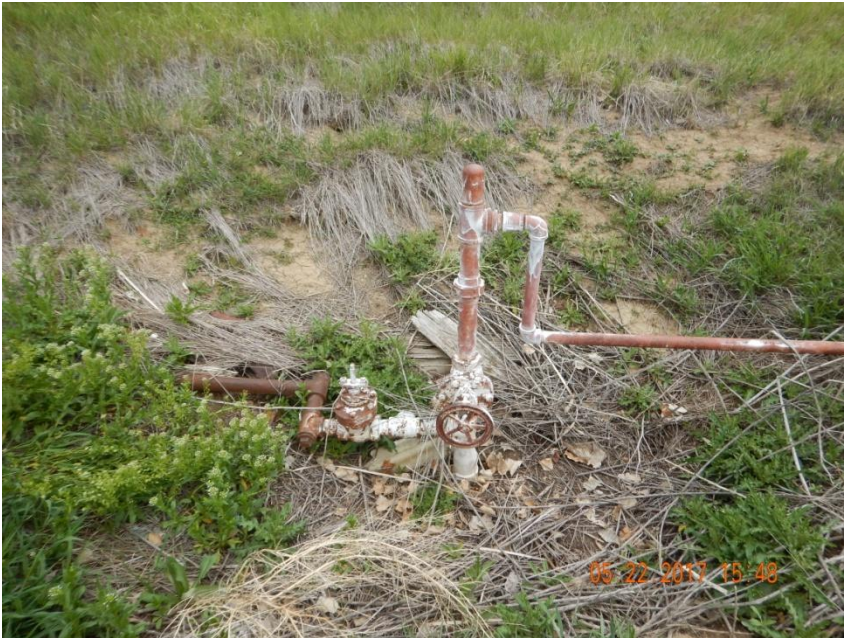
**Photo 1.** Photo taken from the depressed area, facing North. A partially buried flowline from this setup appears to be connected to the house illustrated in the previous aerial photo.

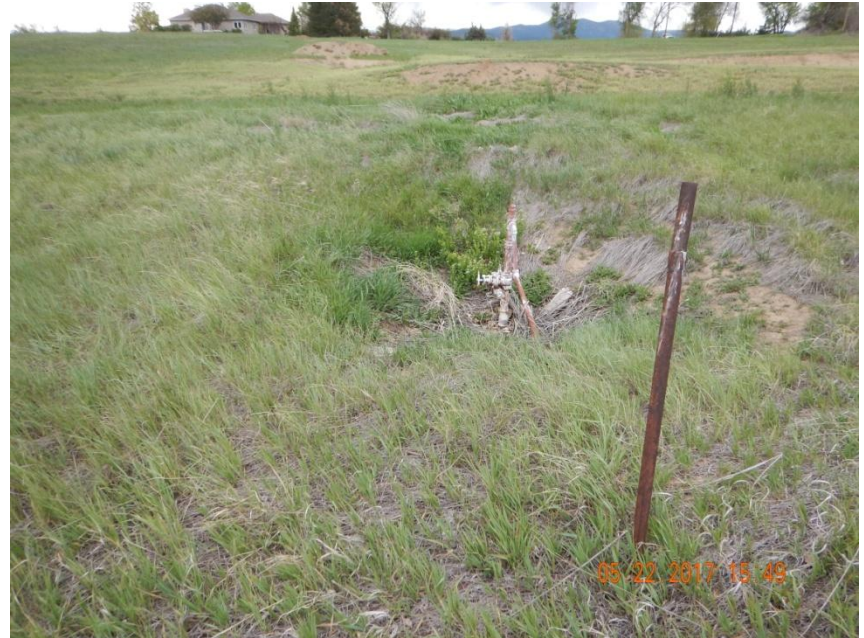
**Photo 2.** Photo taken east ~10' east of the depressed area, facing West. A partially buried flowline from this setup appears to be connected to the house illustrated in the previous aerial photo.
