Inspection Photos

Operator: BARRETT CORPORATION* BILL -
10071

Location ID: 318664

Inspection Doc. Number: 682502290

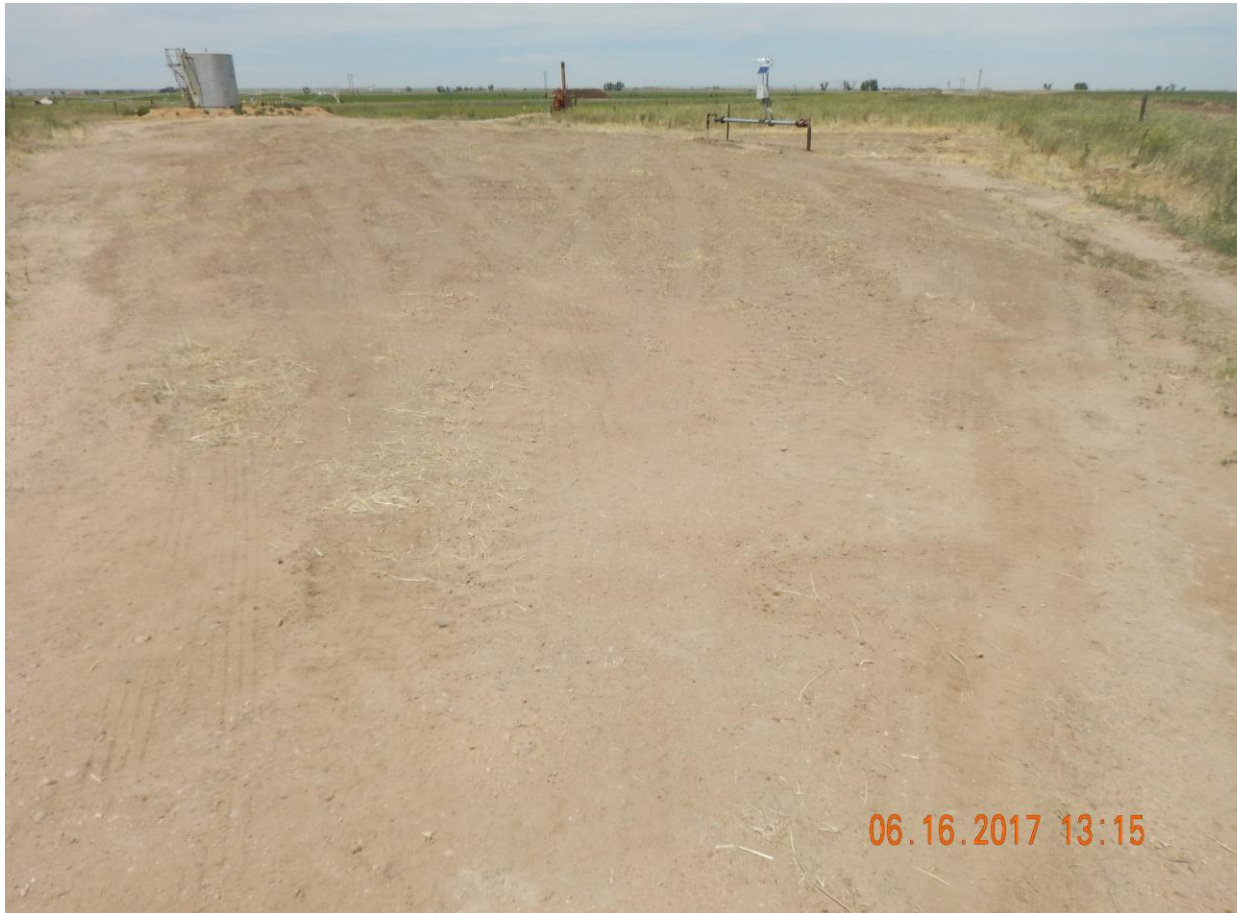
Photo 1: Photo taken from the south end of the tank battery location, facing north. Per CA from inspection doc. #682502057. Reclamation in process. Site stabilization of the location will need to occur per 1003.b
