# Flowline and Final Reclamation Inspection

Operator: SOVEREIGN OPERATING COMPANY LLC- #10383

API: 05-014-09147

Inspection Photos  
Location Name: BROZOVICH #MA 8-11  
API: 05-014-09147

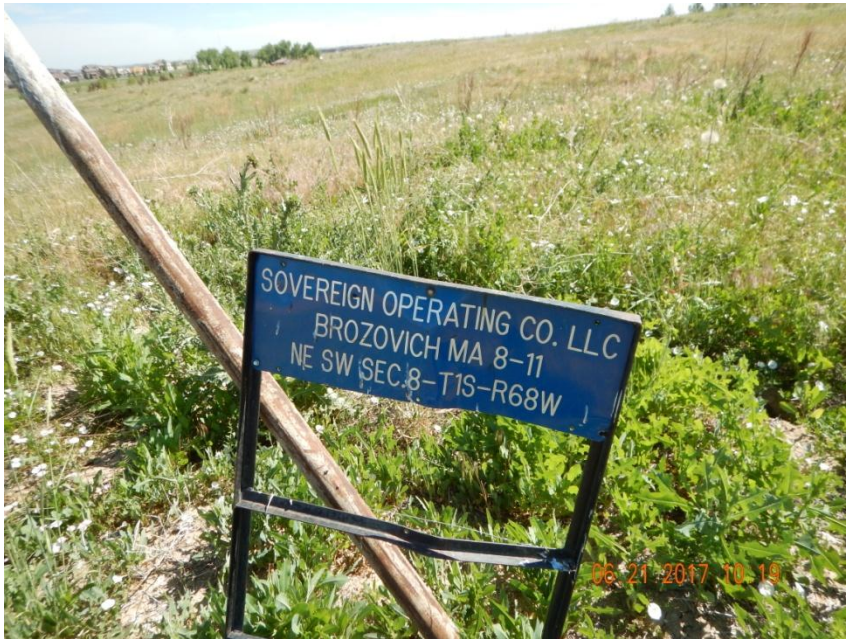
**Photo 1.** Photo taken from the well location. Operator needs to remove the sign from the location.

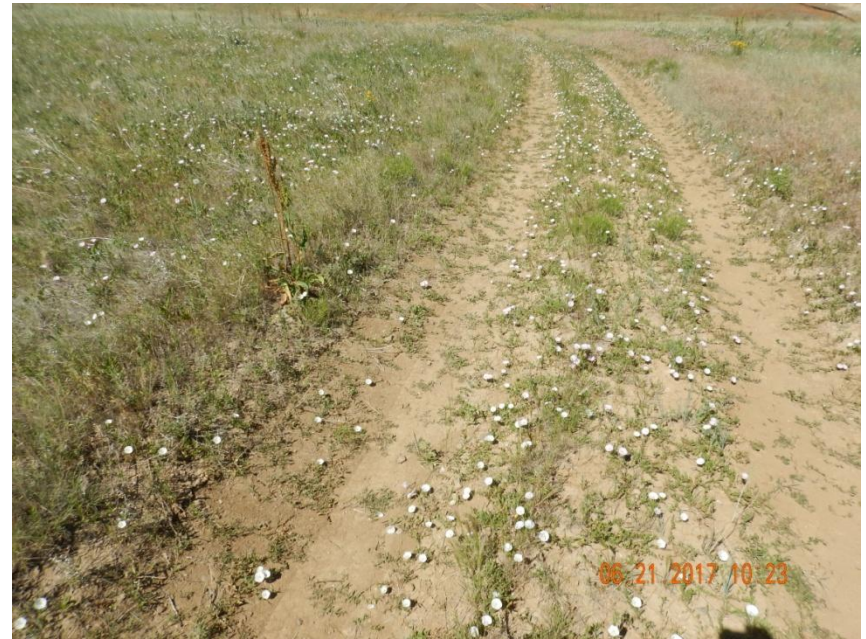
**Photo 2.** Photo taken along a portion of the access, east of the well location, facing West. Access road has not been regraded and contoured per Rule 1004.

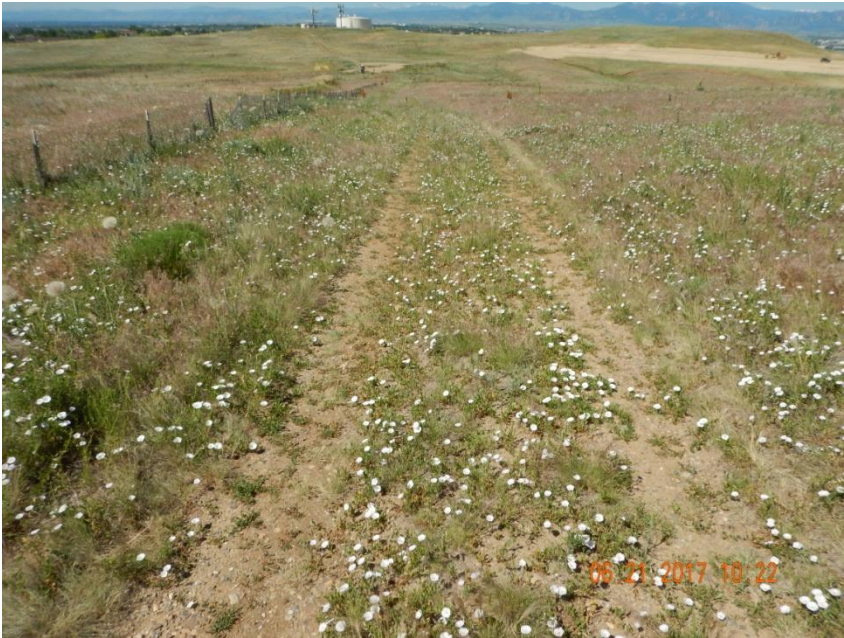
**Photo 3.** Photo taken along a portion of the access, south of the well location, facing West. Access road has not been regraded and contoured per Rule 1004.
